# Pre Purchase Inspection Report

## Inspectmate Pty Ltd

Report/Agreement # 25082509092479

Inspection Date: 25 Aug 2025

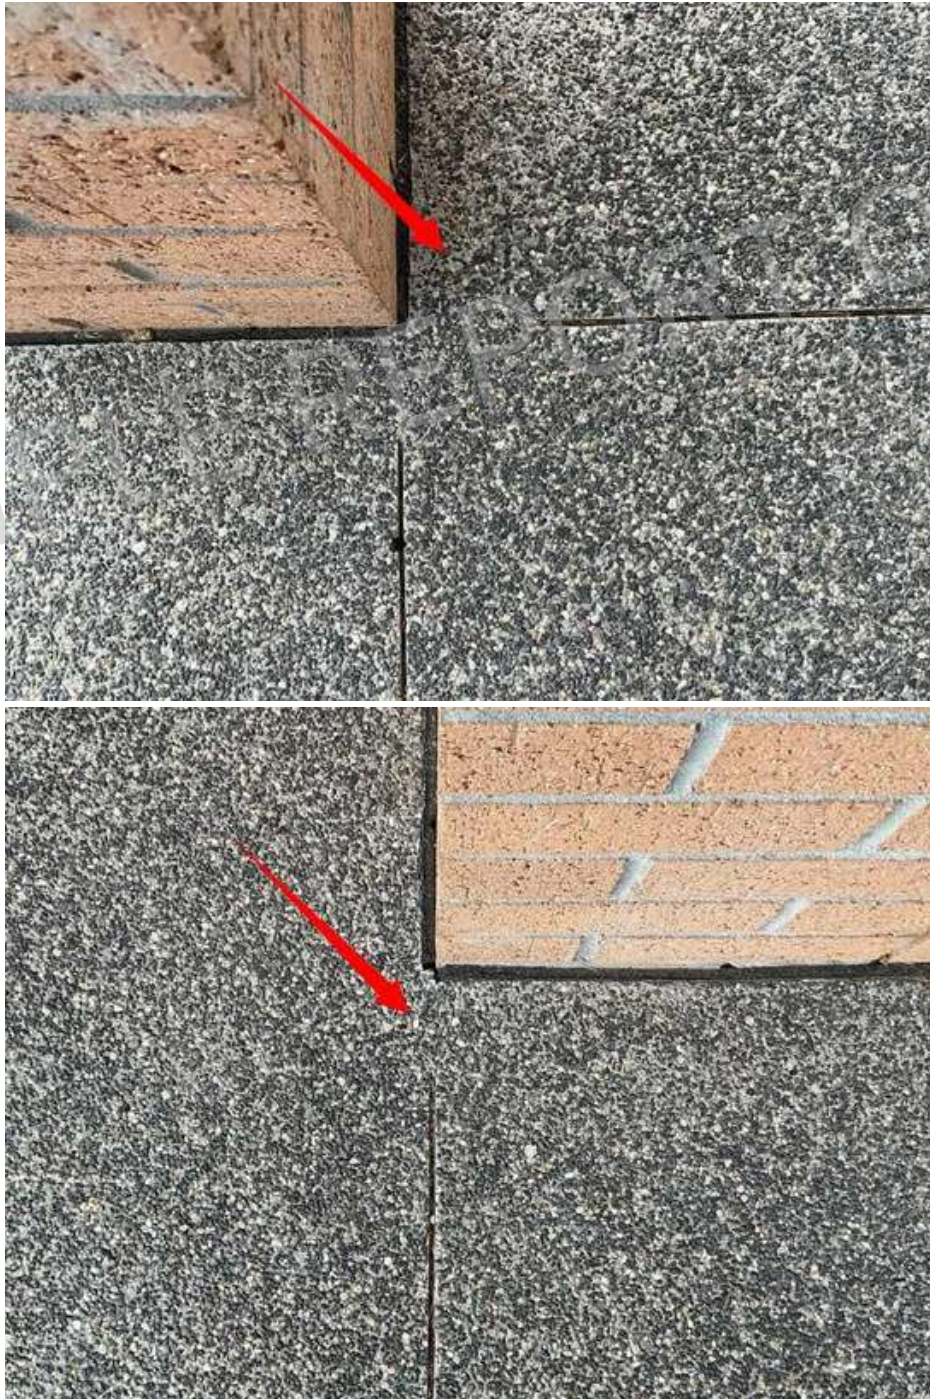
#### Driveway Condition(1)

Common cracks were observed on the driveway. Whilst these cracks appeared to be typical at the time of inspection, we strongly recommend you monitor these cracks and if worsening occurs contact a concreter for further advice.

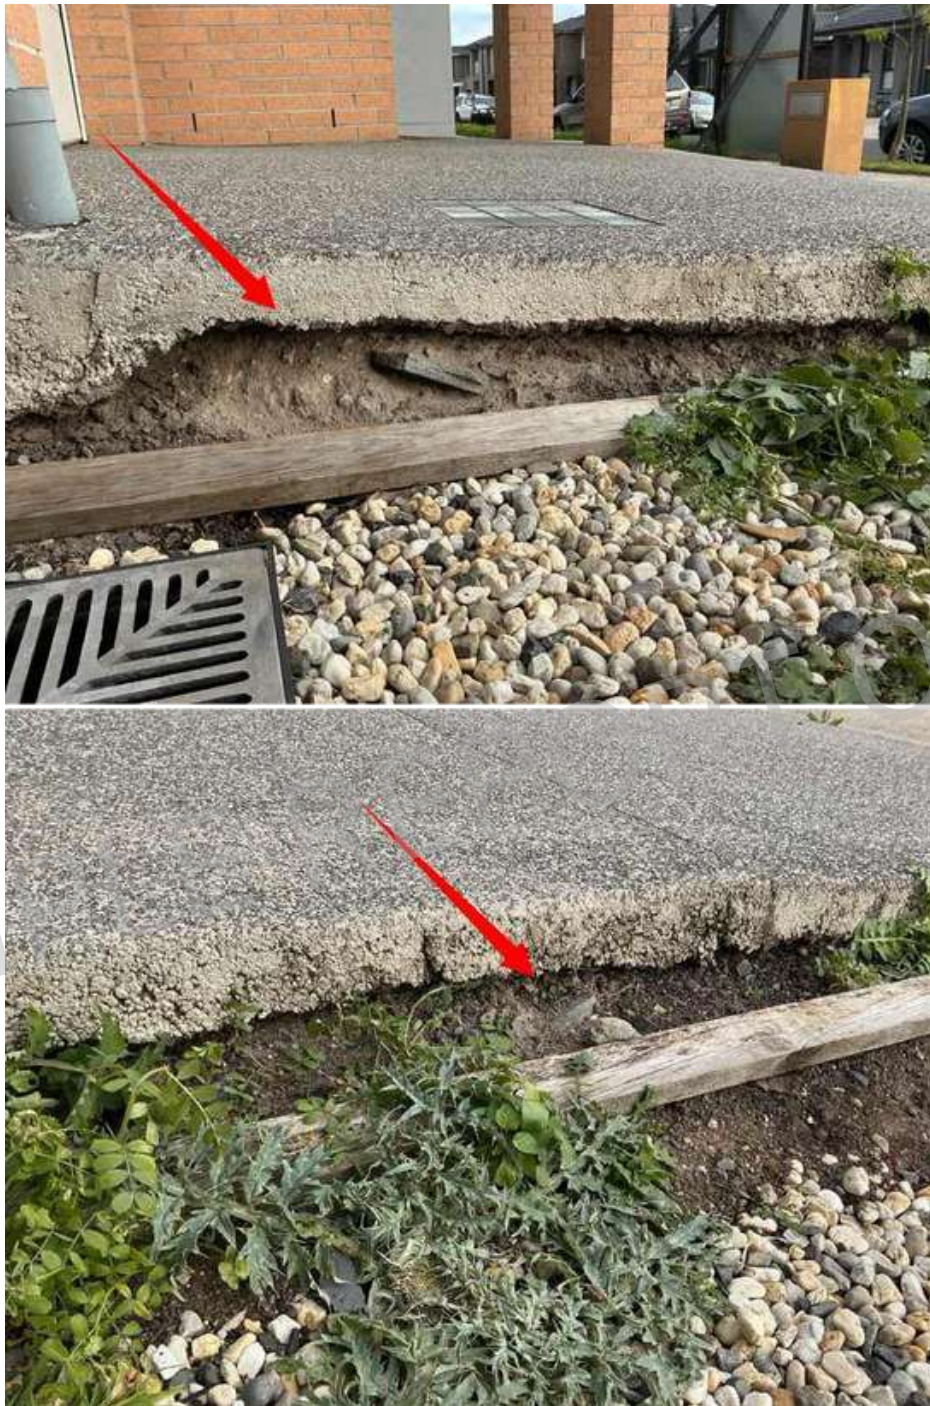
## Driveway Condition(2)

| Section | Location | Name | Comment |
|---|---|---|---|
| SITE & CONCRETED AREAS | Driveway | Driveway Condition(2) | Upon visual inspection, the concrete sub-surface reveals inadequate base preparation. It is recommended to engage a licensed contractor to assess the sub surface and ensure compliance with industry standards and prevent future complications. |

Upon visual inspection, the concrete sub-surface reveals inadequate base preparation. It is recommended to engage a licensed contractor to assess the sub surface and ensure compliance with industry standards and prevent future complications.

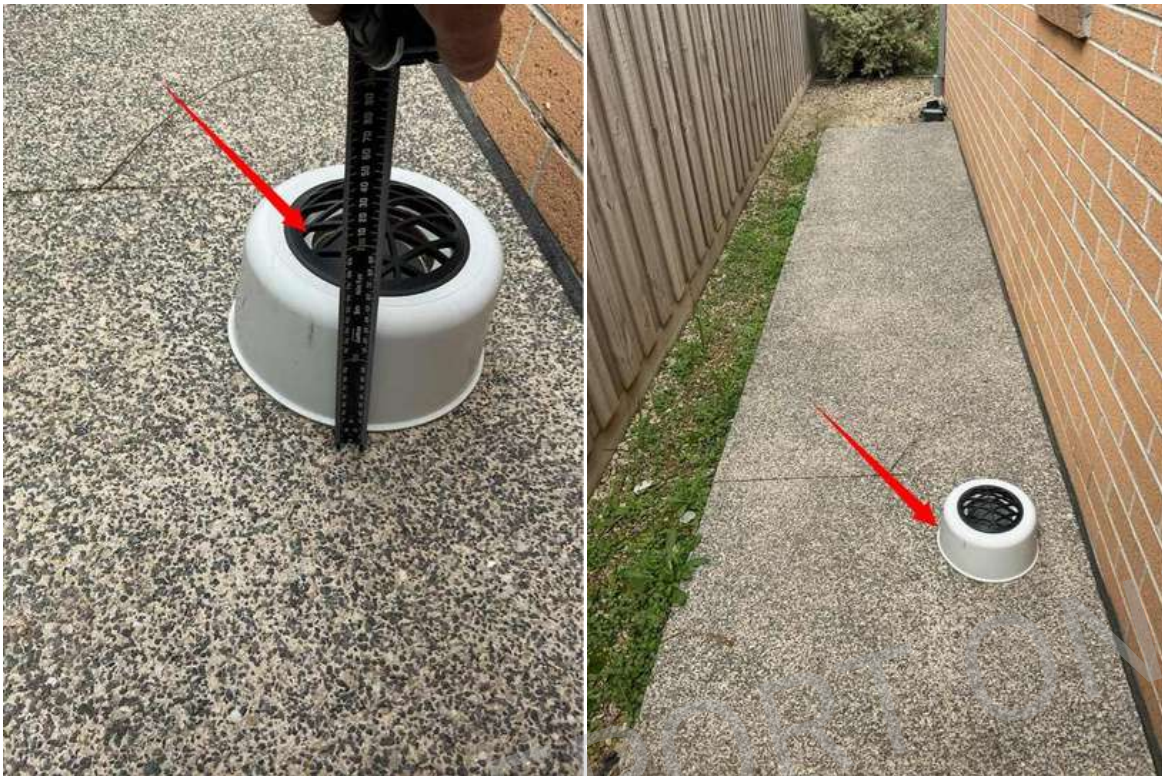
| Section | Location | Name | Comment |
|---|---|---|---|
| SITE & CONCRETED AREAS | Surface Drainage | Drains | Upon visual inspection, the overflow release gully heights are inadequate, posing a risk of water ingress. It is recommended to adjust the gully heights to meet standard regulations. Engage a licensed plumber to ensure proper installation and compliance with local codes. Regular maintenance checks should be scheduled to prevent future issues and ensure the system functions effectively. |

Upon visual inspection, the overflow release gully heights are inadequate, posing a risk of water ingress. It is recommended to adjust the gully heights to meet standard regulations. Engage a licensed plumber to ensure proper installation and compliance with local codes. Regular maintenance checks should be scheduled to prevent future issues and ensure the system functions effectively.

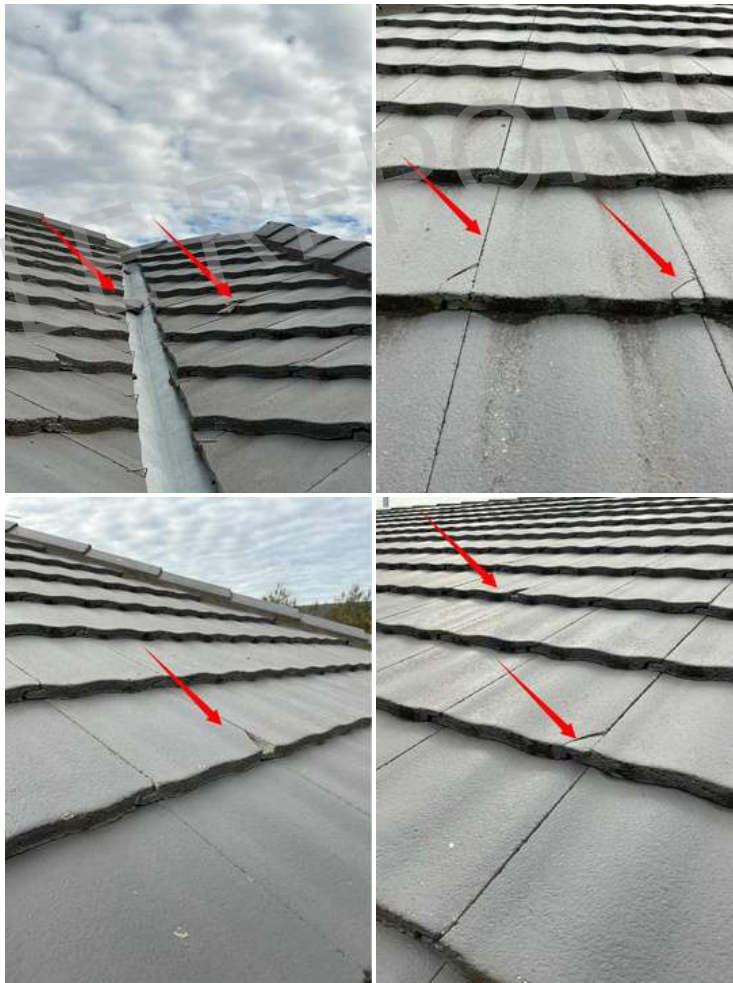
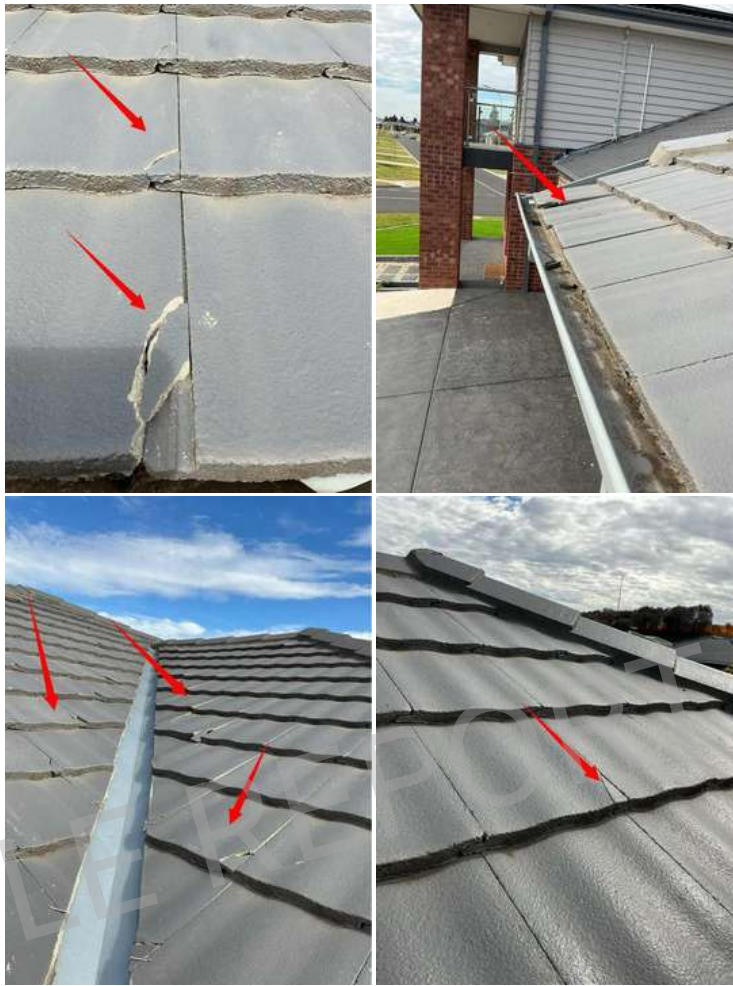
| Section | Location | Name | Comments |
|---|---|---|---|
| ROOF AND GUTTER | Roof Covering | Roof Clad Condition(1) | Cracked tiles were visible. Contact a roof tiler for repairs. This has the potential to become a serious issue if left unattended, as it may allow water ingress into the roof cavity |

Cracked tiles visible. Contact a roof tiler for repairs. This has potential to become a serious issue if repairs aren't carried out due to water ingress into the roof cavity.

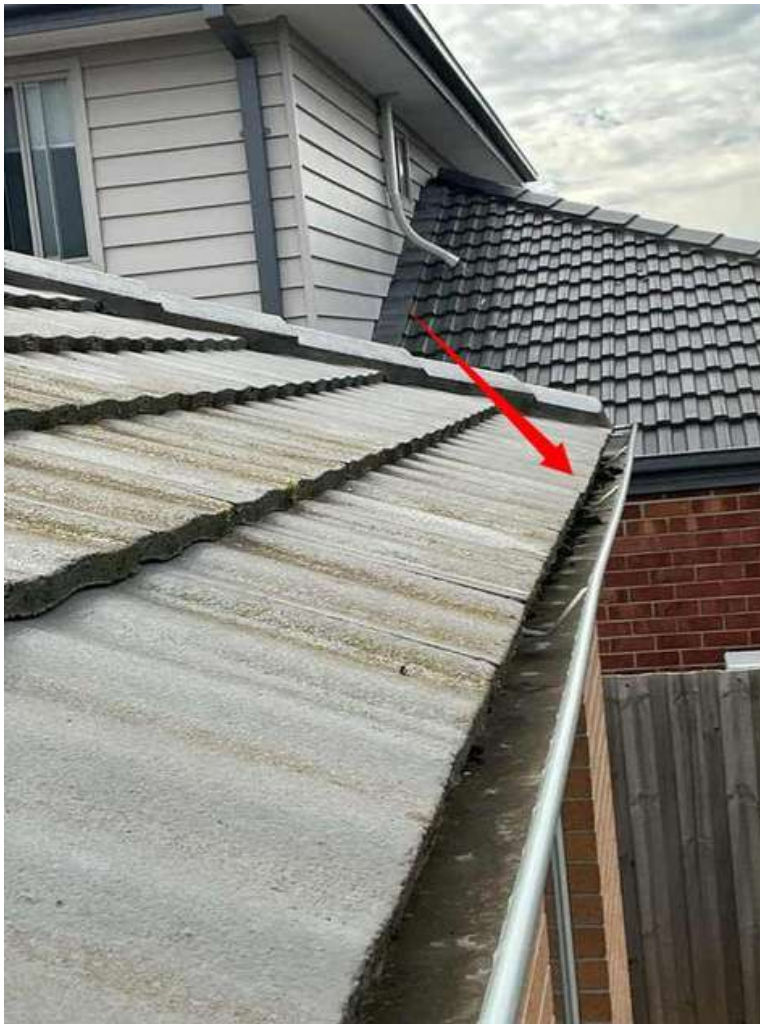
| Section | Location | Name | Comments |
|---|---|---|---|
| ROOF AND GUTTER | Guttering | Gutter Findings | Debris was noted in guttering areas. This requires cleaning to prevent blocked downpipes and leaking into eaves and fascia<br>Have gutters cleaned and assessed by a plumber for adequate fall. Regular maintenance is required to prevent ponding, which can contribute to rust. |

Debris in guttering areas- this requires cleaning out to prevent blocking of downpipes and leaking into eaves and fascia. Have gutters cleaned and assessed by a plumber for adequate fall. Regularly clean to prevent ponding. Ponding water will contribute to rust.

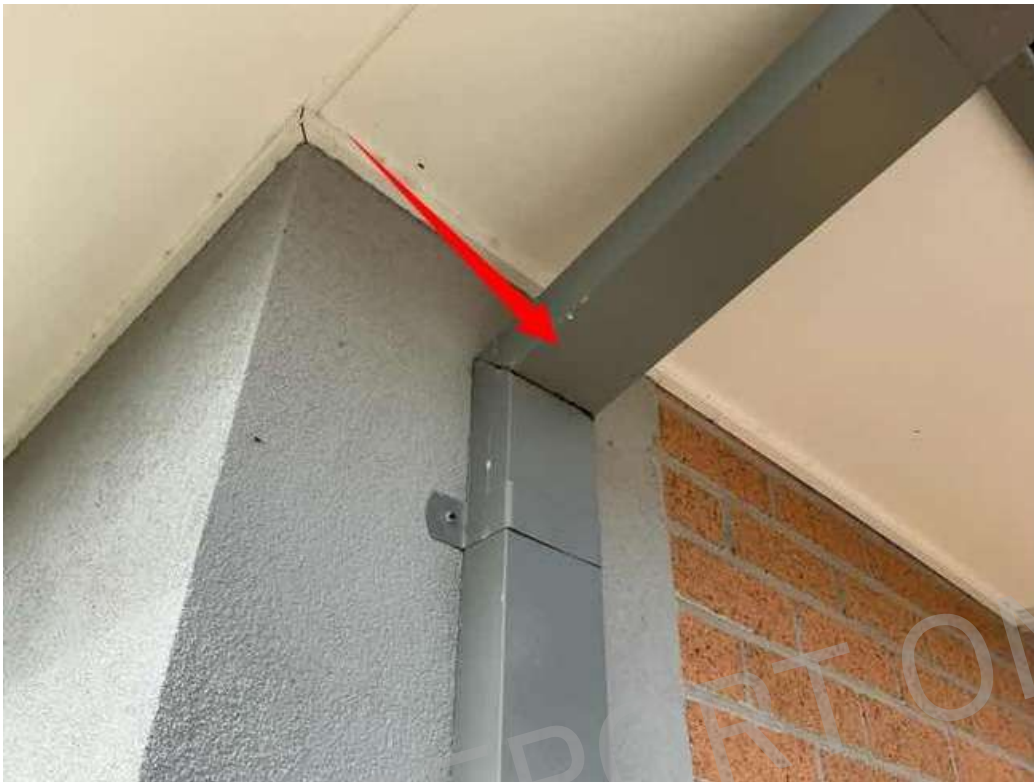
| Section | Location | Name | Comments |
|---|---|---|---|
| ROOF AND GUTTER | Downpipes | Downpipe Findings | Leaking downpipe joints were visible. This can be conducive to termite infestation and cause water damage to cladding over time. A qualified roof plumber should be engaged for repairs. |

Leaking downpipe joints visible. This can be conducive to termite infestation and cause water damage to cladding over time. A qualified roof plumber should be engaged to repair.

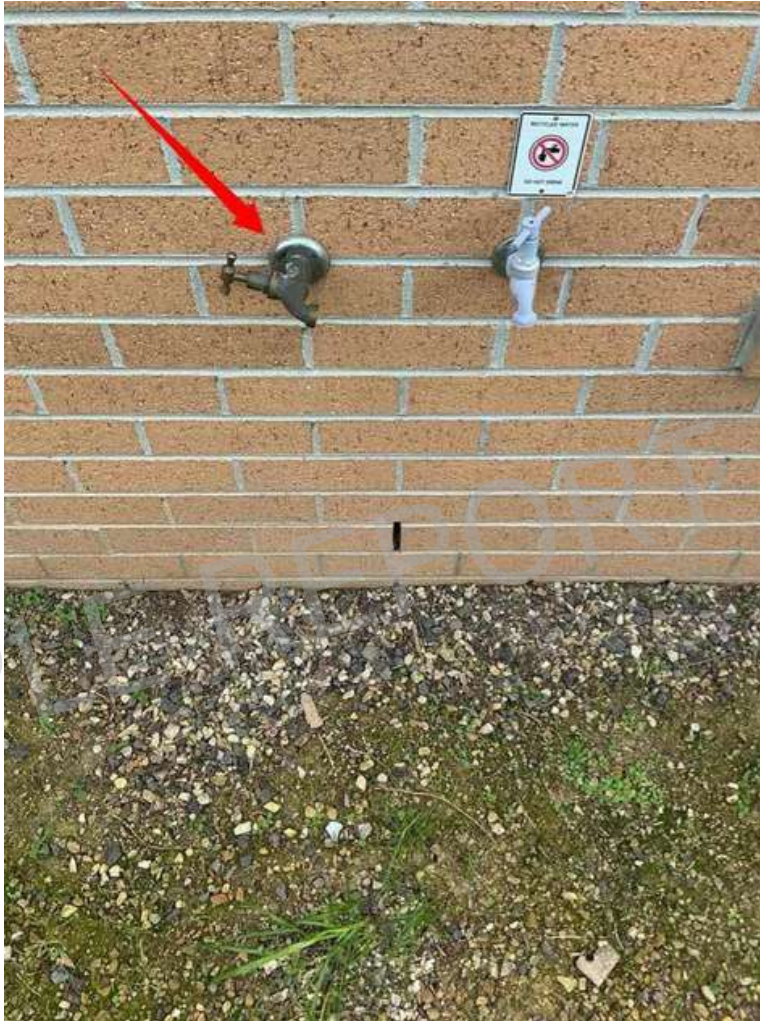
| Section | Location | Name | Comments |
|---|---|---|---|
| HOT WATER SYSTEM | External Plumbing Pipes | Plumbing Pipes | An external tap was noted without visible drainage. Engage a licensed plumber to assess and install proper drainage to prevent water accumulation and damage. Immediate attention is advise |

Upon visual inspection, the tap lacks visible drainage. It is recommended to engage a licensed plumber to assess and rectify the issue. The plumber should ensure proper drainage installation to prevent water accumulation and potential damage. Immediate attention is advised to maintain functionality and prevent further complications.

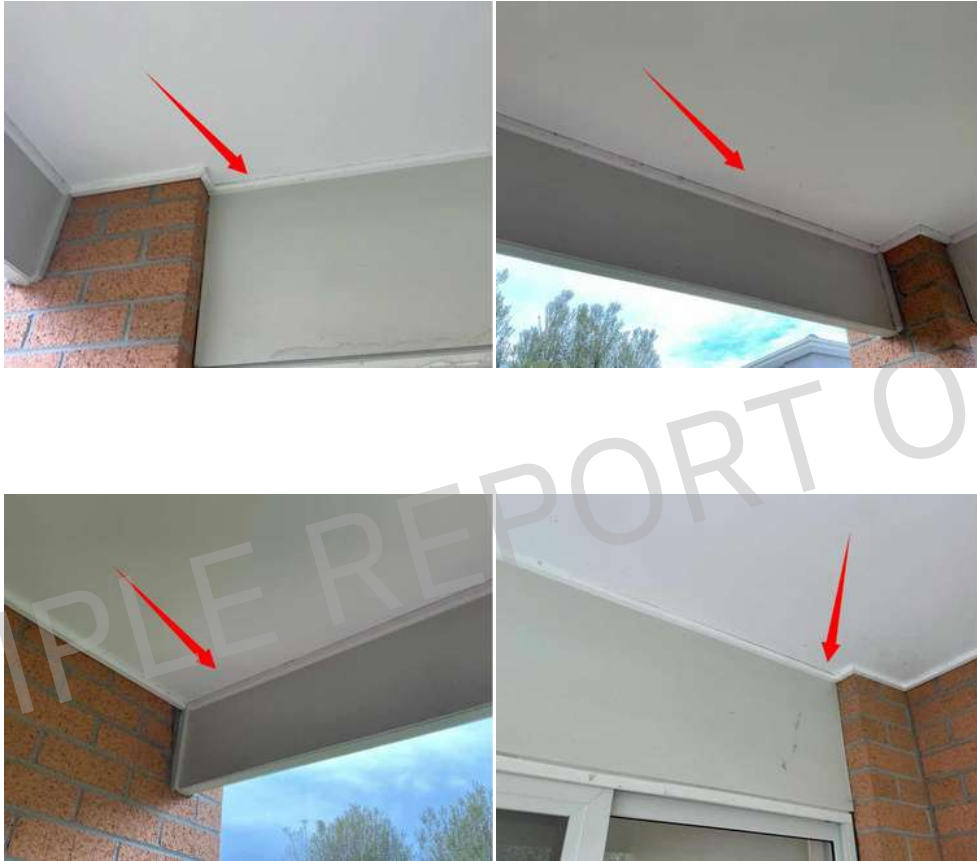
Ceilingliningjointcracks.Contact a qualified painter for repairs.

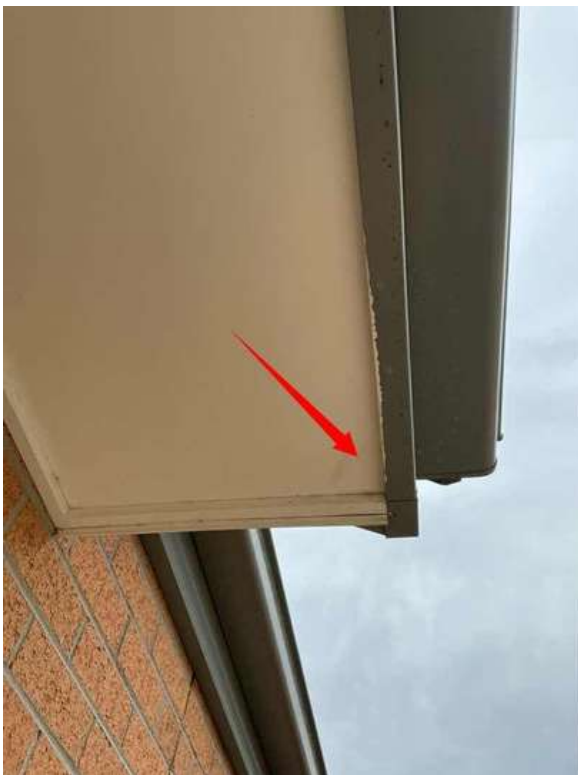
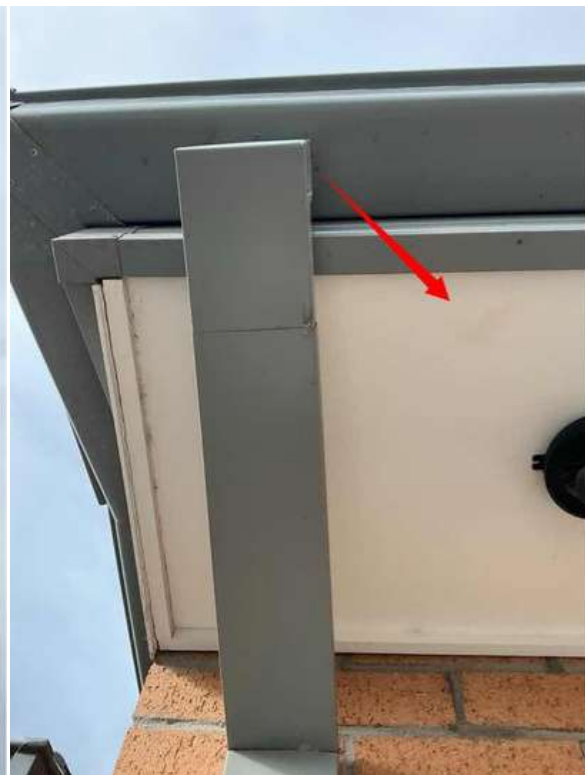
| Section | Location | Name | Comments |
|---|---|---|---|
| EXTERIOR | Eaves | Eave Condition | Eave lining stains were observed, likely due to overflow from blocked gutters.<br>Recommendation: Keep gutters clear of debris. Paint or repair affected eave linings as required. |

Eave lining stains observed. Normally this occurs due to overflow in blocked gutters. Recommendations. Gutters should be kept clear of debris and eave linings can then be painted or repaired as required.

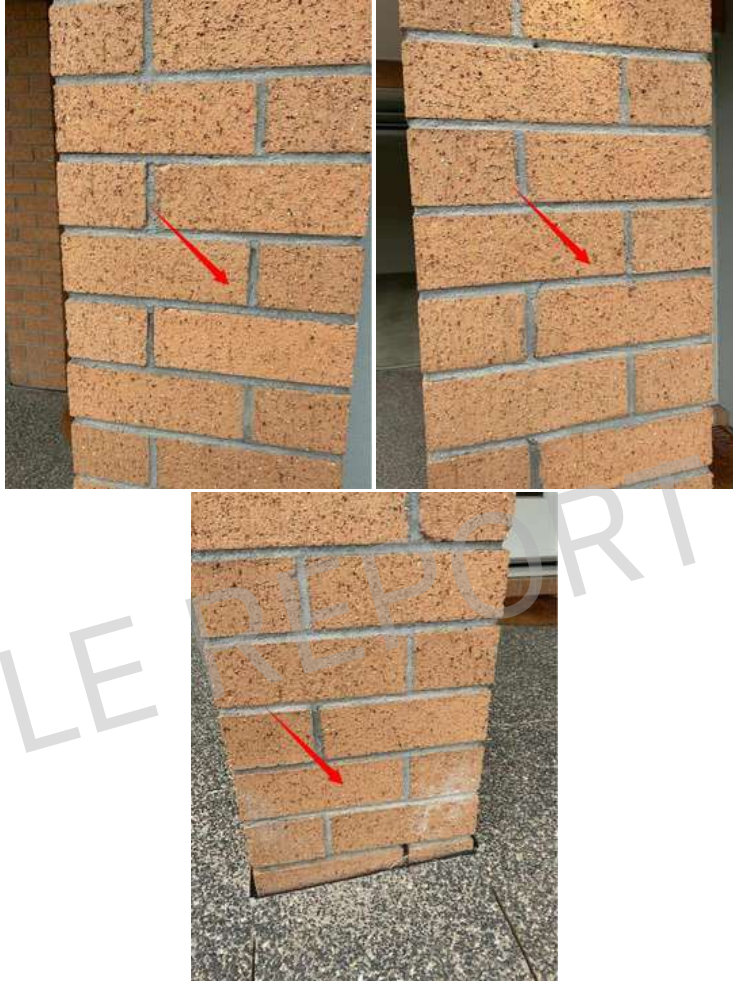
| Section | Location | Name | Comments |
|---|---|---|---|
| EXTERIOR | Entry Porch Area | Column or Post Condition | Minor mortar cracks were observed.<br>Recommendation: Monitoring advised. If cracks widen, further assessment by a structural engineer will be required. |

Minormortar cracks - Recommendations: Monitoring advised. If widening subsequently occurs it will require assessing by a structural engineer.

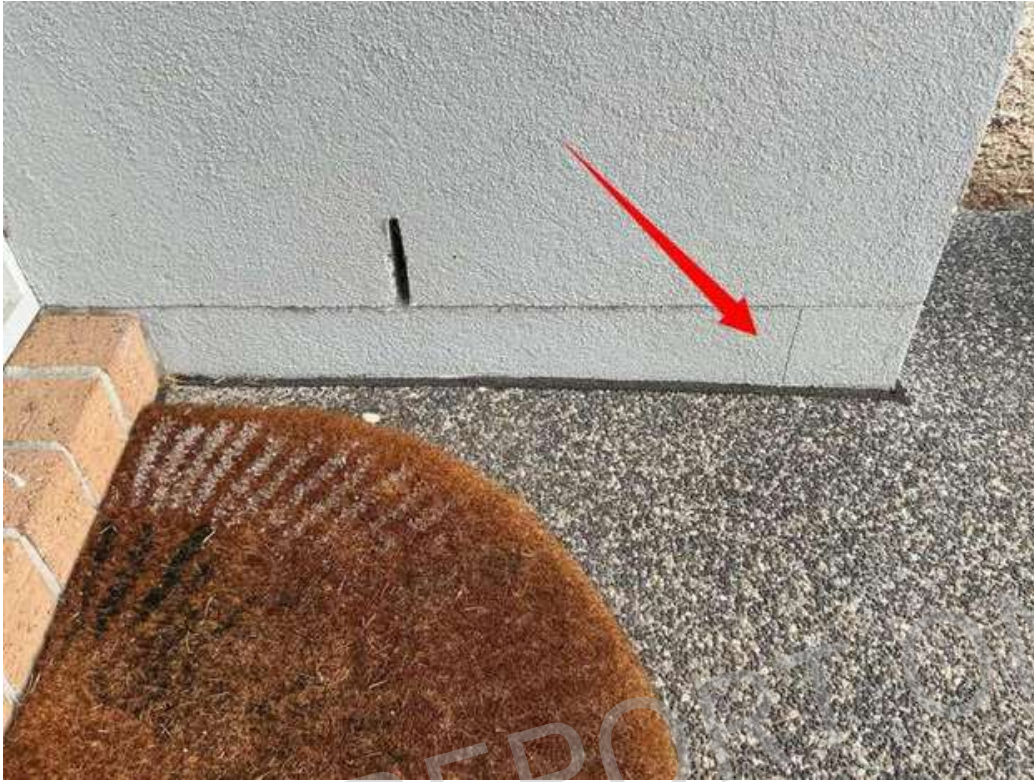
### **Wall Siding Condition**

| EXTERIOR | Entry Porch Area | Wall Siding Condition | Settlement cracks - Recommendations: Monitoring advised. If widening subsequently occurs it will require assessing by a structural engineer. |

Settlement cracks - Recommendations: Monitoring advised. If widening subsequently occurs it will require assessing by a structural engineer.

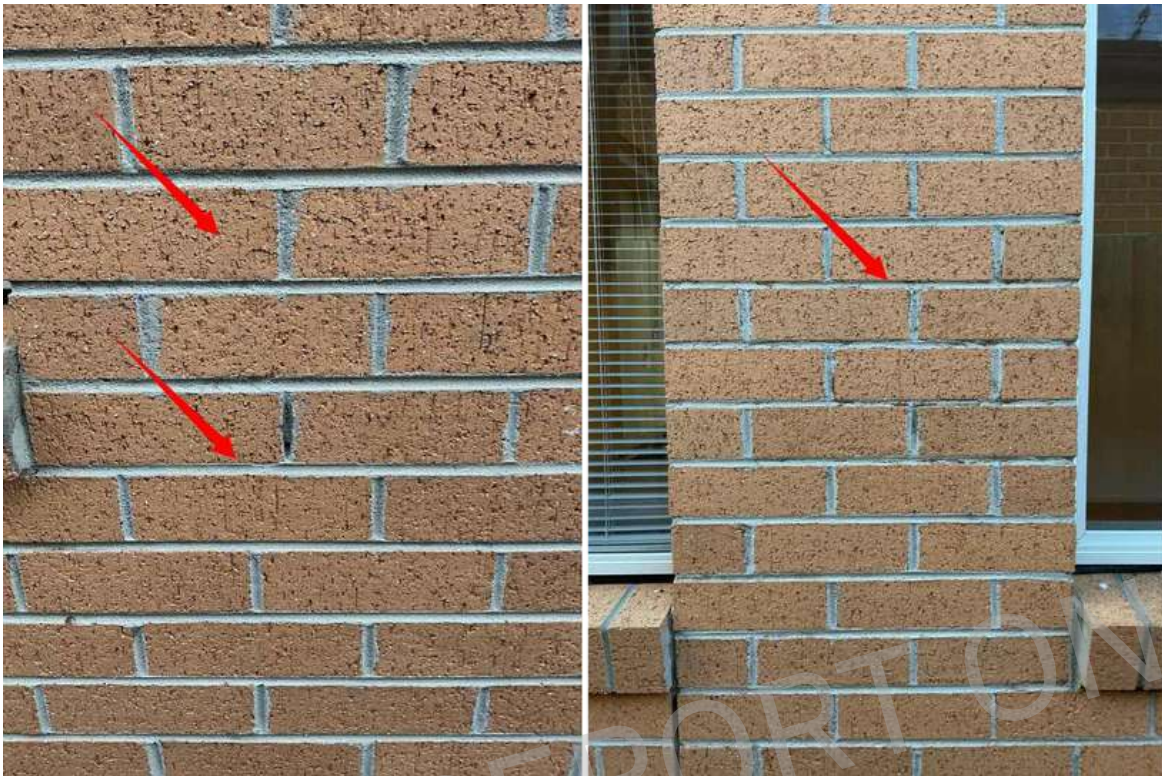
| EXTERIOR | Walls | Condition (3) | Mortar erosion between the brickwork is eroded. Contact a qualified bricklayer for repairs. |

Mortar erosion between the brickwork is eroded. Contact a qualified bricklayer for repairs.

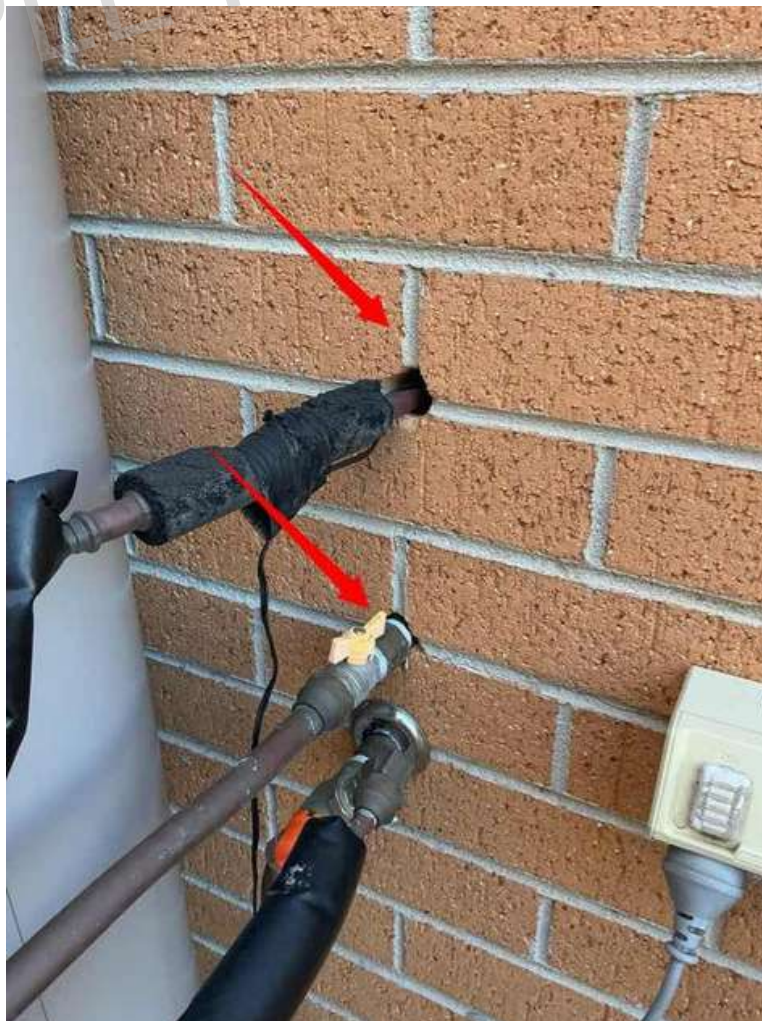
**Condition (4)**

| EXTERIOR | Walls | Condition (4) | Penetration openings observed. I recommend sealing these off so as to avoid vermin and other pest infestation. |

Penetration openings observed. I recommend sealing these off so as to avoid vermin and other pest infestation.

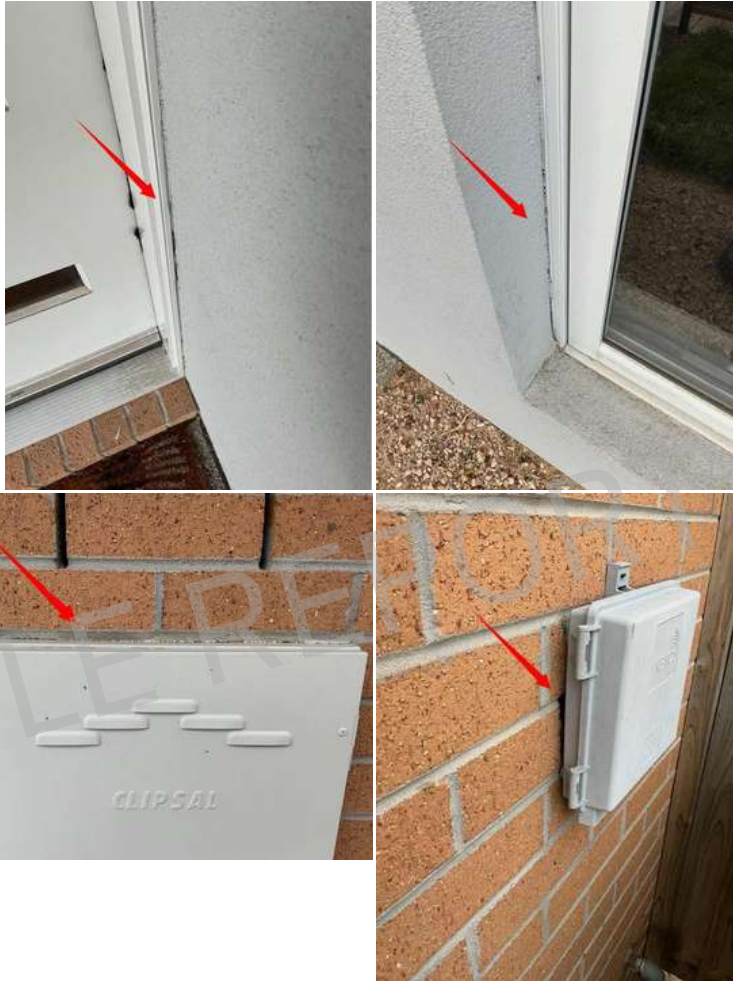
**Condition (2)**

| EXTERIOR | Walls | Condition (2) | Upon visual inspection, gaps were observed in the external wall areas. These gaps may lead to water ingress and energy inefficiency. It is recommended to seal the gaps using appropriate weatherproof sealant and ensure proper insulation. Engage a licensed tradesperson to assess and repair the affected areas to prevent further deterioration and maintain structural integrity. |

Upon visual inspection, gaps were observed in the external wall areas. These gaps may lead to water ingress and energy inefficiency. It is recommended to seal the gaps using appropriate weatherproof sealant and ensure proper insulation. Engage a licensed tradesperson to assess and repair the affected areas to prevent further deterioration and maintain structural integrity.

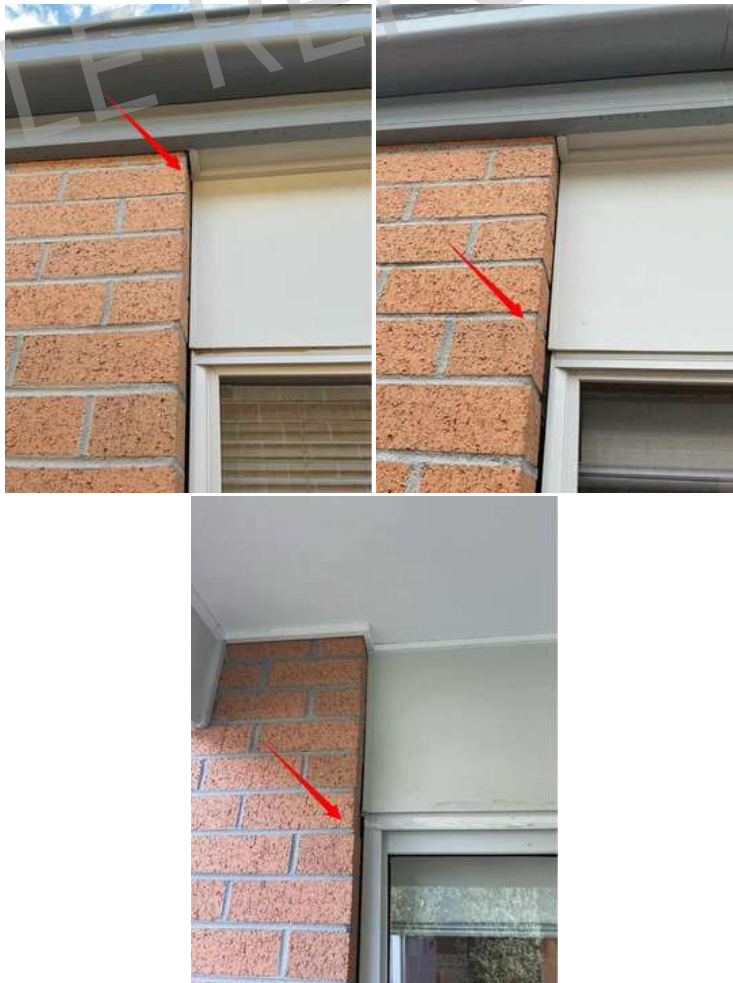
| EXTERIOR | Windows | Overall Condition(1) | Gaps between window frame and wall cladding evident - This can be due to poor workmanship, wall movement, footings settlement. A qualified carpenter should be engaged for advice and recommendations. |

Gaps between window frame and wall cladding evident - This can be due to poor workmanship, wall movement, footings settlement. A qualified carpenter should be engaged for advice and recommendations.

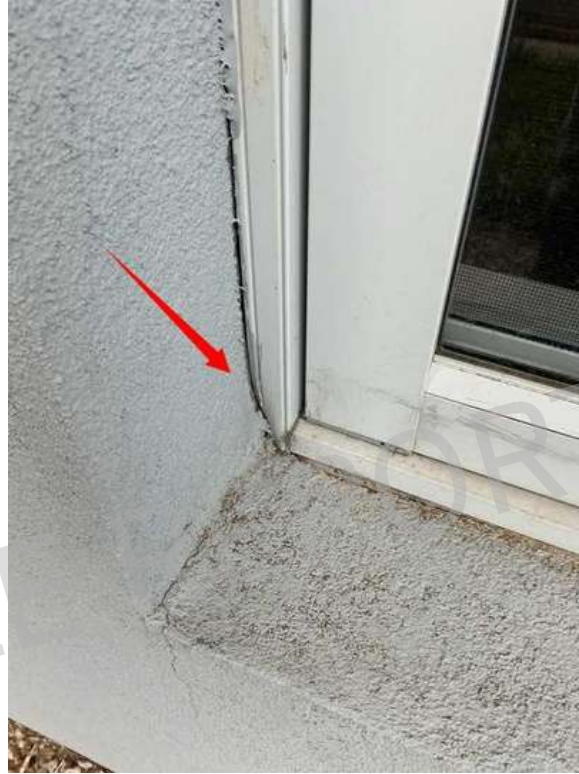
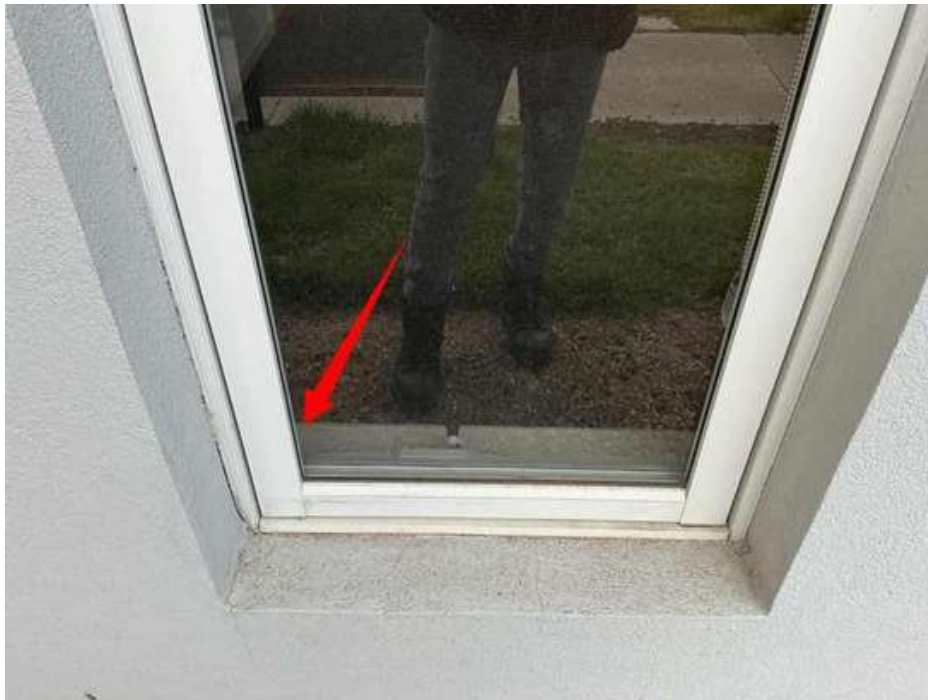
## Overall Condition

| EXTERIOR | Windows | Overall Condition | Upon visual inspection, window frame damage to lower right hand corner is evident. Recommend monitoring this area and hiring a licensed carpenter or contractor to assess and repair the affected areas. Repairs may involve replacing damaged sections, sealing gaps to prevent moisture intrusion, and repainting to protect against further deterioration. If further movement or deviation occurs a structural engineer may be required to assess and further report on the condition. Ensure all work complies with local building codes to maintain structural integrity and aesthetic appeal |

Upon visual inspection, window frame damage to lower right hand corner is evident. Recommend monitoring this area and hiring a licensed carpenter or contractor to assess and repair the affected areas. Repairs may involve replacing damaged sections, sealing gaps to prevent moisture intrusion, and repainting to protect against further deterioration. If further movement or deviation occurs a structural engineer may be required to assess and further report on the condition. Ensure all work complies with local building codes to maintain structural integrity and aesthetic appeal

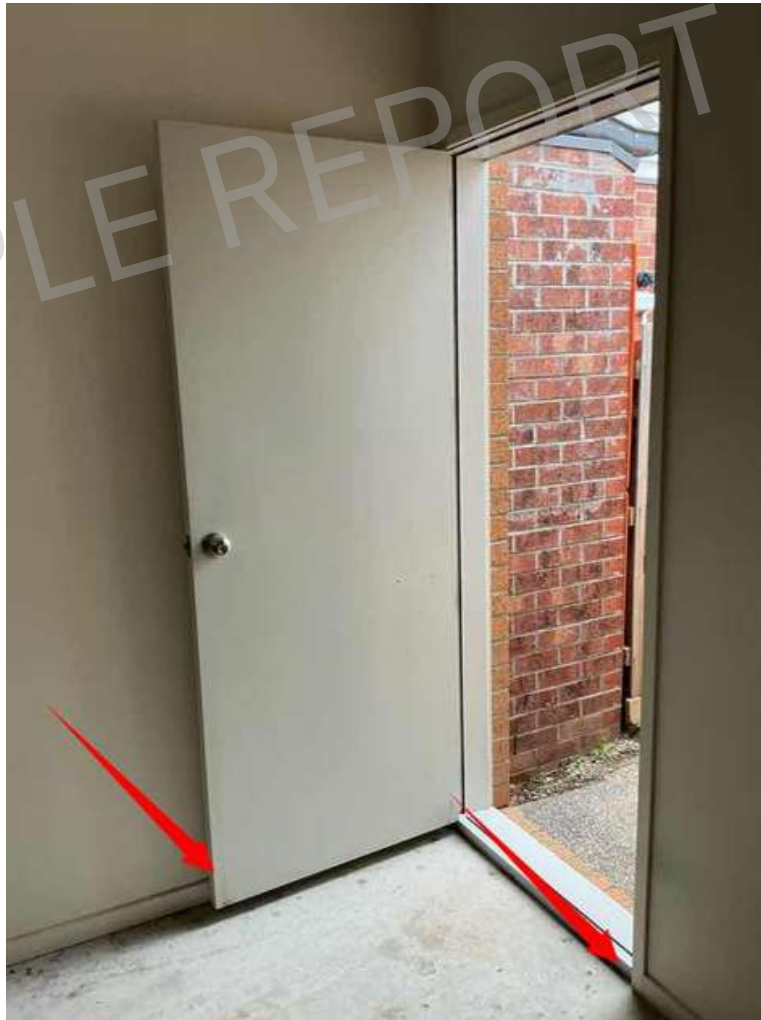
| GARAGE - CARPORT | Garaging | Door Findings(1) | Binding garage door - This can relate to differential settlement in the footings, frame movement, age and the like. It can also be seasonal where it may bind for some months and then open and close sufficiently. A qualified carpenter should be engaged for advice and recommendations. |

Binding garage door - This can relate to differential settlement in the footings, frame movement, age and the like. It can also be seasonal where it may bind for some months and then open and close sufficiently. A qualified carpenter should be engaged for advice and recommendations.

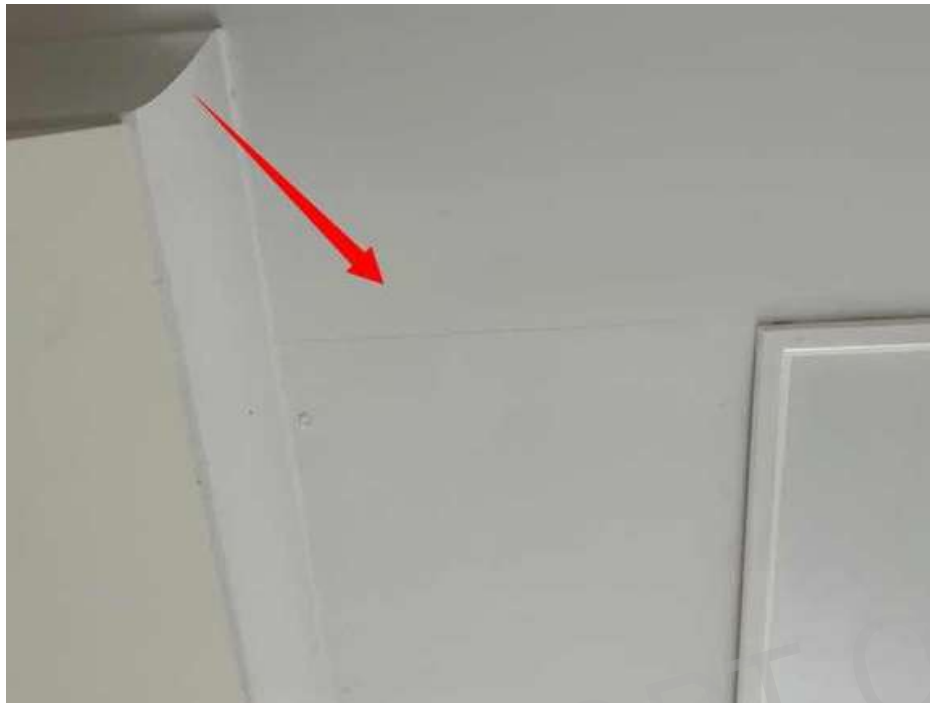
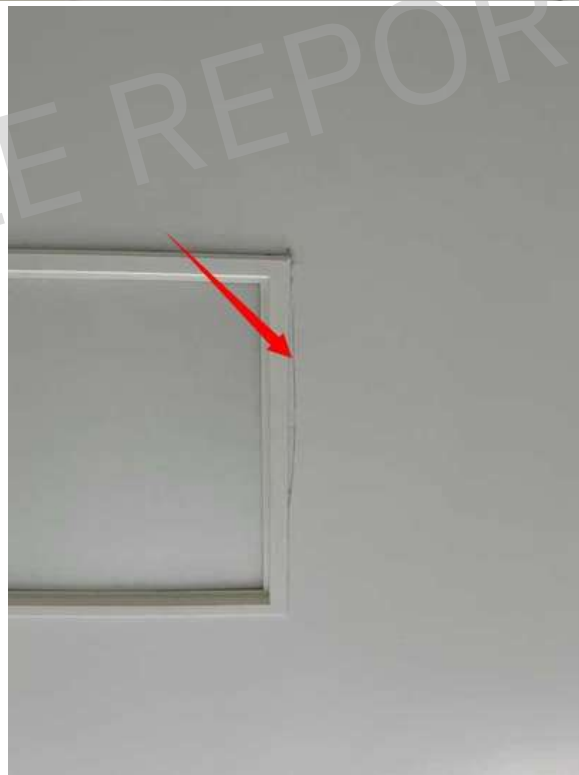
#### Ceiling Findings

| GARAGE - CARPORT | Garaging | Ceiling Findings | Settlement Cracks Noted . These are typical and generally patch and paint will suffice, however Monitoring these cracks advised for 12 months and if become wider or longer, you will need to contact a structural engineers to assess. |

Settlement Cracks Noted . These are typical and generally patch and paint will suffice, however Monitoring these cracks advised for 12 months and if become wider or longer, you will need to contact a structural engineers to assess.

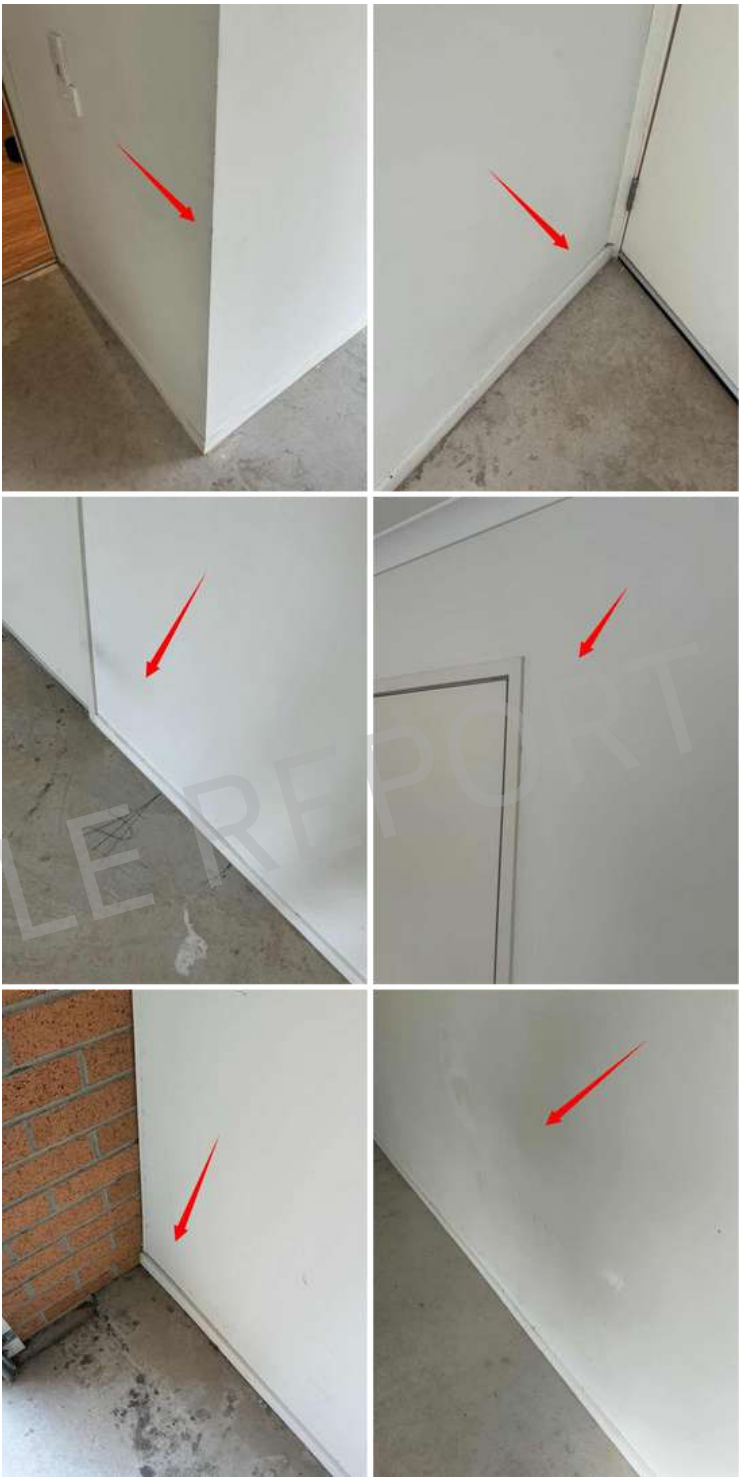
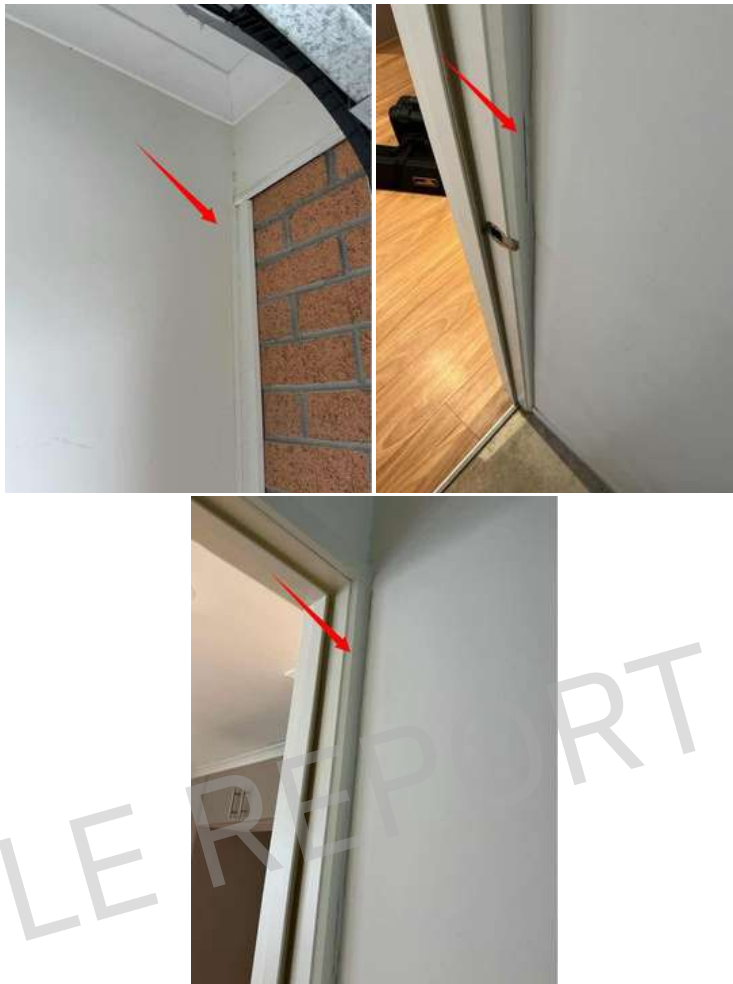
| GARAGE - CARPORT | Garaging | Internal Wall Findings | General ageing and/or denting and/or wear and/or previous wall patching and the like is evident on wall linings - Recommendations: A qualified painter should be engaged to assess and repair as required. |

Recommendations: A qualified painter should be engaged to assess and repair as required.

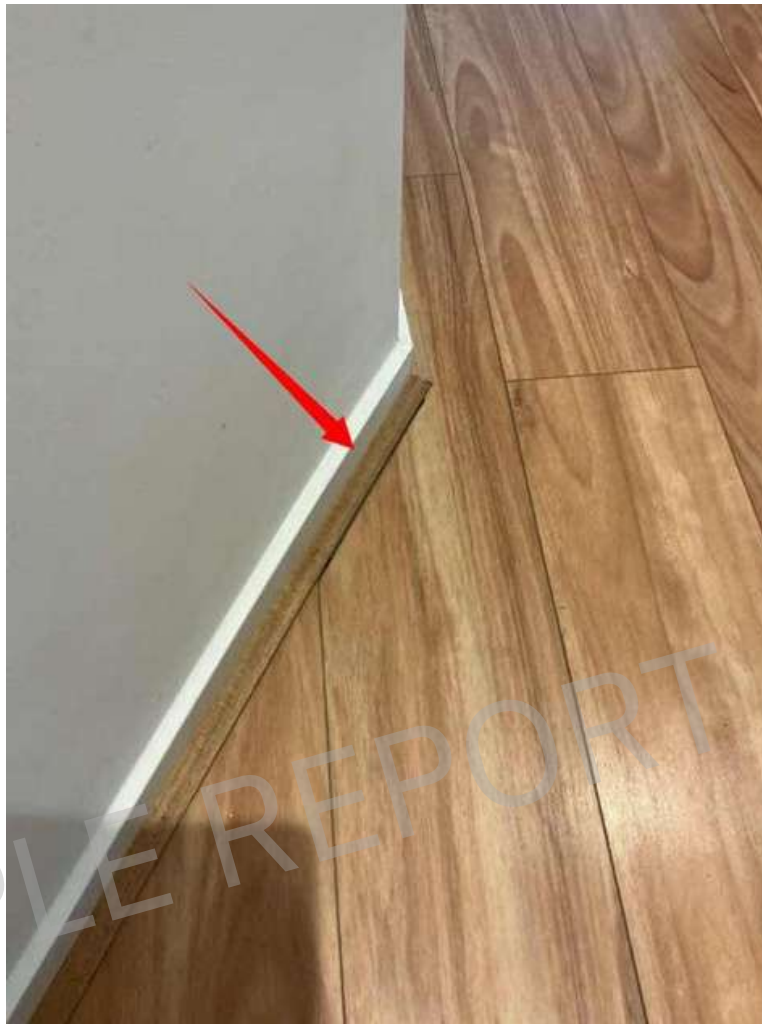
Upon visual inspection, gaps were observed in the laminate flooring. These gaps may lead to moisture ingress and potential damage. It is recommended to have a licensed flooring specialist assess the issue. Repairs may involve repositioning or replacing affected planks and ensuring proper expansion gaps are maintained to prevent future issues.

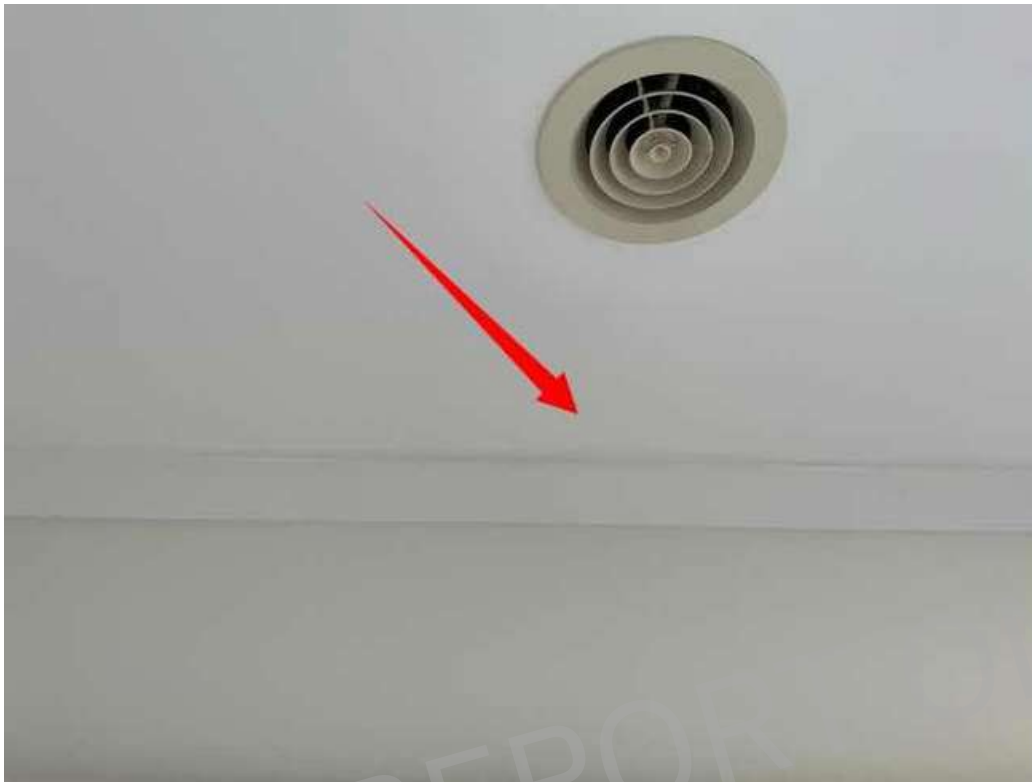
Settlement Cracks Noted. These are typical and generally patch and paint will suffice, however monitoring these cracks is advised for 12 months and if they become worse, further investigation by a suitably qualified professional is advised.
