# Pre Purchase Inspection Report

## Inspectmate Pty Ltd

Report/Agreement # 25082509092479

Inspection Date: 25 Aug 2025

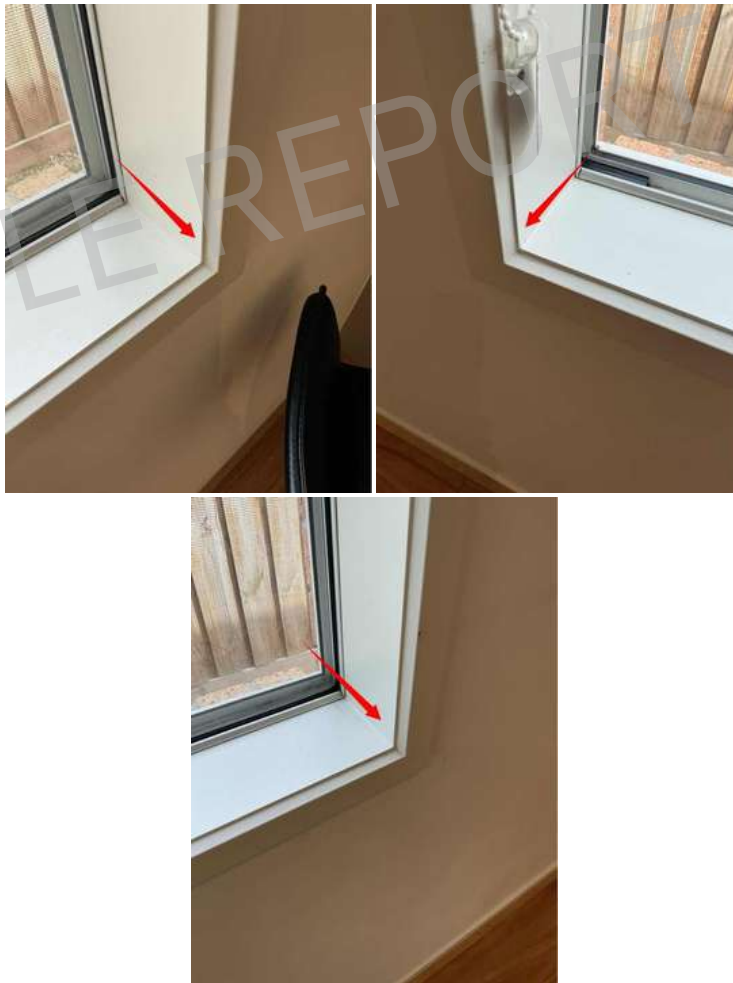
General age wear deterioration - The window frame/components showed evidence of ageing and wear. General maintenance works required.

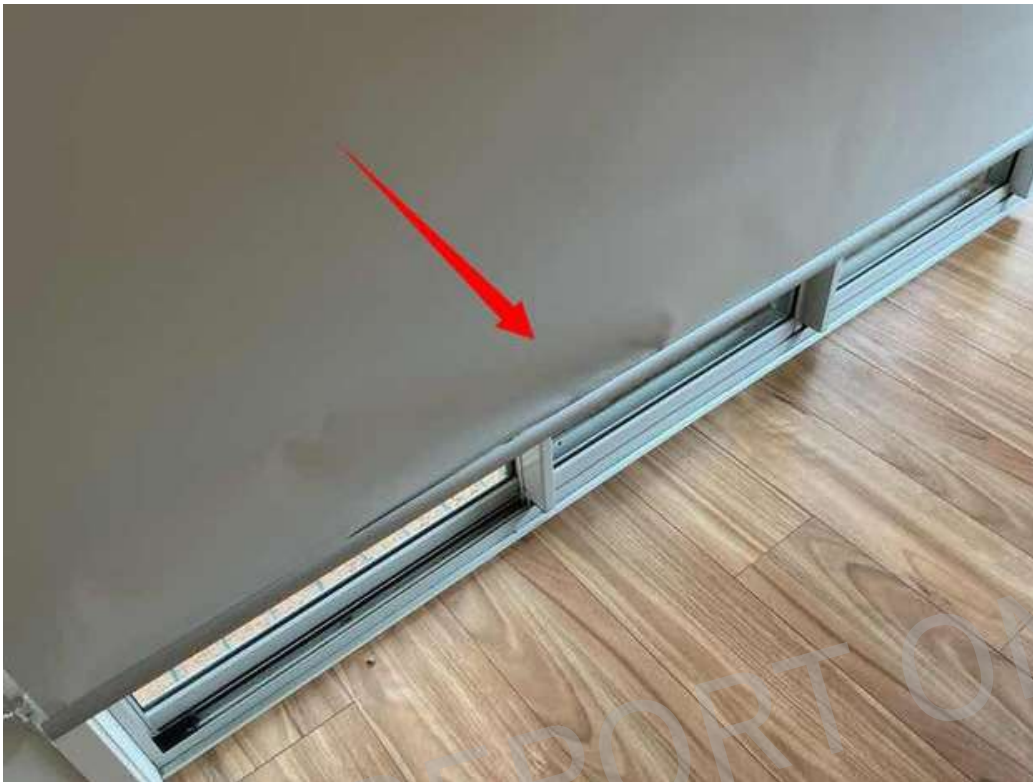
## Windows (1)

Upon visual inspection, minor damage was noted on the curtain blinds. It is recommended to have a licensed tradesperson assess the extent of the damage and perform necessary repairs or replacements to restore functionality and appearance. Regular maintenance checks can prevent further deterioration and ensure the longevity of the blinds.

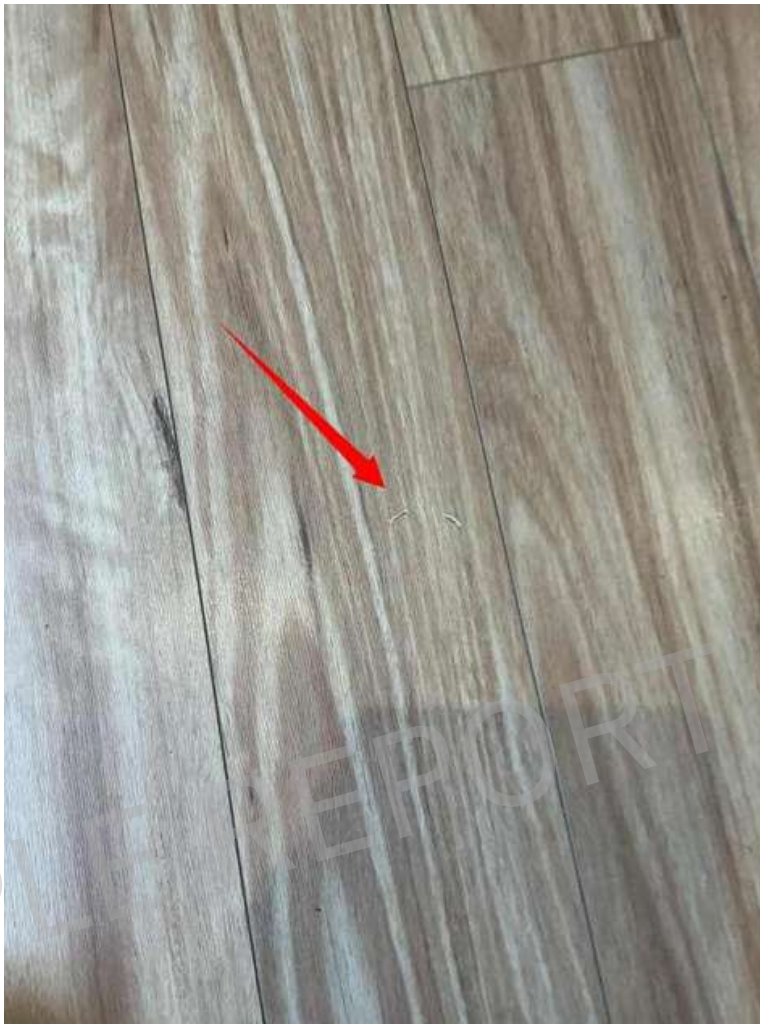
Upon visual inspection, a minor surface indentation was noted on the laminate flooring. It is recommended to consult a licensed flooring specialist to assess the extent of the damage. The tradesperson may suggest options such as filling the indentation with a laminate repair kit or replacing the affected plank to restore the floor's appearance and prevent further issues.

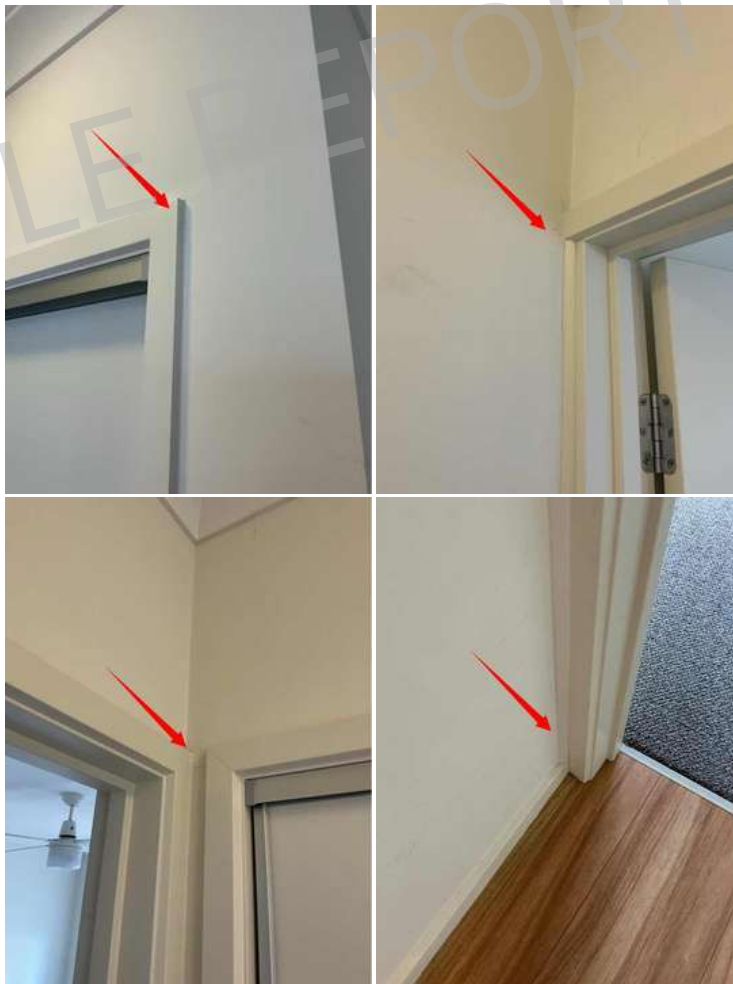
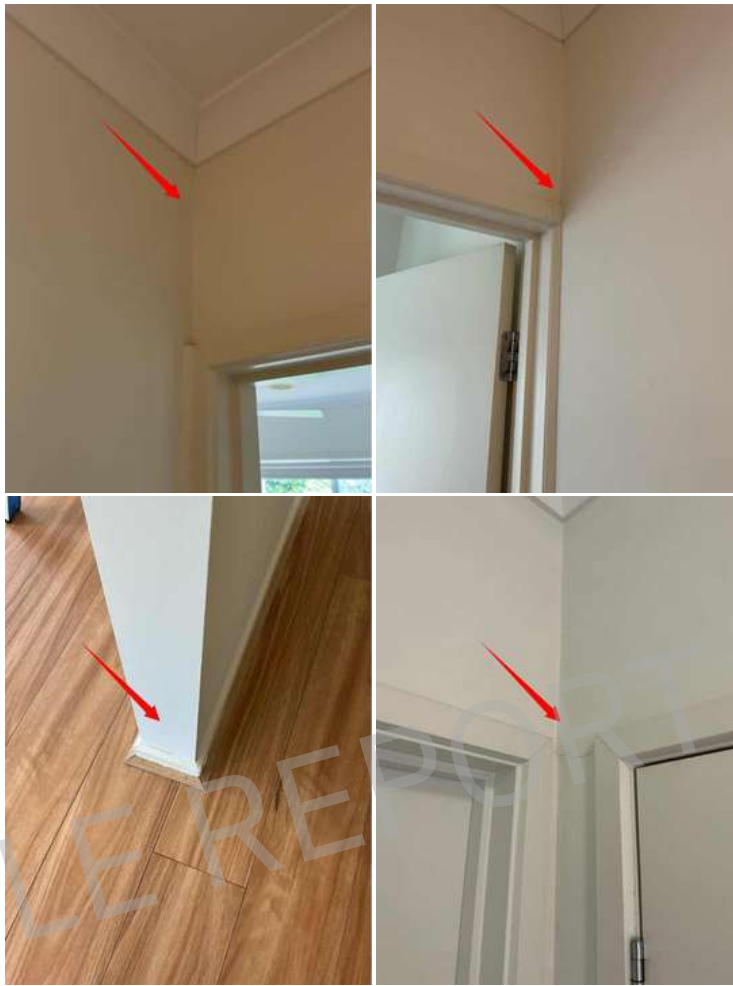
Settlement Cracks Noted. These are typical and generally patch and paint will suffice, however we recommend you monitor these cracks and if they become wider or longer, you will need to contact a structural engineers to assess.

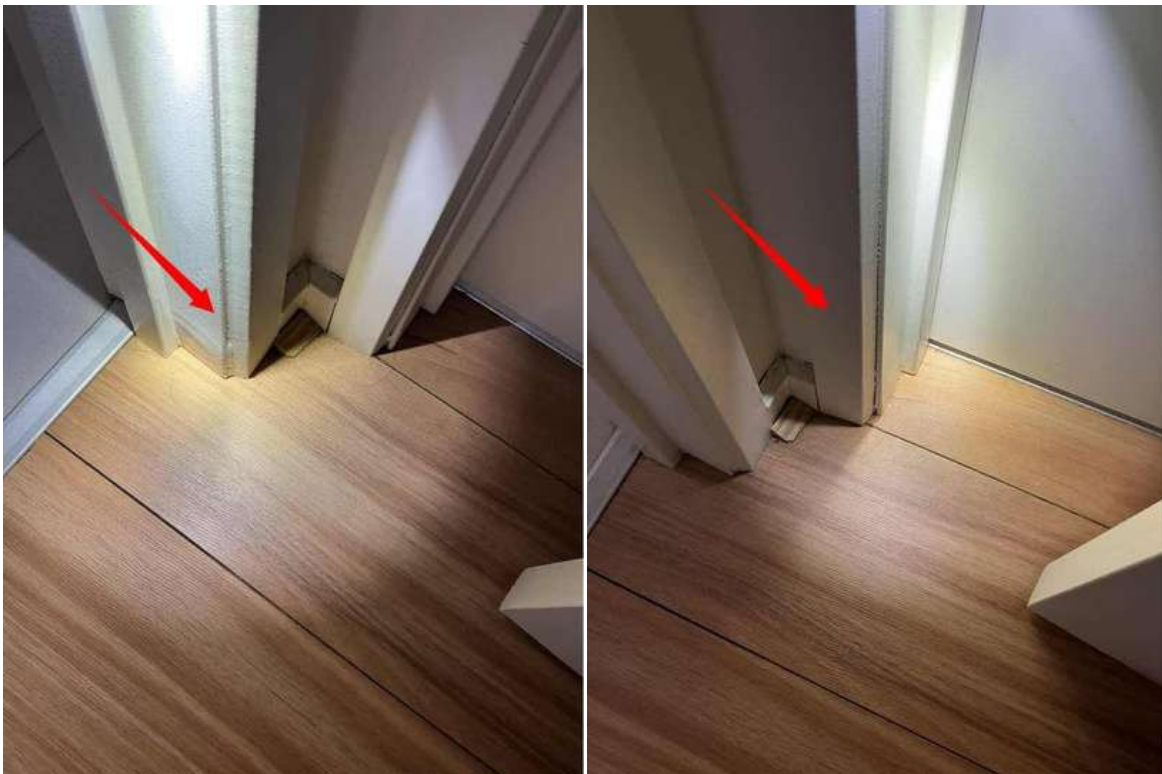
**Walls (1)**

Skirting board damage. Possibly bath/shower recess leak related. Have bathroom/shower assessed by a qualified plumber for leaks and maintenance/replace skirting boards as required.

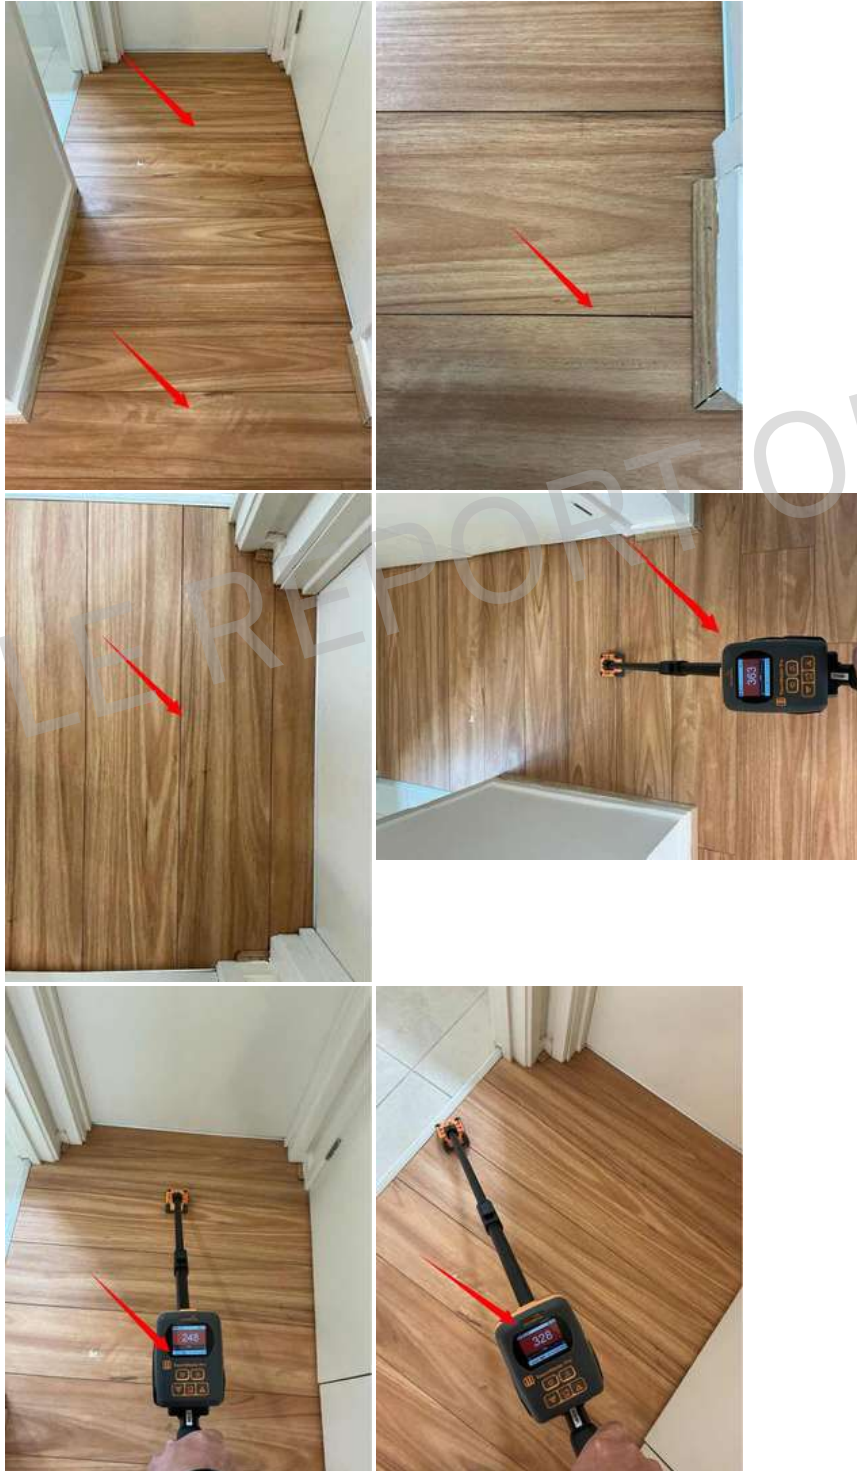
| Section | Location | Name | Comment |
|---|---|---|---|
| INTERIORS | Hallway/s | Flooring | Upon visual inspection, signs of moisture damage were detected in the laminate timber flooring, including warping and discoloration. It is recommended to address the source of moisture immediately. A suitably licensed or qualified tradesperson should replace affected flooring sections and ensure proper sealing and ventilation to prevent future issues. Regular maintenance and monitoring are advised to maintain flooring integrity. |

Upon visual inspection, signs of moisture damage were detected in the laminate timber flooring, including warping and discoloration. It is recommended to address the source of moisture immediately. A suitably licensed or qualified tradesperson should replace affected flooring sections and ensure proper sealing and ventilation to prevent future issues. Regular maintenance and monitoring are advised to maintain flooring integrity.

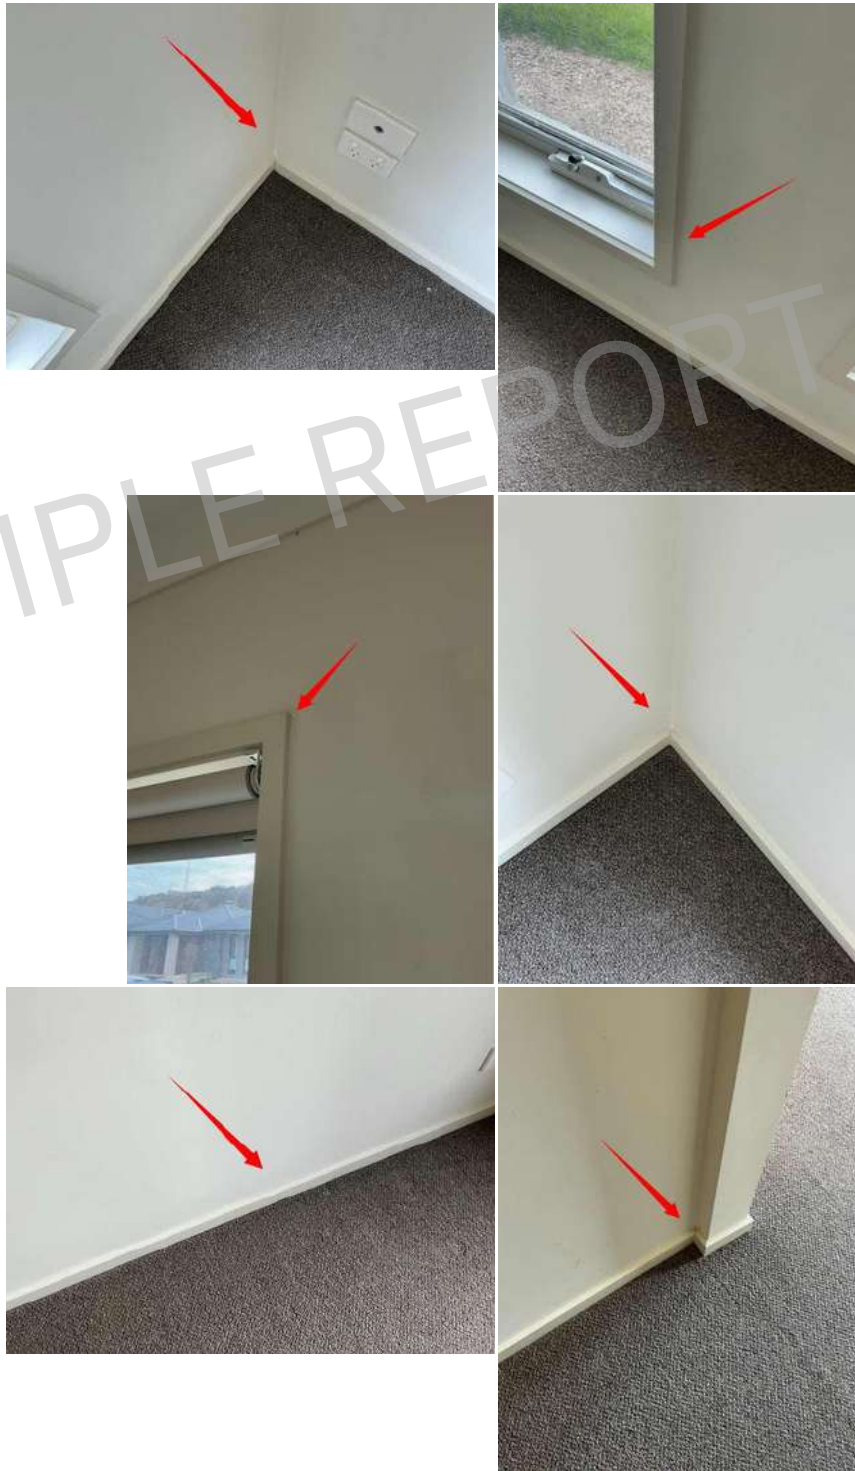
Settlement Cracks Noted. These are typical and generally patch and paint will suffice, however we recommend monitor these cracks and if become wider or longer, you will need to contact a structural engineers to assess.

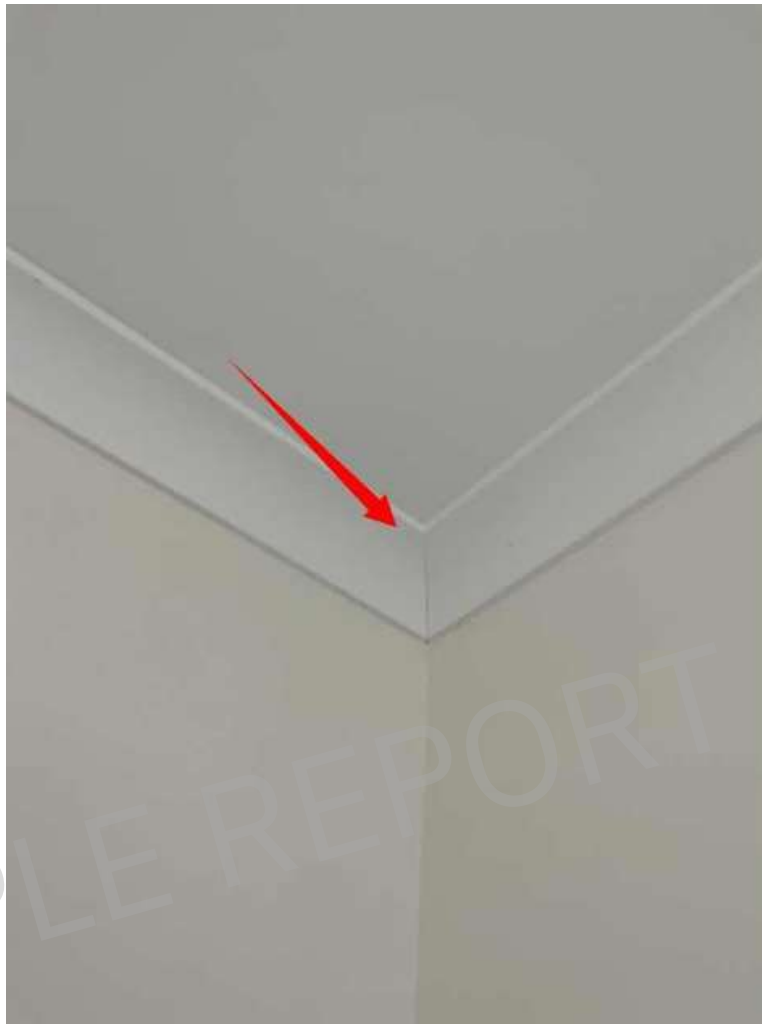
Settlement Cracks Noted. These are typical and generally patch and paint will suffice, however monitoring these cracks is advised for 12 months and if they become worse, further investigation by a suitably qualified professional is advised.

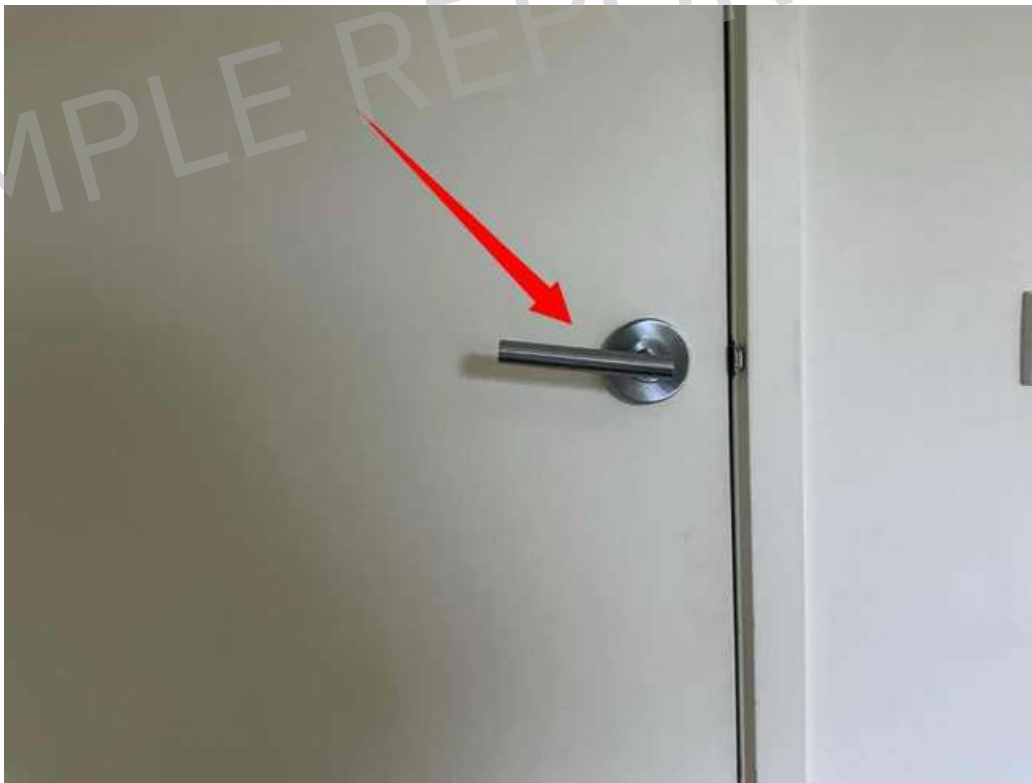
Upon visual inspection, the door handle is misaligned, causing operational issues. This defect may lead to increased wear or potential damage to the door mechanism. It is recommended to engage a licensed tradesperson to realign the handle to ensure proper function. This will involve adjusting the handle's position and securing it to maintain alignment and prevent future issues.

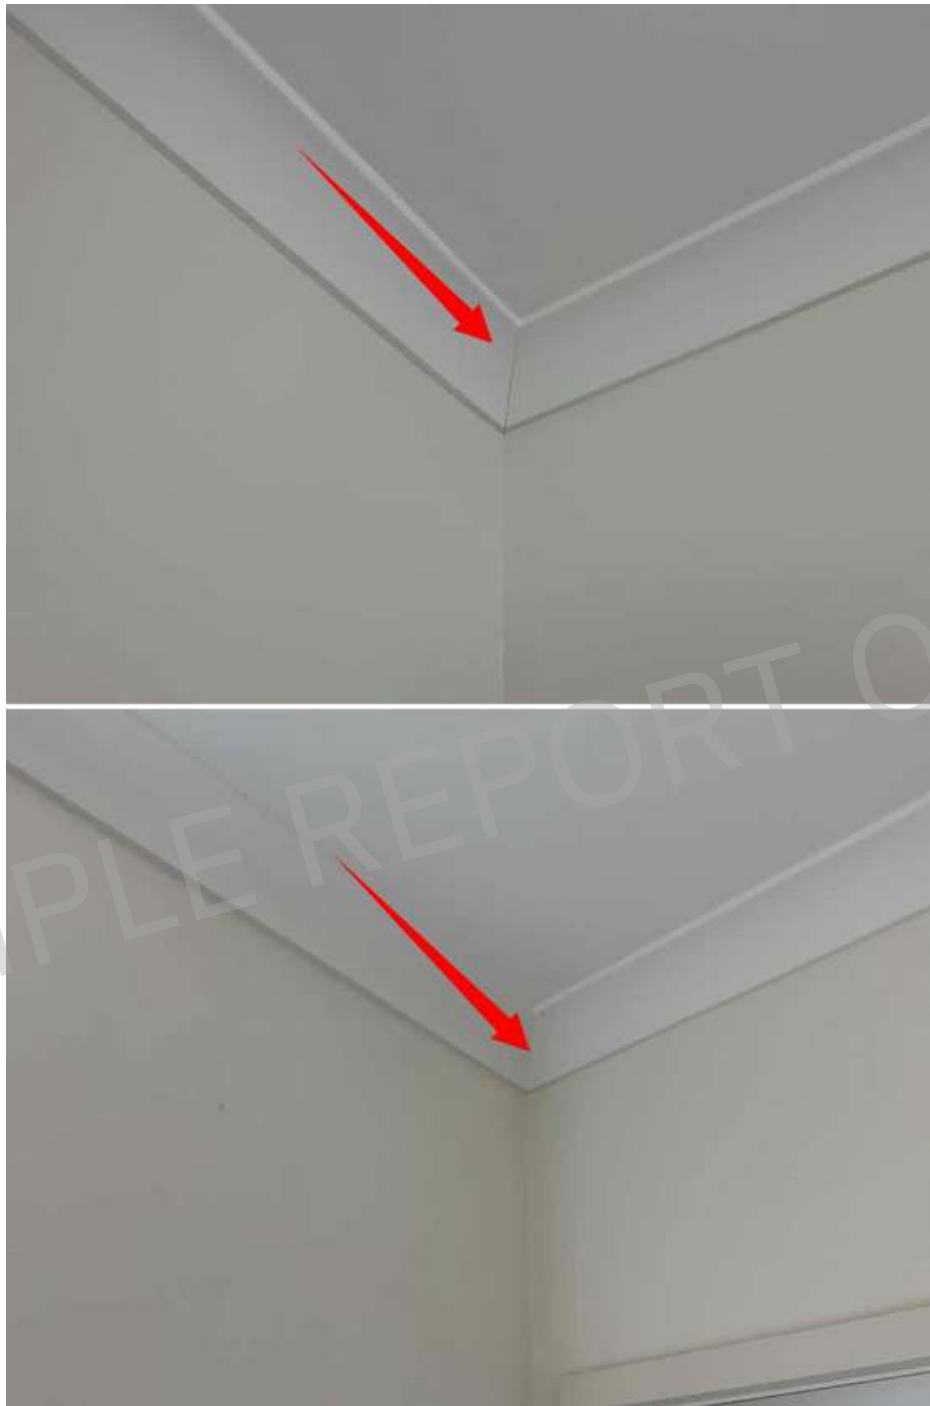
Settlement Cracks Noted. These are typical and generally patch and paint will suffice, however monitoring these cracks is advised for 12 months and if they become worse, further investigation by a suitably qualified professional is advised.

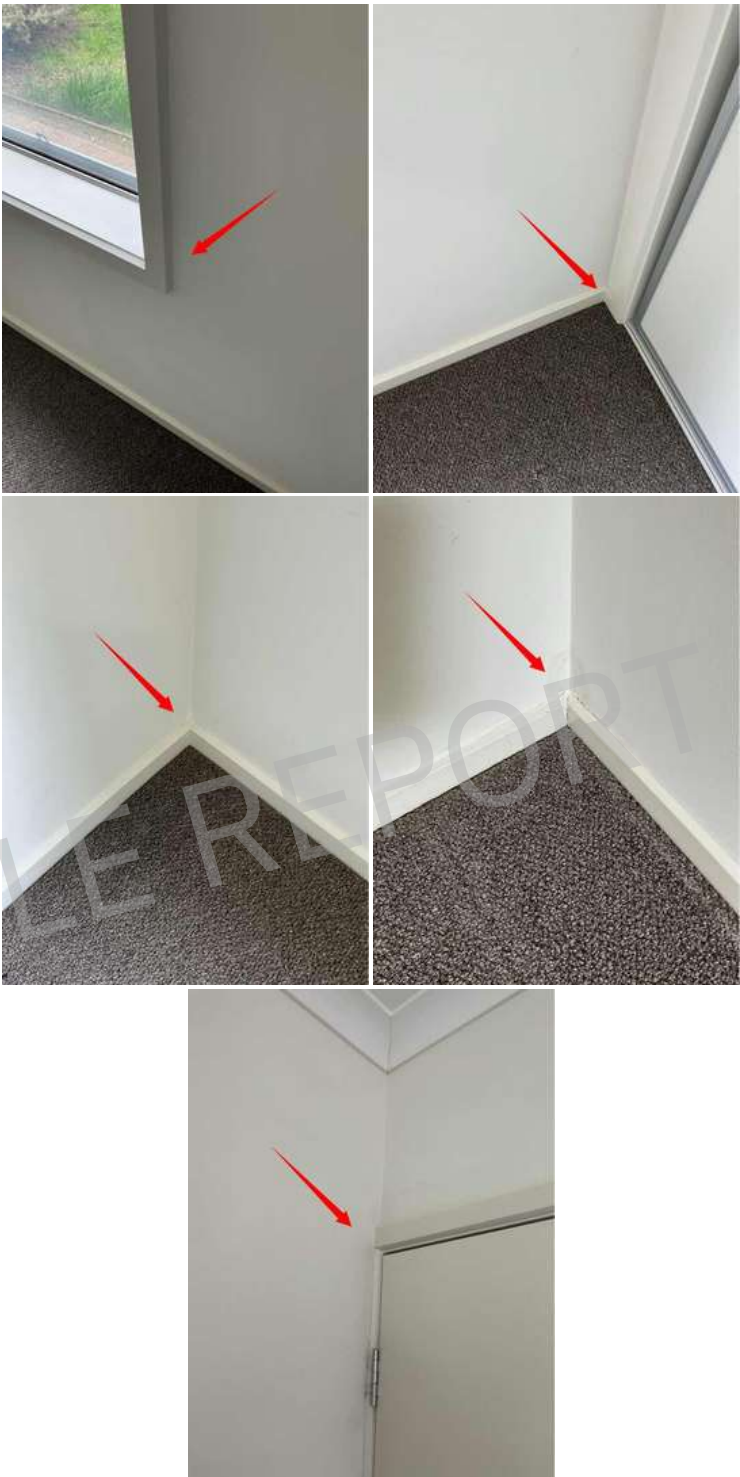
Settlement Cracks Noted. These are typical and generally patch and paint will suffice, however we recommend monitor these cracks and if become wider or longer, you will need to contact a structural engineers to assess.

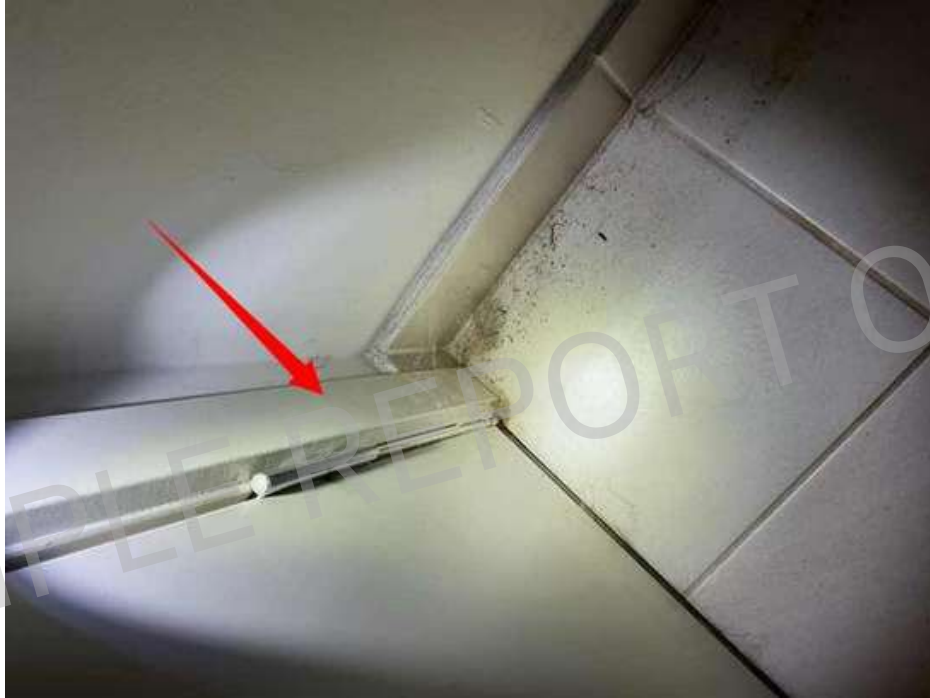
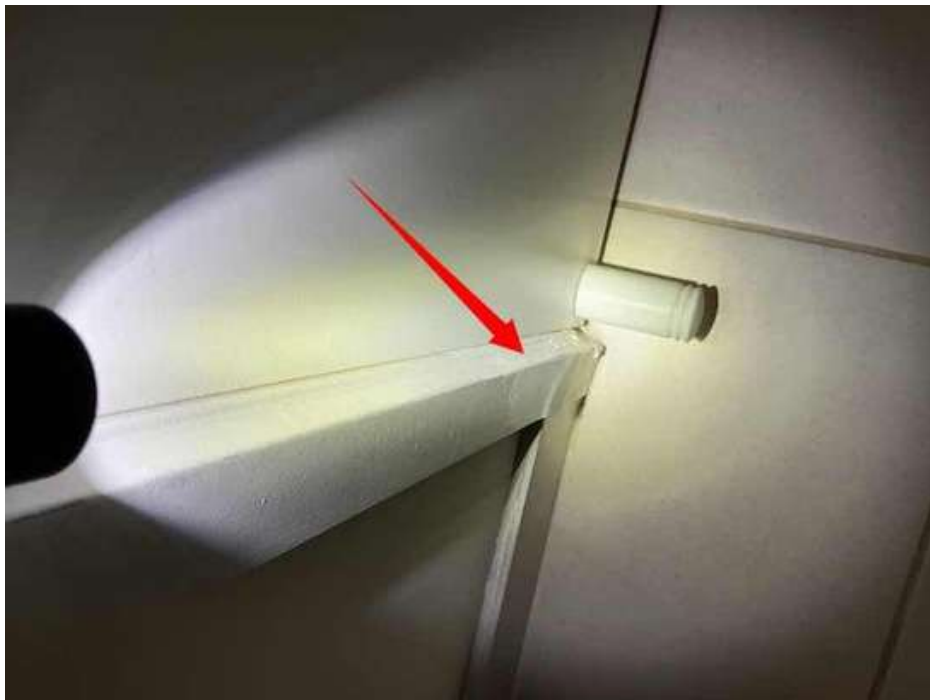
Water damaged door. Possible due to leak in bathroom. Replacement recommended.

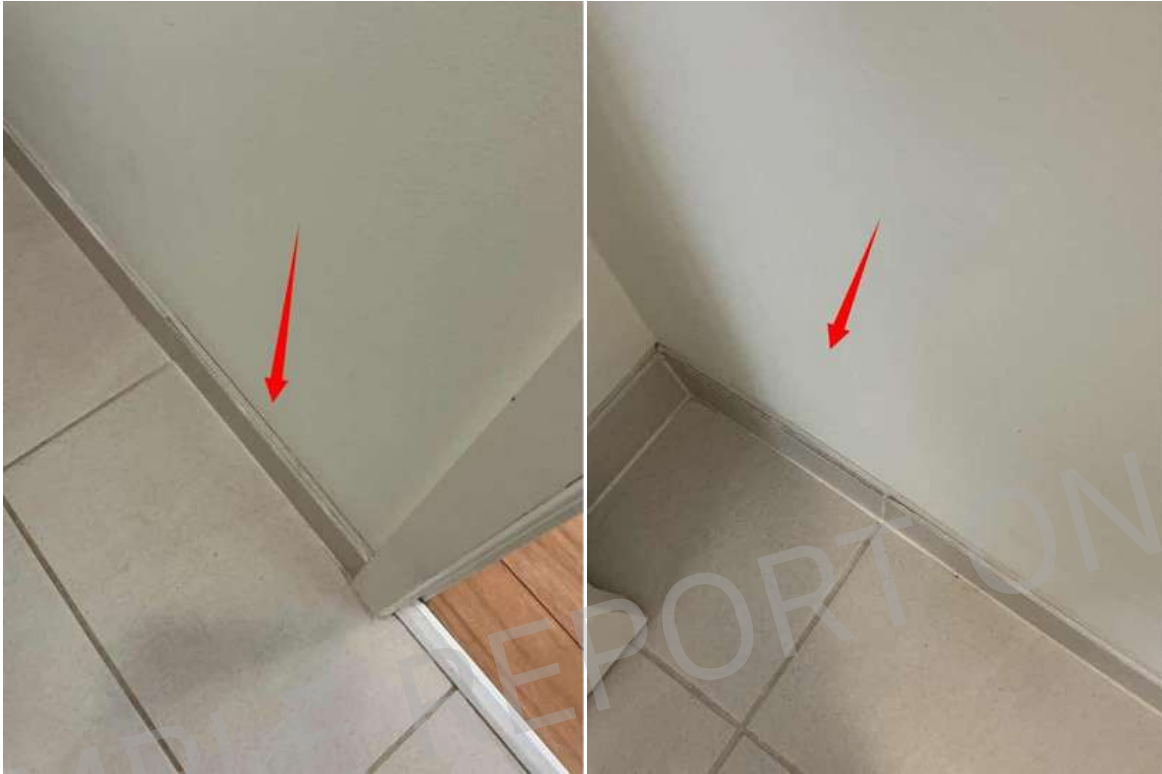
Settlement Cracks Noted . These are typical and generally patch and paint will suffice, however Monitoring these cracks advised for 12 months and if become wider or longer, you will need to contact a structural engineers to assess.

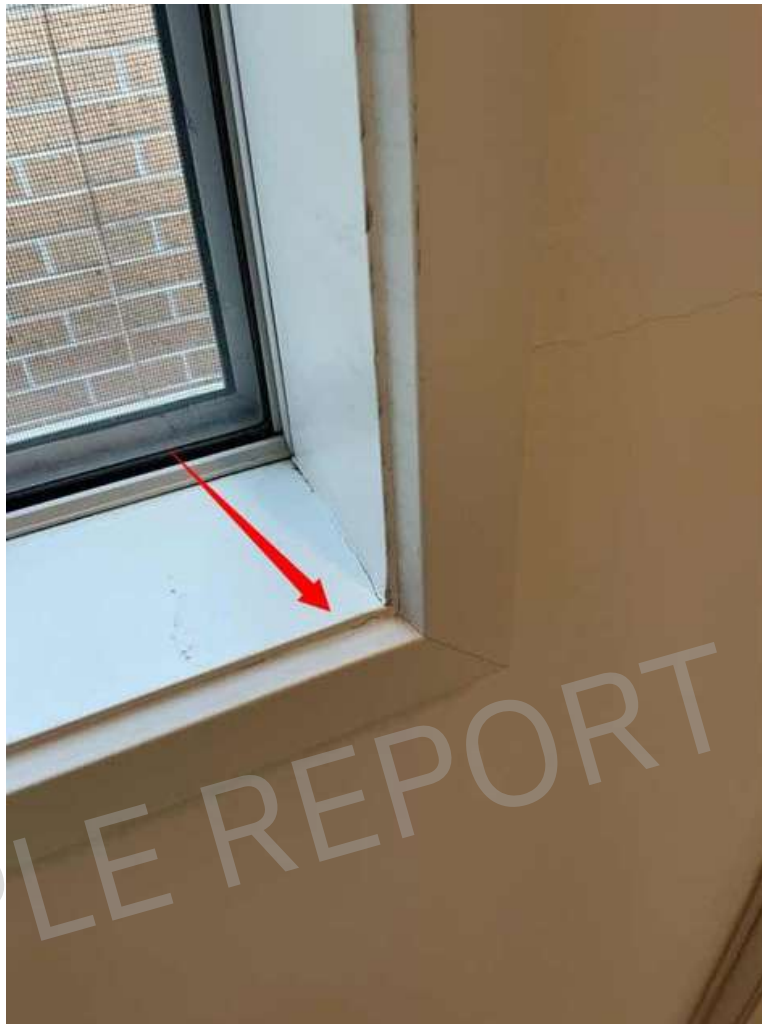
Generalage wear deterioration - The window frame/components showed evidence of ageing and wear.General maintenance works required.

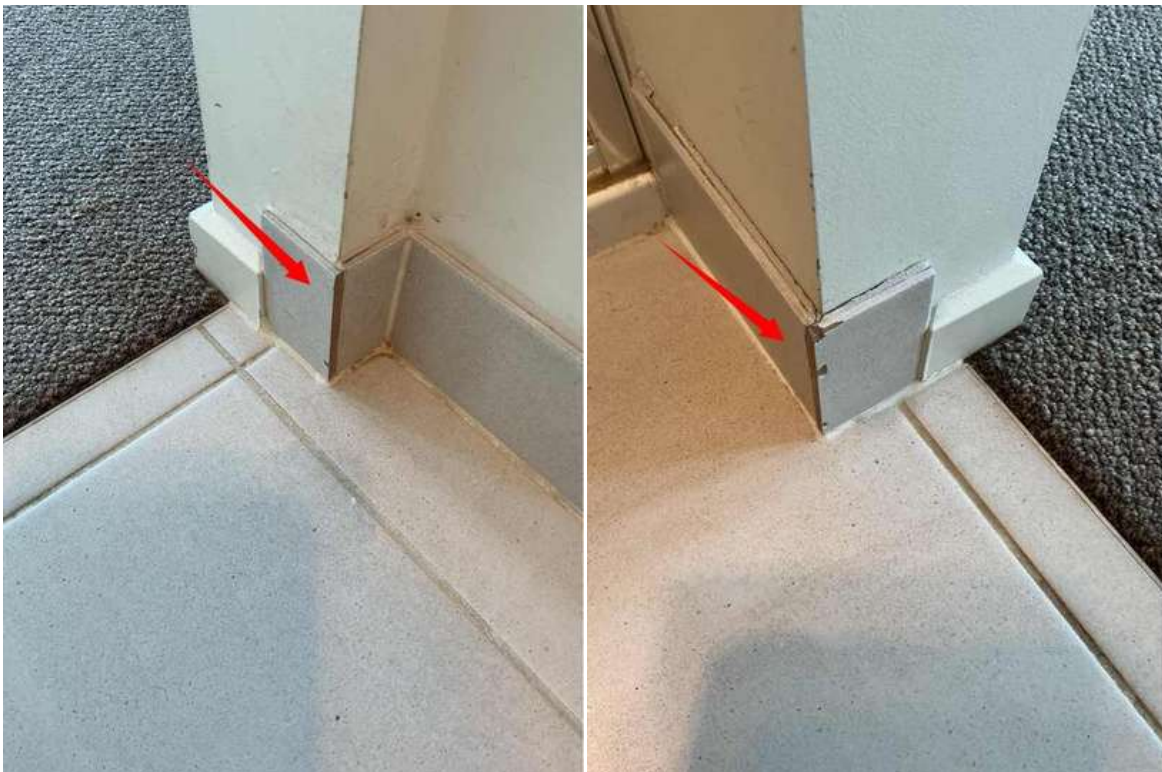
Some chipped and damaged tiled were noted. Replacement recommended by a qualified tiler

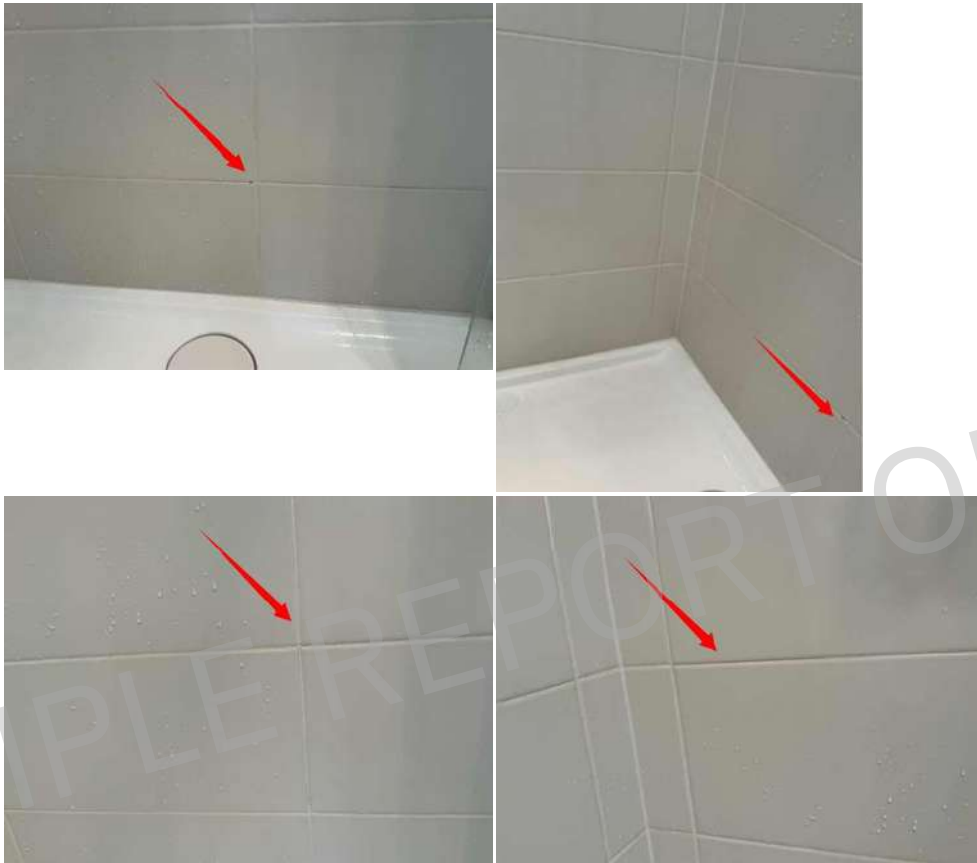
Minor Tile grout deterioration to tiles to the shower area. Re-grout / seal. A qualified tiler should be engaged recommendations and repairs as water may seep in causing rot and creating conducive conditions termites.

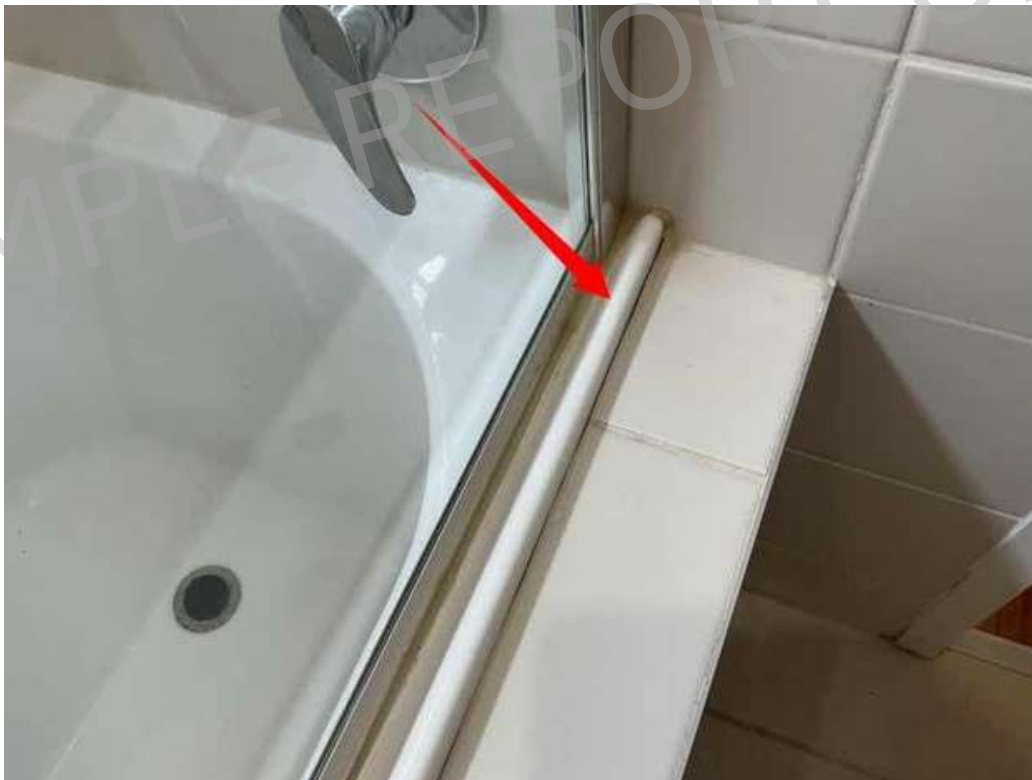
Upon visual inspection, silicone deterioration is evident, leading to potential water ingress. Recommend removal of old silicone and application of high-quality, weather-resistant sealant by a licensed tradesperson. Ensure all surfaces are clean and dry before application to enhance adhesion and longevity. Regular maintenance checks are advised to prevent future issues and ensure the integrity of the seal.

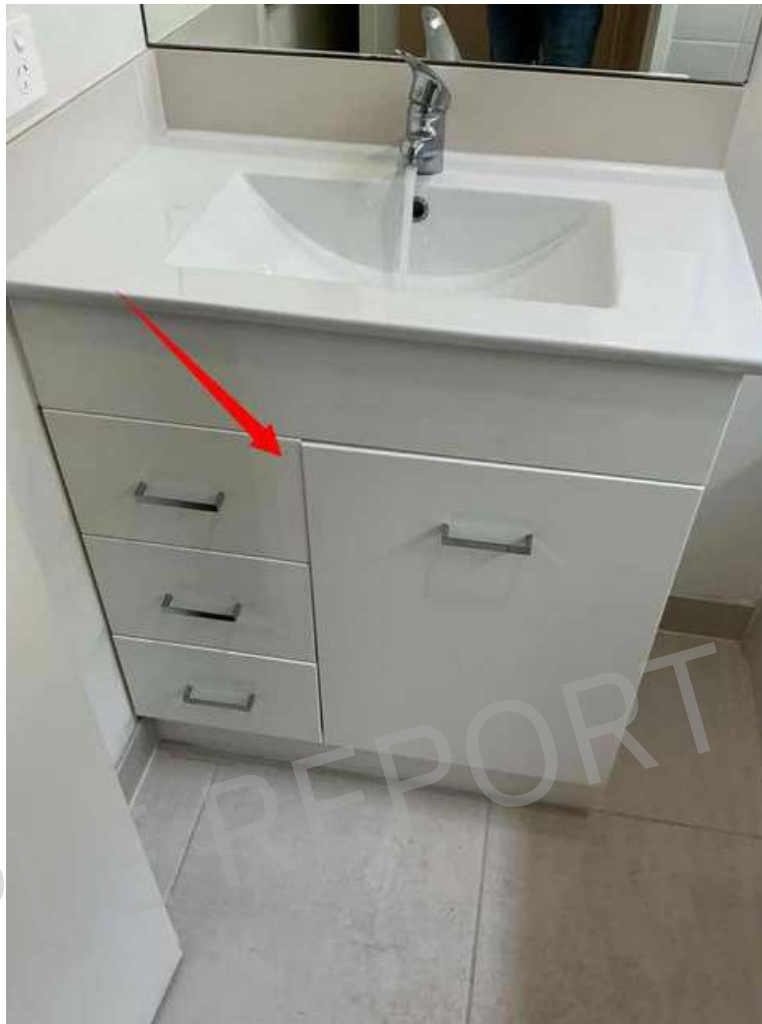
Upon visual inspection, the cabinets show signs of wear, including loose hinges and misaligned doors. Some surfaces have minor scratches and water damage. It is recommended to tighten or replace hinges, realign doors, and refinish or replace damaged surfaces. Engage a licensed carpenter or cabinetmaker to ensure proper repairs and restore functionality and appearance.

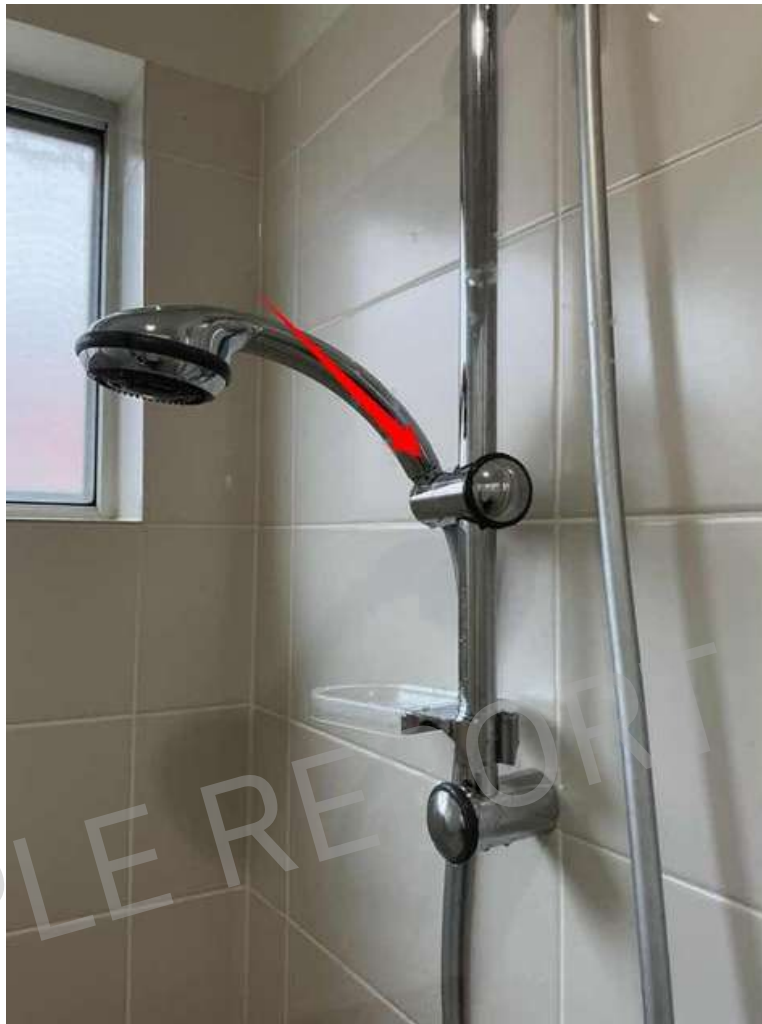
The bath tap set is leaking and will require maintenance or repair.

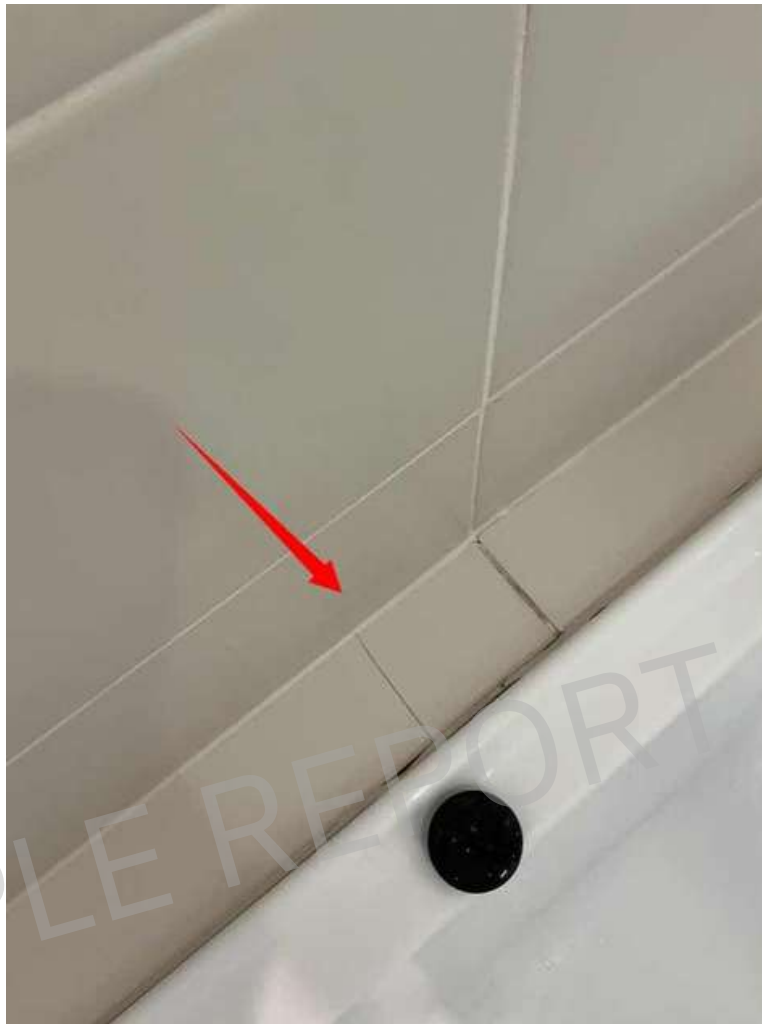
### Shower And Bath(2)

| Section | Location | Name | Comment |
|---|---|---|---|
| BATHROOM(S) | Bathroom 2 | Shower And Bath(2) | Upon visual inspection, visible tiles around the bathtub are cracked, indicating potential water damage. It is recommended to have a suitably licensed or qualified tradesperson assess the extent of the damage. Repairs may involve replacing damaged tiles, checking for underlying water damage, and ensuring proper waterproofing to prevent future issues. Prompt attention will help maintain the integrity of the bathroom area. |

Upon visual inspection, visible tiles around the bathtub are cracked, indicating potential water damage. It is recommended to have a suitably licensed or qualified tradesperson assess the extent of the damage. Repairs may involve replacing damaged tiles, checking for underlying water damage, and ensuring proper waterproofing to prevent future issues. Prompt attention will help maintain the integrity of the bathroom area.

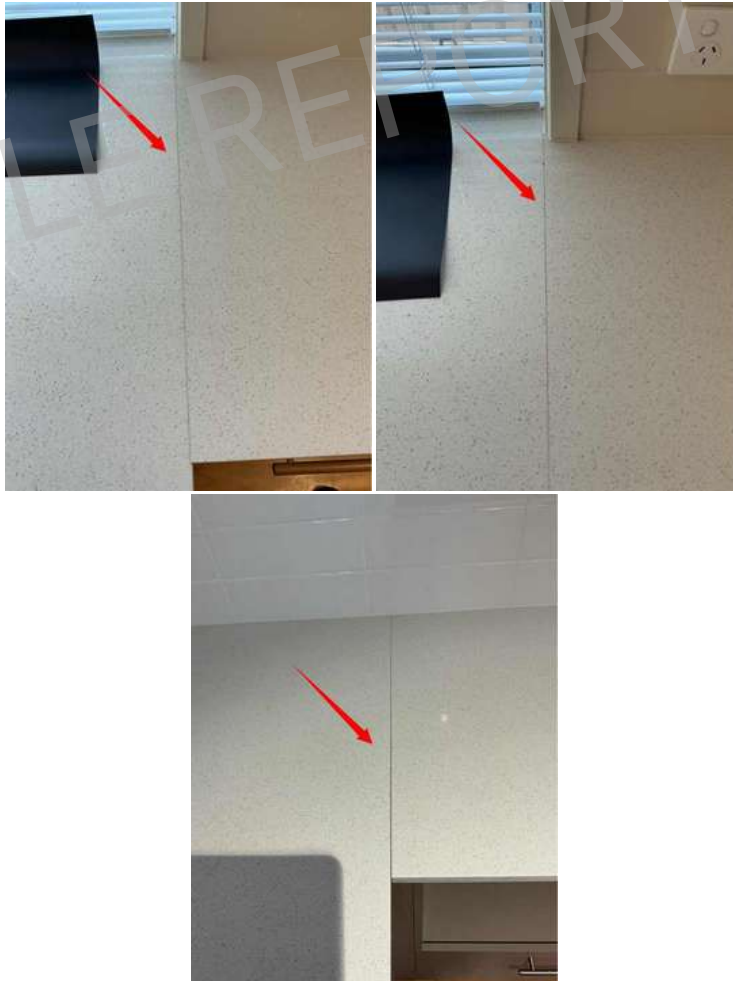
Upon visual inspection, minor joint cracking is visible on the stone benchtop. This may indicate settling or minor structural movement. It is recommended to have a licensed stonemason or countertop specialist assess the extent of the damage. Repairs may involve filling the cracks with a suitable resin or sealant to prevent further deterioration and ensure the benchtop's longevity and stability.

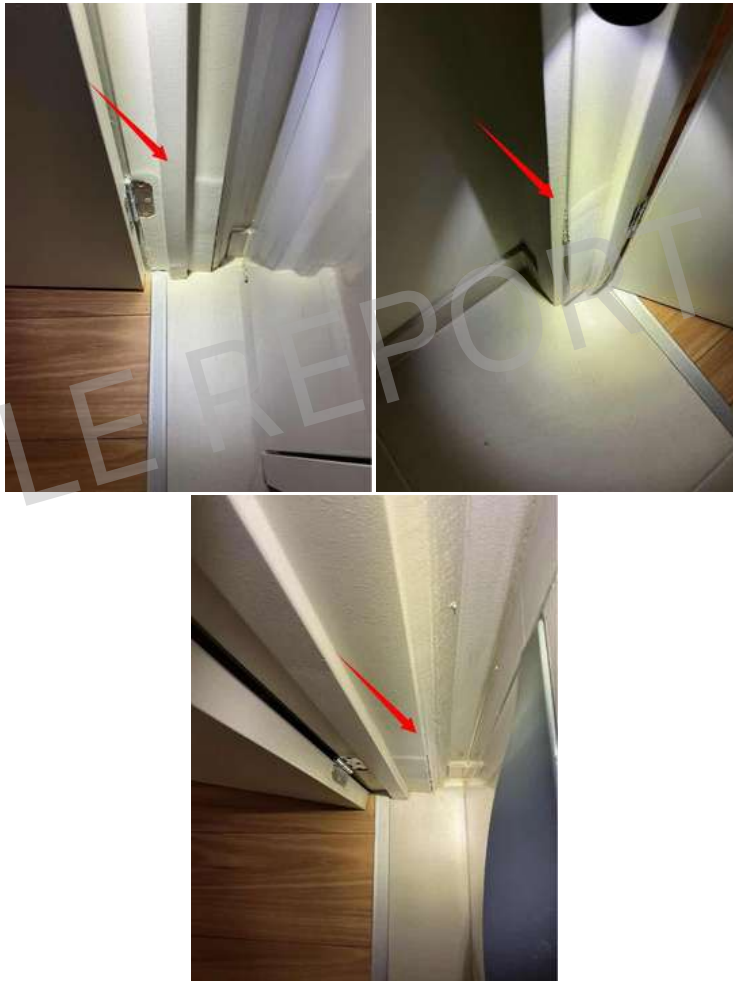
| Section | Location | Name | Comment |
|---|---|---|---|
| KITCHEN & LAUNDRY | Laundry | Doors | Upon visual inspection, swelling is evident in the door architraves, likely due to moisture exposure. It is recommended to engage a licensed carpenter to assess the extent of the damage, replace affected sections, and ensure proper sealing and ventilation to prevent future moisture ingress. Regular maintenance checks are advised to maintain integrity. |

Upon visual inspection, swelling is evident in the door architraves, likely due to moisture exposure. It is recommended to engage a licensed carpenter to assess the extent of the damage, replace affected sections, and ensure proper sealing and ventilation to prevent future moisture ingress. Regular maintenance checks are advised to maintain integrity.
