# Pre Purchase Inspection Report

## Inspectmate Pty Ltd

Report/Agreement # 25082509092479

Inspection Date: 25 Aug 2025

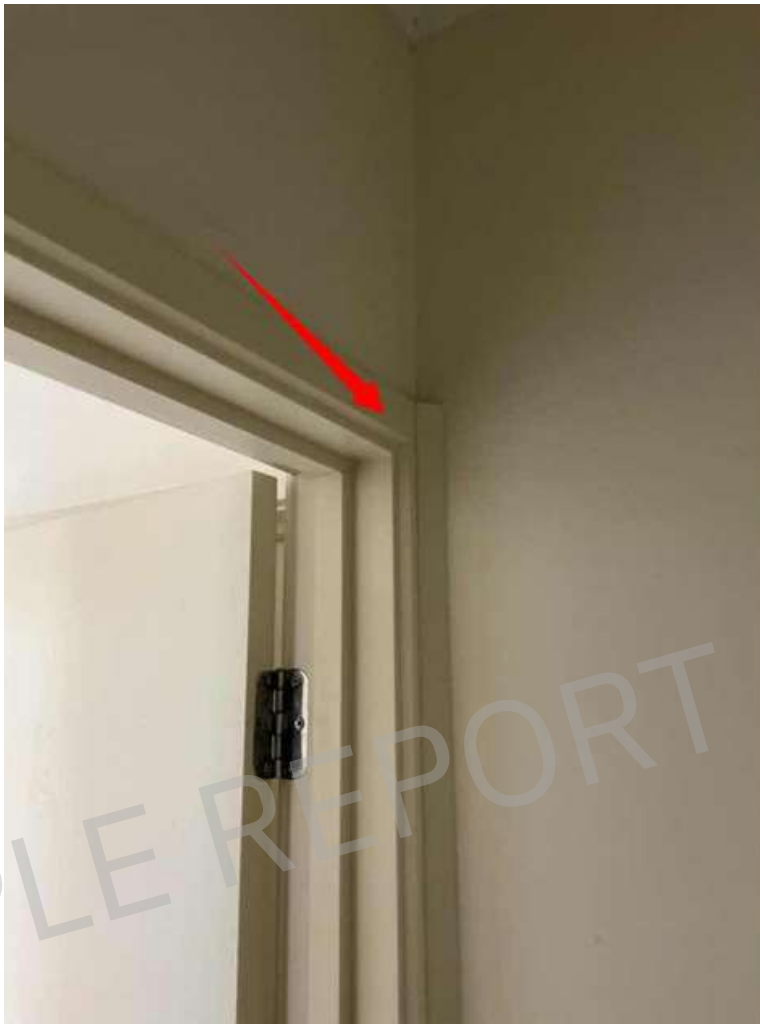
Settlement Cracks Noted . These are typical and generally patch and paint will suffice, however Monitoring these cracks advised for 12 months and if become wider or longer, you will need to contact a structural engineers to assess.

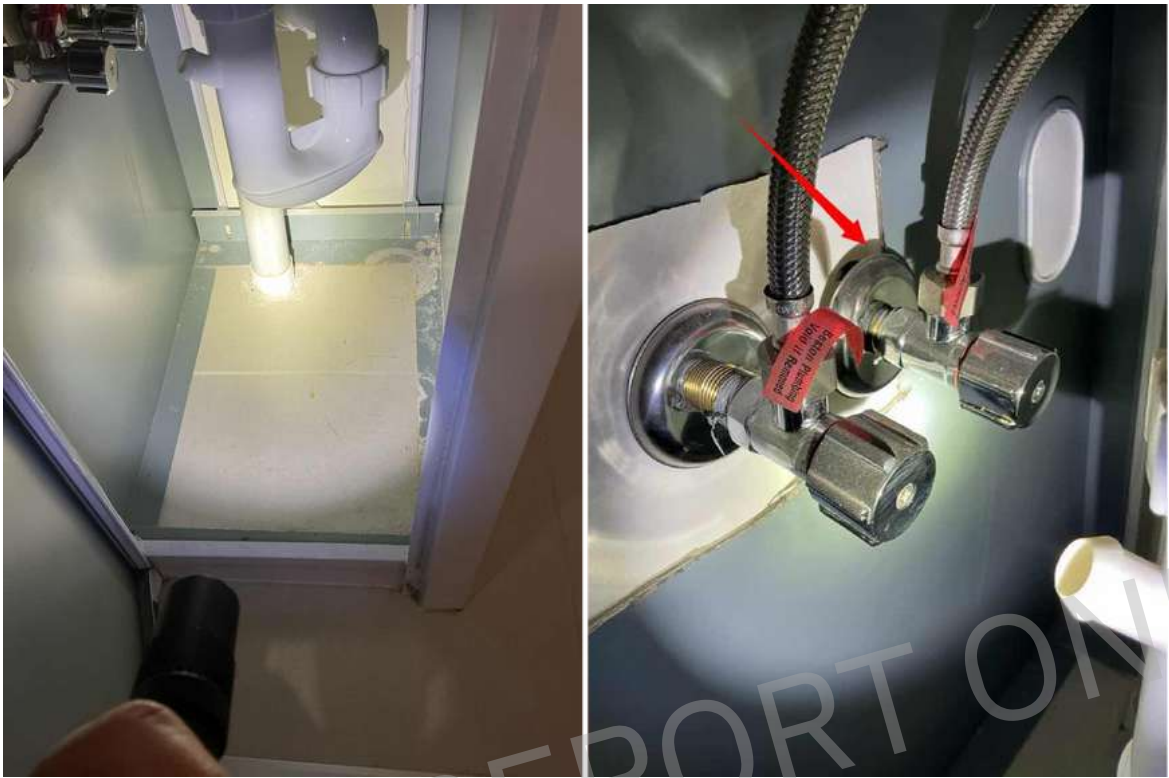
Penetration openings - As per the guide to standards & tolerances 2007 - Clause 7.08 - Pipe penetrations through external walls and inside cupboards - Plumbing holes are defective if they are not properly grouted; or in the case of cabinet work, fitted through neat minimum size penetrations, or fitted with tight fitting cover plates or collars with penetrations kept to the smallest size practicable. Engage a plumber to assess.

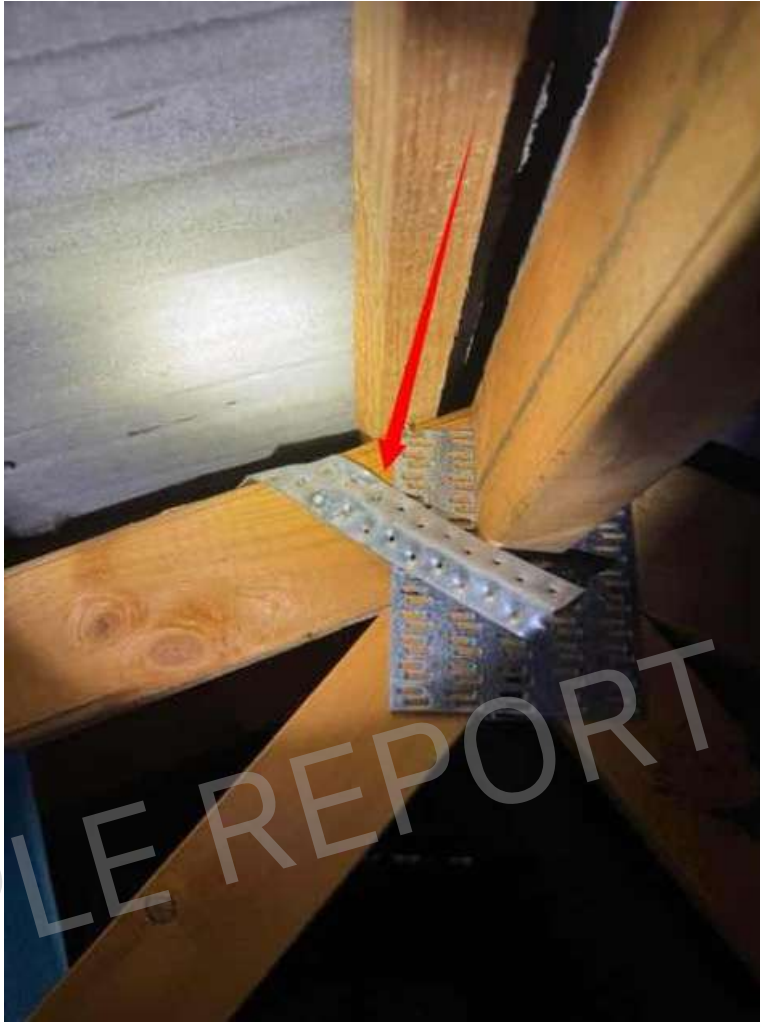
Upon visual inspection, it was noted that the nail fixings securing the bracing are inadequate, potentially compromising structural integrity. It is recommended that a suitably licensed or qualified tradesperson assess the current fixings and replace or reinforce them as necessary to ensure compliance with relevant building standards and maintain safety.

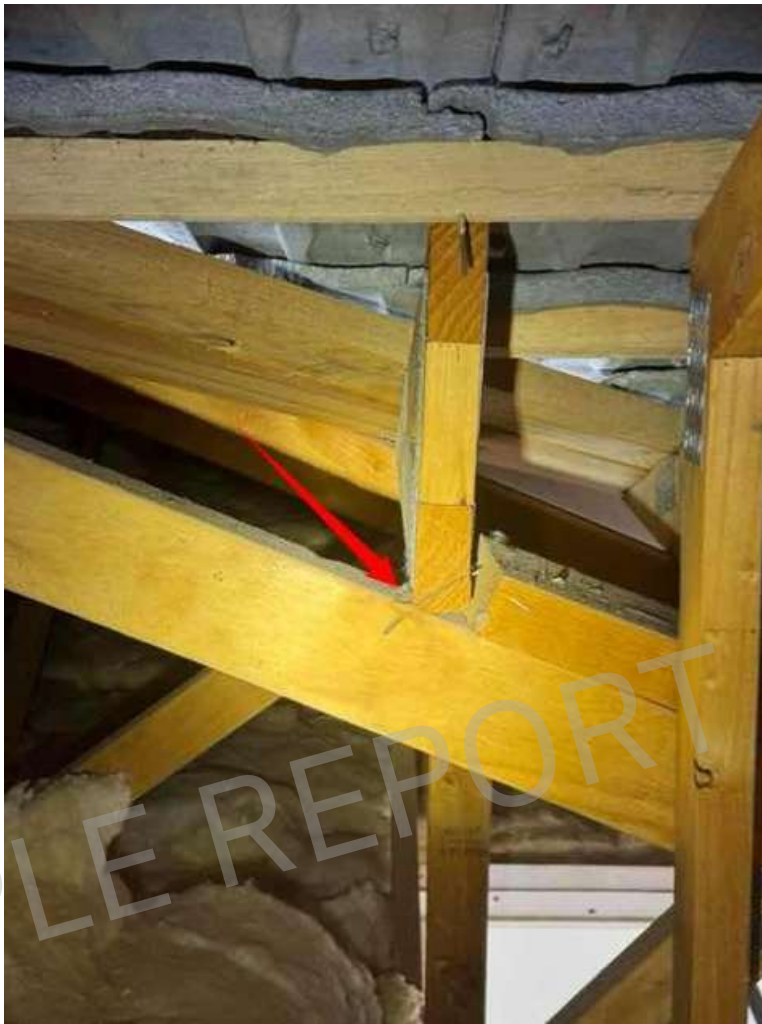
### Roof Framing Defects(1)

Upon visual inspection, it was noted that the nail fixings securing the framing timber members are inadequate. This may compromise structural integrity. It is recommended that a suitably licensed or qualified tradesperson reinforce the connections using appropriate nails or fasteners to ensure compliance with building standards and enhance stability. Regular maintenance checks should be scheduled to prevent future issues.
