# Pre Purchase Inspection Report

## Inspectmate Pty Ltd

Report/Agreement # 25082509092479

Inspection Date: 25 Aug 2025

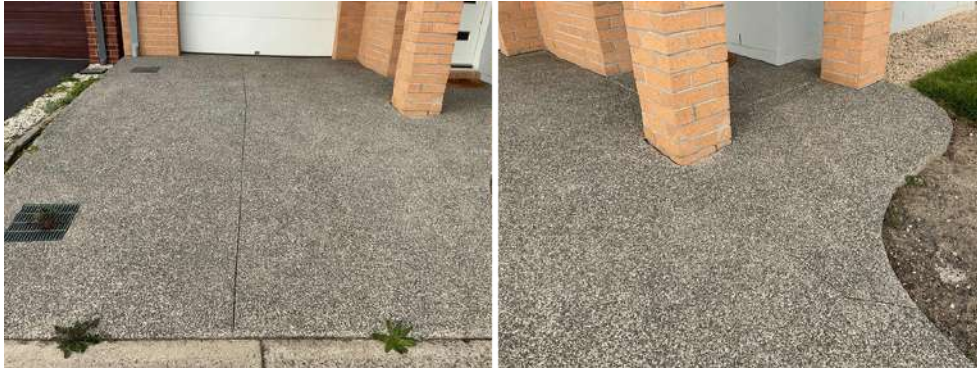
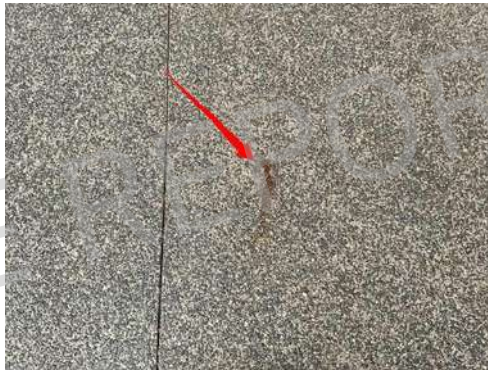
## Driveway Condition

| Section | Location | Name | Comments |
|---|---|---|---|
| SITE & CONCRETED AREAS | Driveway | Driveway Condition | Concrete spalling was visible, with corrosion to exposed steel reinforcement. Engage a qualified concreter to repair affected areas. |

Concrete spalling visible with corrosion to exposed steel reinforcement. Engage a qualified concreter for repairs to affected areas.

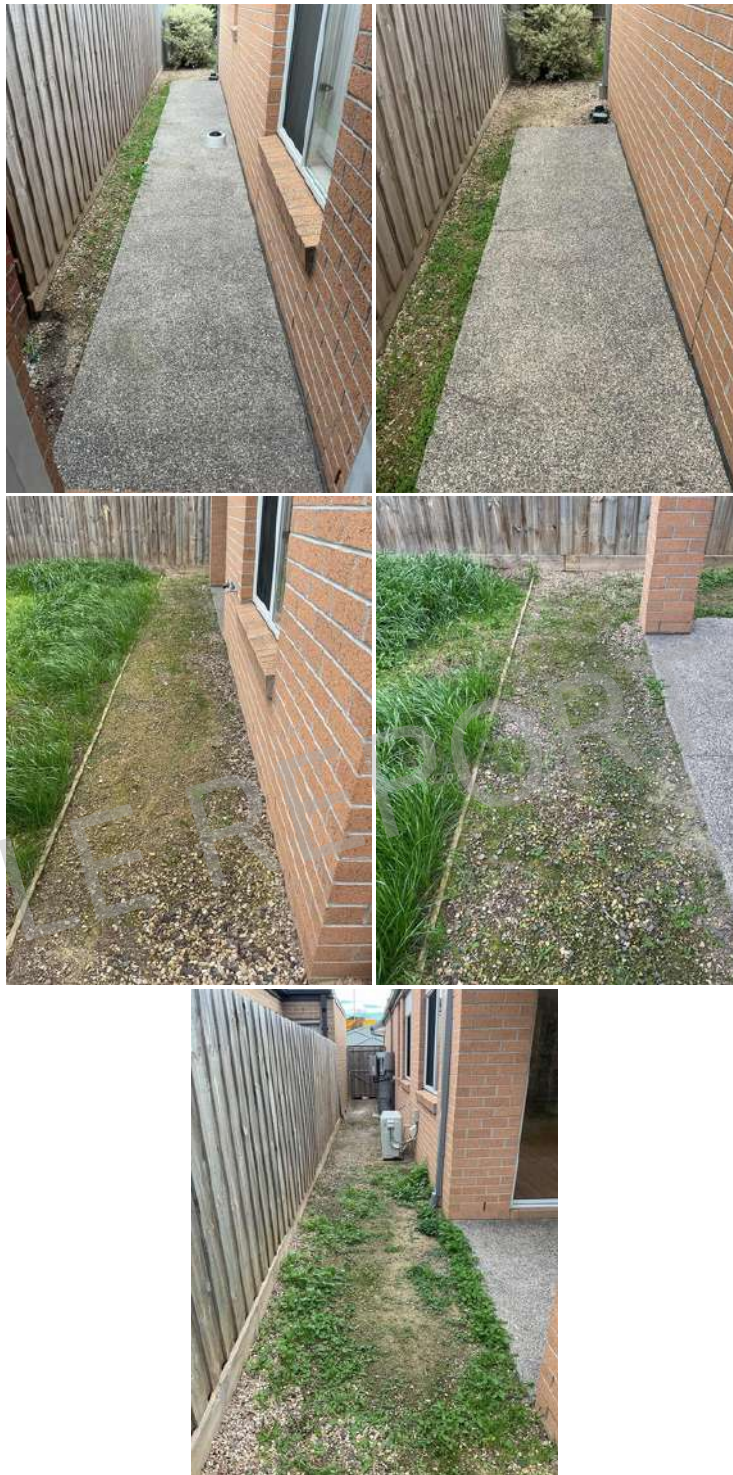
### **Pathways Condition**

The paths around the home are in a serviceable condition for the age of this dwelling with no major defects visible.

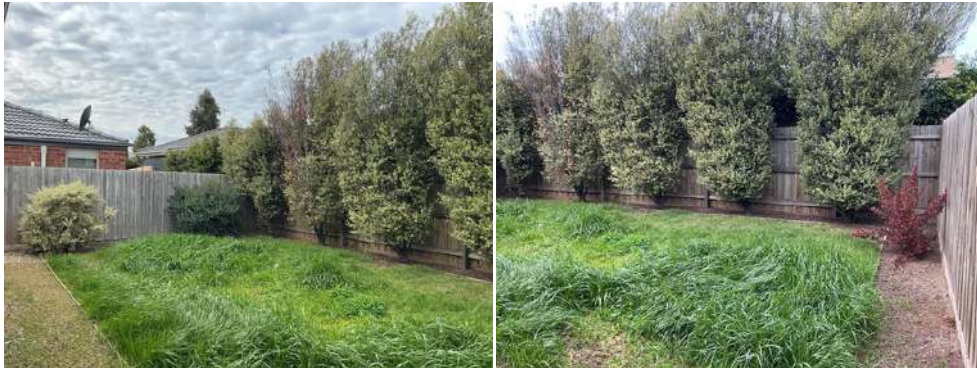
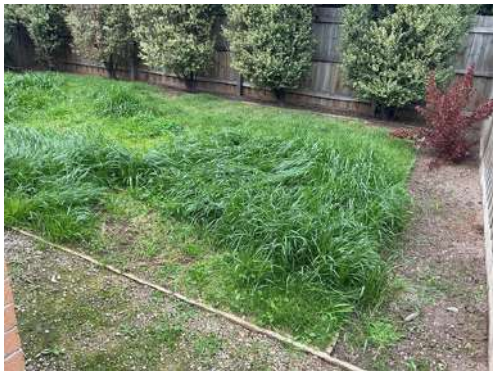
### **Tree Findings**

| Section | Location | Name | Comments |
|---|---|---|---|
| SITE & CONCRETED AREAS | Trees | Tree Findings | The garden and lawn exhibit overgrown grass, uneven patches, and weed infestation. Flower beds are poorly maintained, with wilted plants and inadequate mulching.<br>Recommendation: Hire a licensed landscaper to mow, apply weed control, and reseed bare areas. A professional gardener should prune plants, refresh mulch, and ensure proper irrigation. |

Upon visual inspection, the garden and lawn exhibit overgrown grass, uneven patches, and weed infestation. The flower beds are poorly maintained, with wilted plants and inadequate mulching. Recommend hiring a licensed landscaper to mow the lawn, apply weed control treatments, and reseed bare areas. Additionally, a professional gardener should prune plants, refresh mulch, and ensure proper irrigation for optimal plant health and appearance.

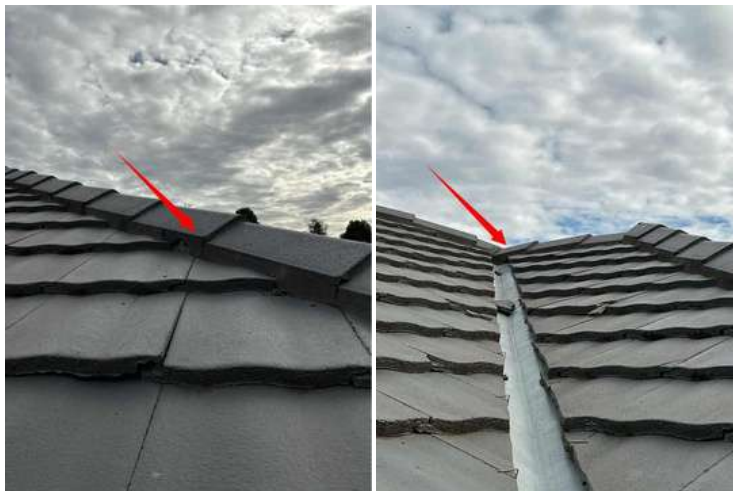
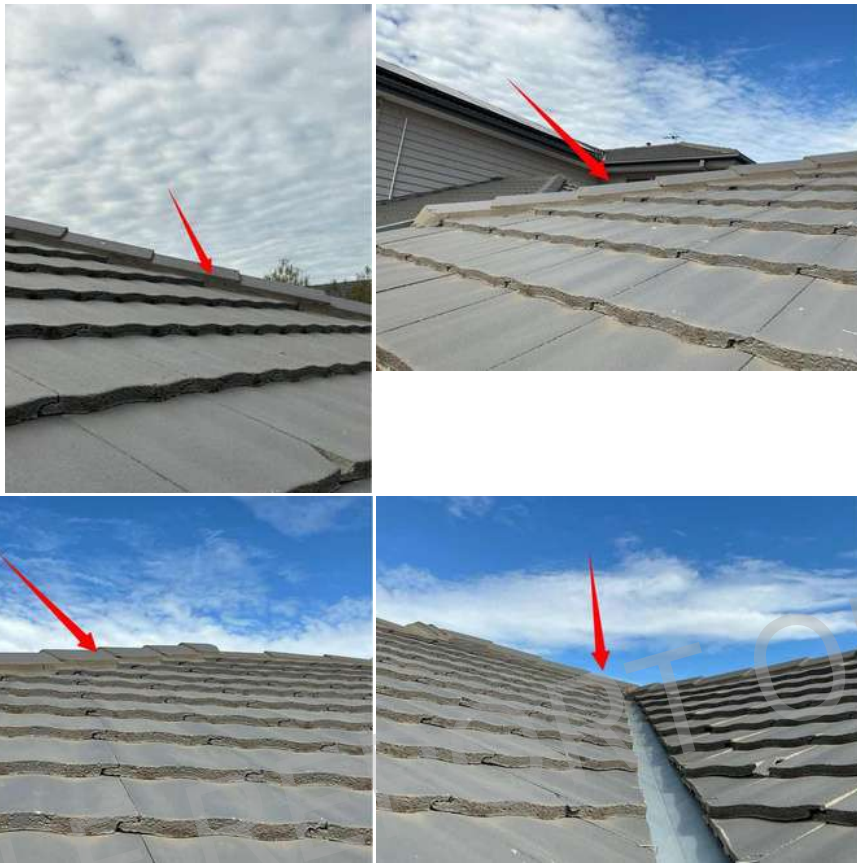
### Roof Clad Condition

| Section | Location | Name | Comments |
|---|---|---|---|
| ROOF AND GUTTER | Roof Covering | Roof Clad Condition | Mortar cracks were visible. We recommend repair by a qualified roofer, as they may contribute to water ingress. |

Mortar cracks visible. We recommend having these repaired by a qualified roofer as they may contribute to water ingress.

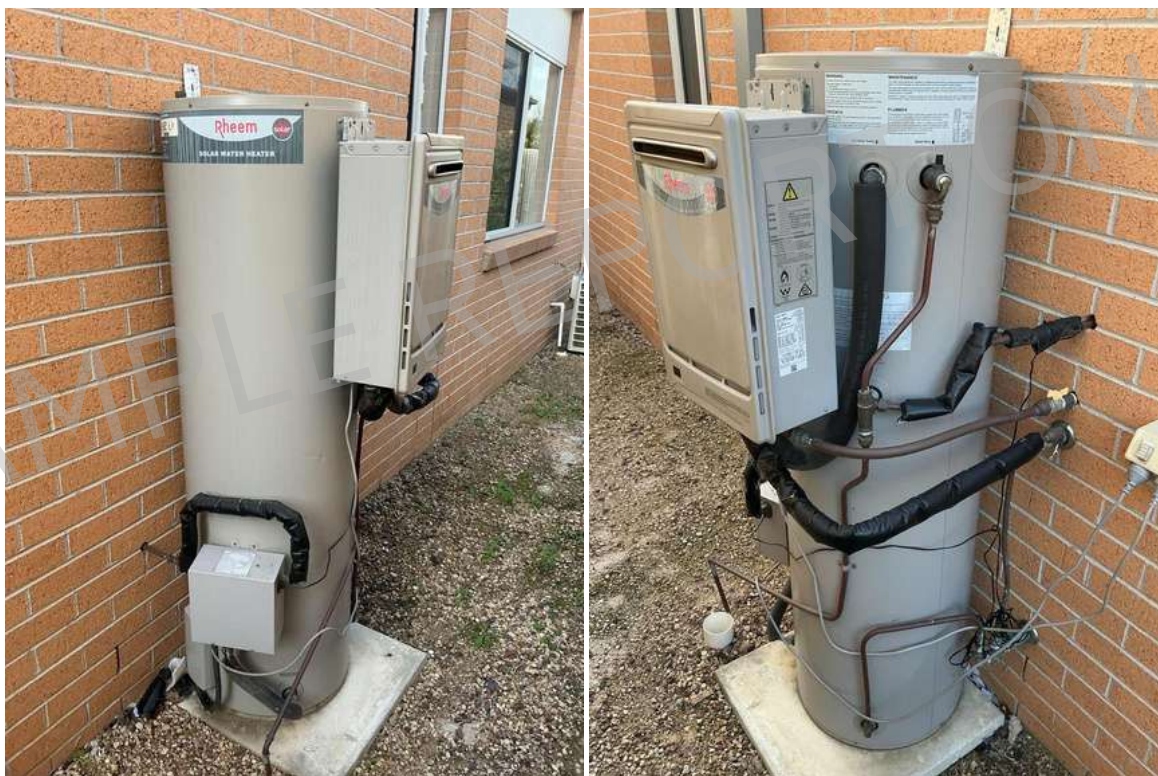
#### System Type

The hot water unit is a solar gas boosted unit.

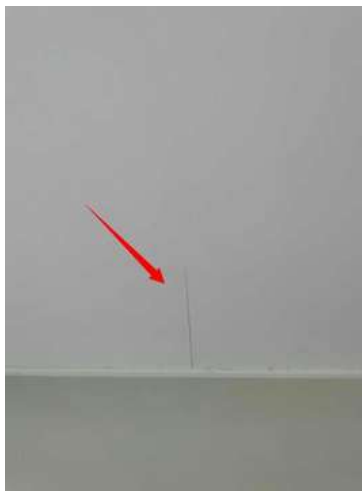
#### Ceiling Lining Condition

Ceilingliningjointcracks.Contact a qualified painter for repairs.

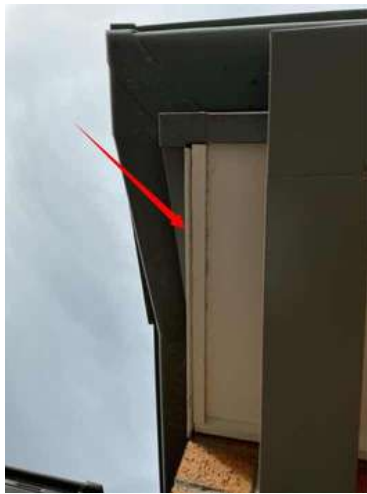
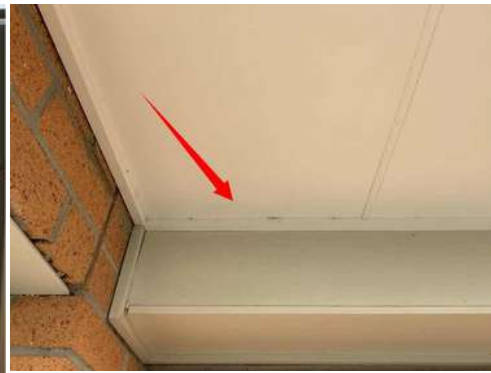
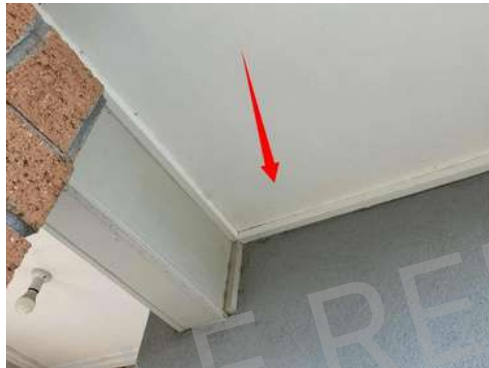
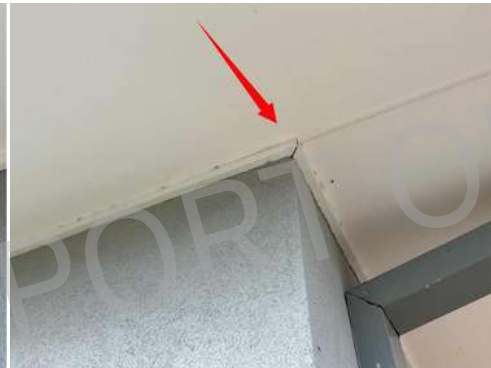
#### Eave Condition (1)

| Section | Location | Name | Comments |
|---|---|---|---|
| EXTERIOR | Eaves | Eave Condition (1) | Minor deterioration and ageing were evident. General maintenance and upkeep are recommended. |

Minor eavedeterioration & ageing evident. Recommendations: Maintenance works, general upkeep should be carried out.

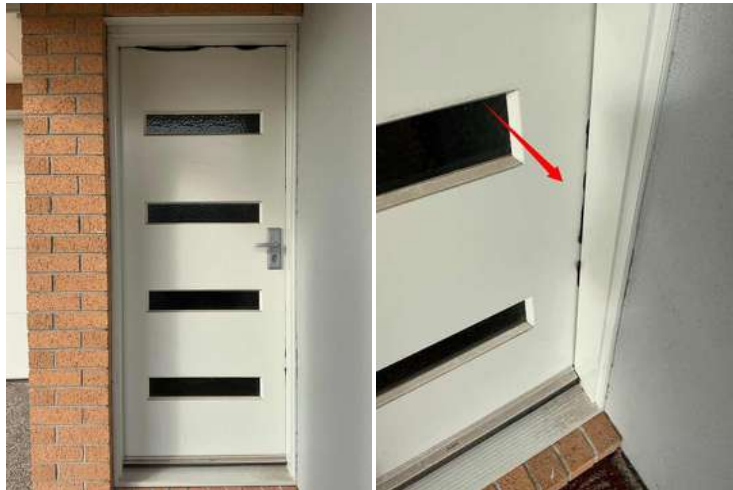
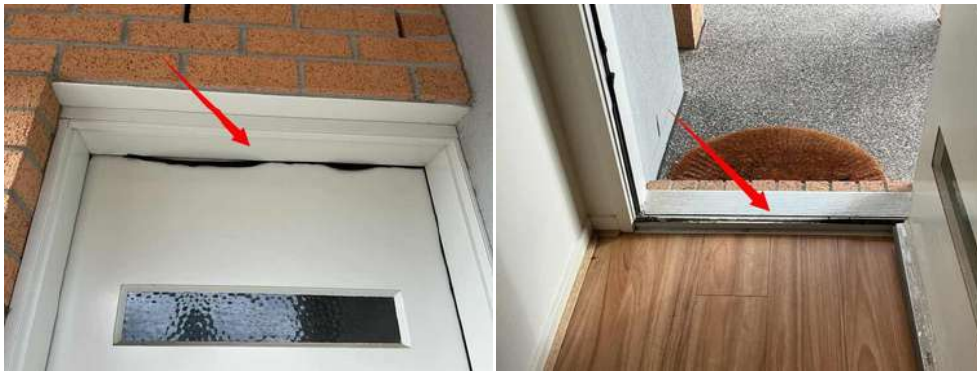
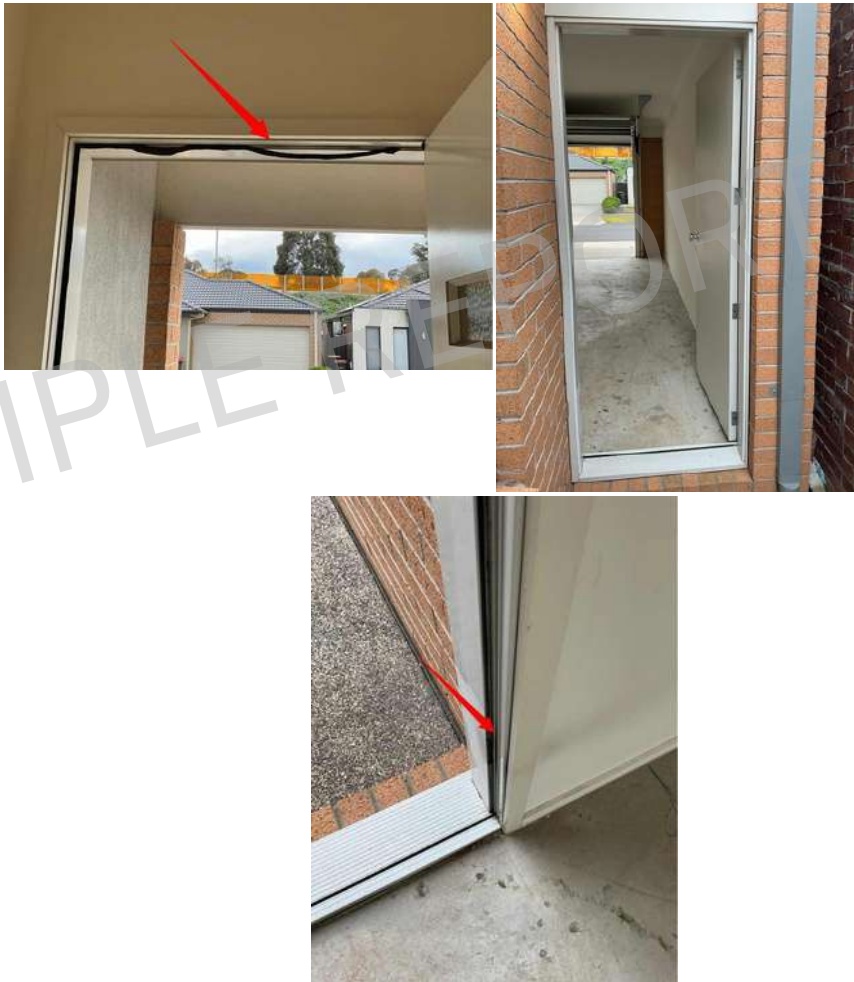
#### **Door Findings**

| EXTERIOR | External Door Components | Door Findings | Upon visual inspection, the weather strip on the entry door is deteriorated, leading to potential drafts and energy inefficiency. It is recommended to replace the damaged weather strip to ensure proper sealing and insulation. A suitably licensed or qualified tradesperson should be engaged to carry out the replacement to restore the door's functionality and improve energy efficiency. |

Upon visual inspection, the weather strip on the entry door is deteriorated, leading to potential drafts and energy inefficiency. It is recommended to replace the damaged weather strip to ensure proper sealing and insulation. A suitably licensed or qualified tradesperson should be engaged to carry out the replacement to restore the door's functionality and improve energy efficiency.

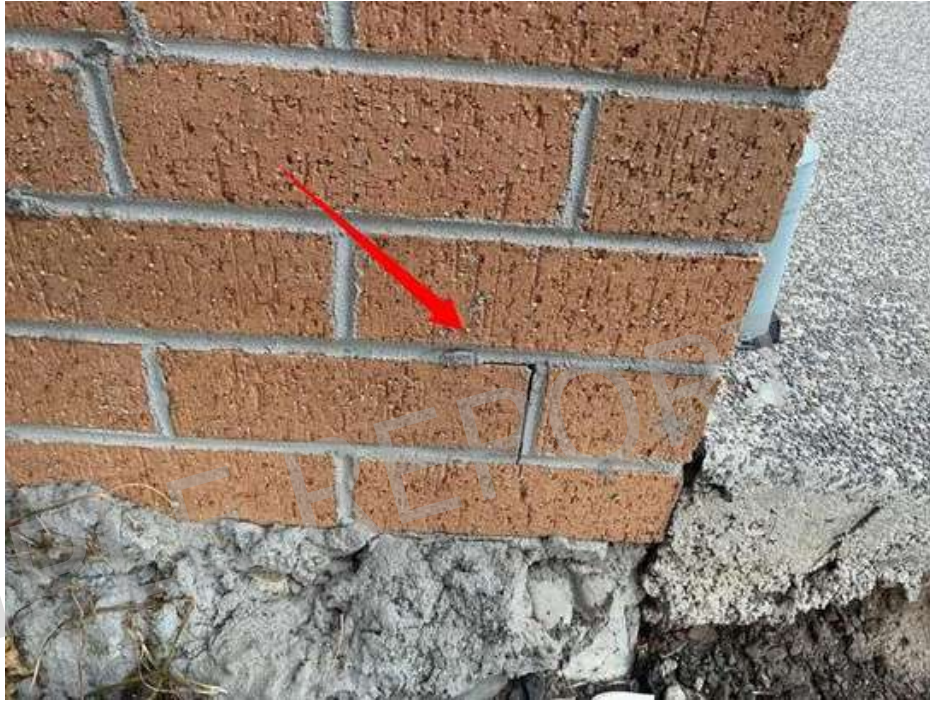
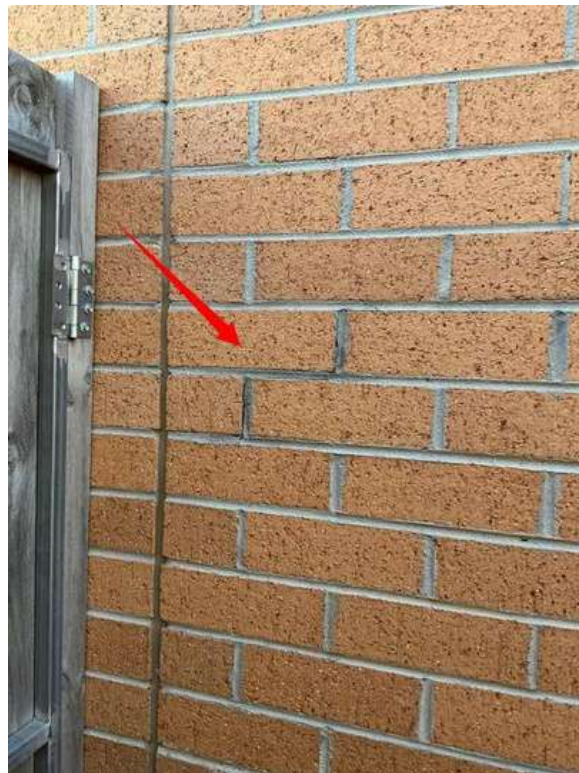
| EXTERIOR | Walls | Condition | <p>There appears to have been some settlement in the building which has caused some cracking to the walls. These crack are catergorized as 0 to 2. This can also cause some doors to bind or be out of square. In the inspectors opinion these cracks are due to settlement, usually due to ground movement and subsequent movement to building materials can be expected. Any cracks should be monitored and if cracks increase in size, further investigation should be carried out by a structural engineer.</p> <p>For clarification on the category of cracks please refer to Cracking of Building Elements in Section 2D of the Terms and Conditions contained in this report.</p> |

There appears to have been some settlement in the building which has caused some cracking to the walls. These cracks are categorized as 0 to 2. This can also cause some doors to bind or be out of square. In the inspector's opinion, these cracks are due to settlement, usually due to ground movement and subsequent movement to building materials can be expected. Any cracks should be monitored and if cracks increase in size, further investigation should be carried out by a structural engineer.

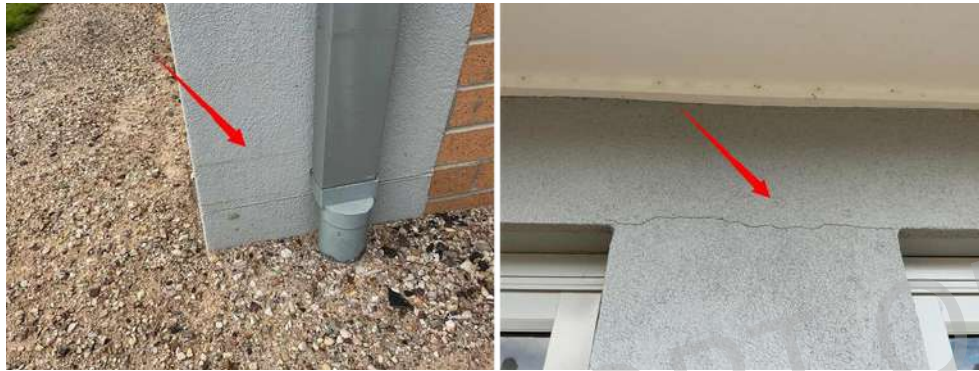
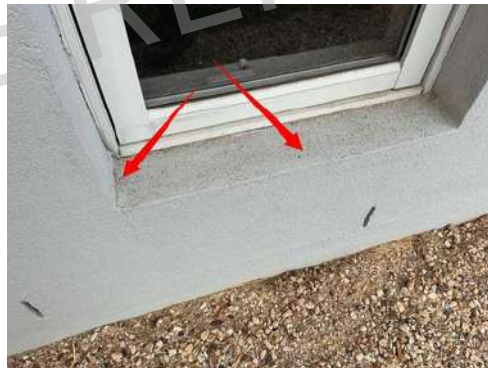
**Condition (1)**

| EXTERIOR | Walls | Condition (1) | <p>There appears to have been some settlement in the building which has caused some cracking to the walls. These crack are catergorized as 0 to 2. This can also cause some doors to bind or be out of square. In the inspectors opinion these cracks are due to settlement, usually due to ground movement and subsequent movement to building materials can be expected. Any cracks should be monitored and if cracks increase in size, further investigation should be carried out by a structural engineer.</p> <p>For clarification on the category of cracks please refer to Cracking of Building Elements in Section 2D of the Terms and Conditions contained in this report.</p> |

There appears to have been some settlement in the building which has caused some cracking to the walls. These cracks are categorized as 0 to 2. This can also cause some doors to bind or be out of square. In the inspector's opinion these cracks are due to settlement, usually due to ground movement and subsequent movement to building materials can be expected. Any cracks should be monitored and if cracks increase in size, further investigation should be carried out by a structural engineer.

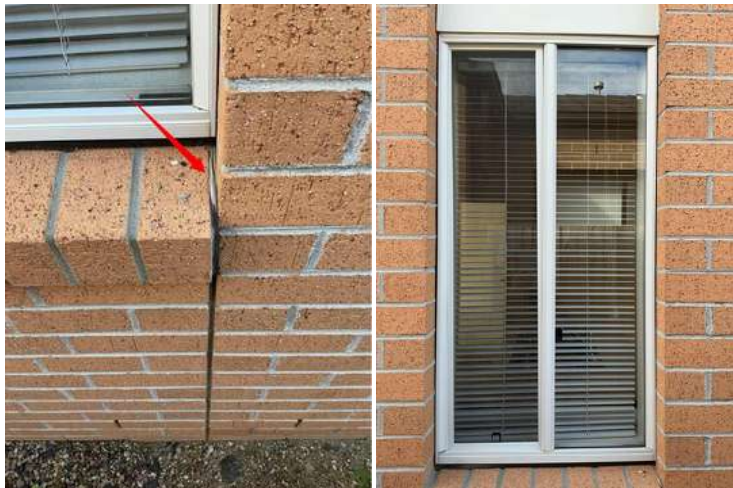
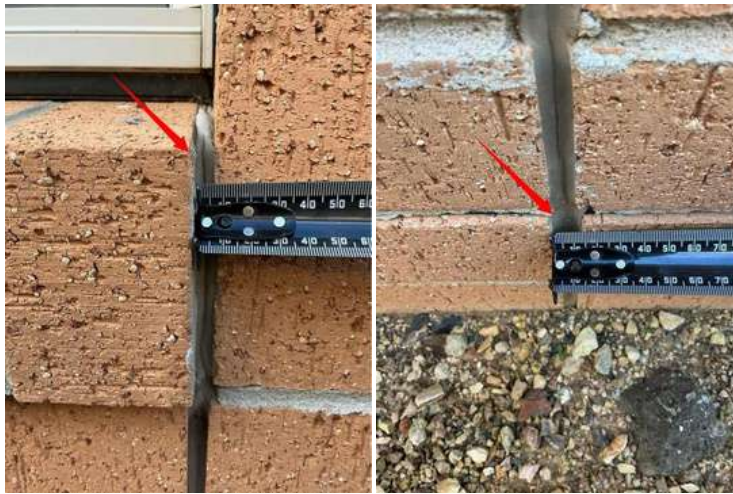
**Condition (5)**

| Section | Location | Name | Comment |
|---|---|---|---|
| EXTERIOR | Walls | Condition (5) | Upon visual inspection, We have noted that the external control join has had movement occurring . We recommend monitoring the control join and if widen please contact structural engineer for assessment and evaluation. |

Upon visual inspection, We have noted that the external control join has had movement occurring . We recommend monitoring the control join and if widen please contact structural engineer for assessment and evaluation.

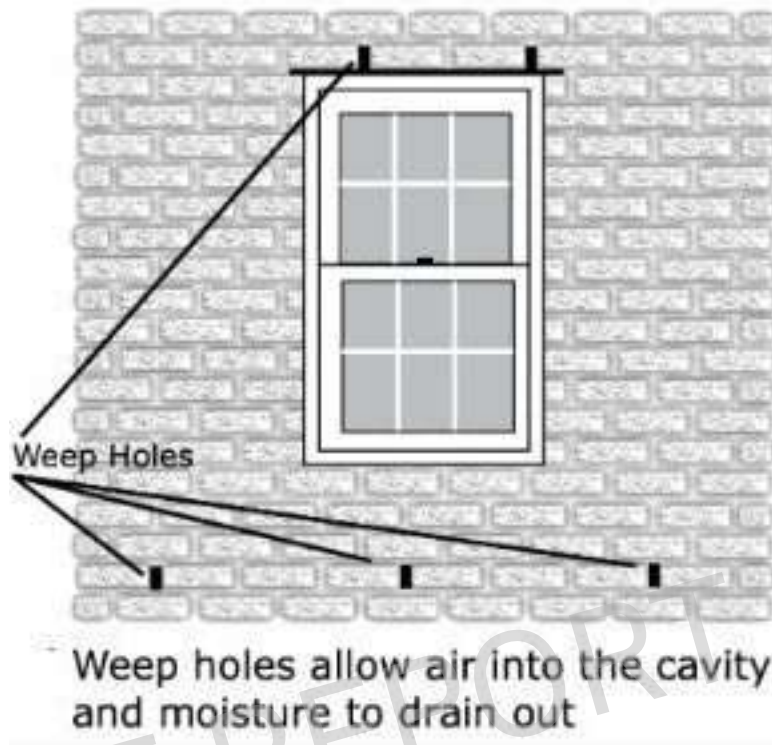
### Findings

The weep holes are unobstructed .

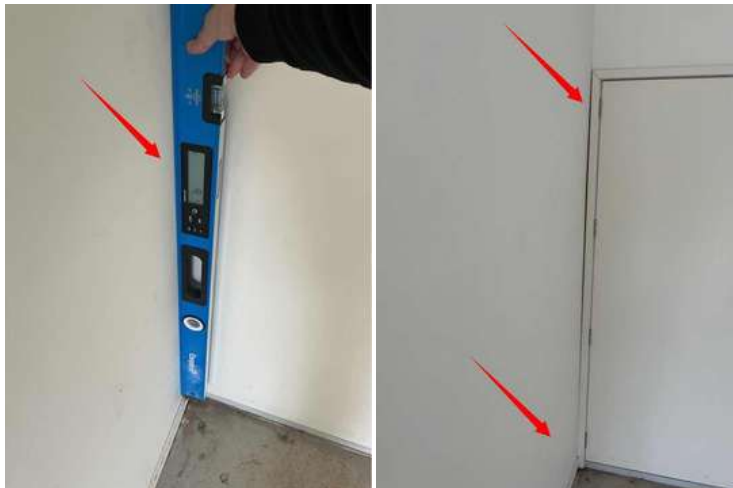
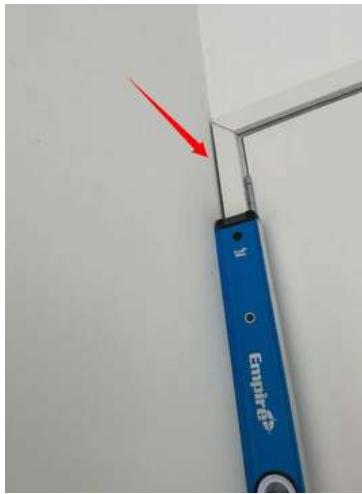
### Internal Wall Findings(1)

Upon visual inspection, a noticeable deviation was observed at the wall junction. It is recommended that a licensed tradesperson assess the area to determine the cause and implement necessary repairs, such as realignment or reinforcement, to ensure structural integrity and prevent further damage.

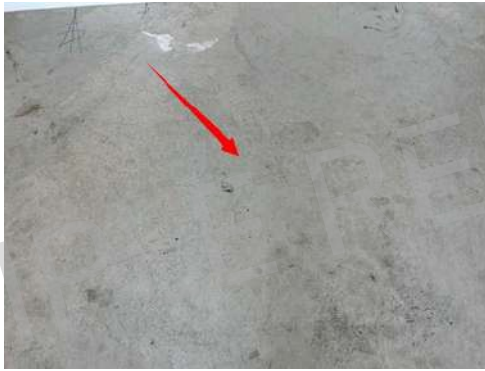
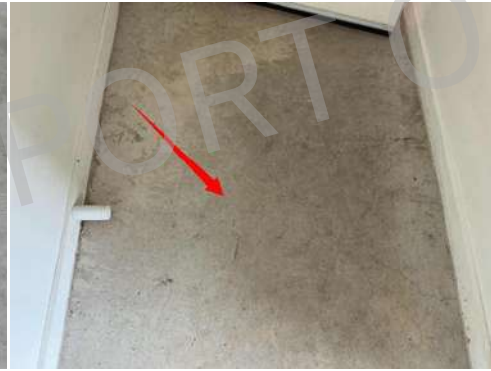
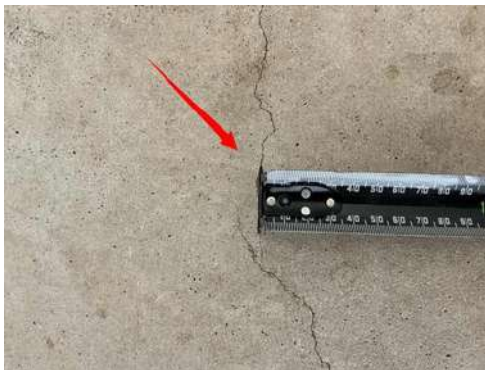
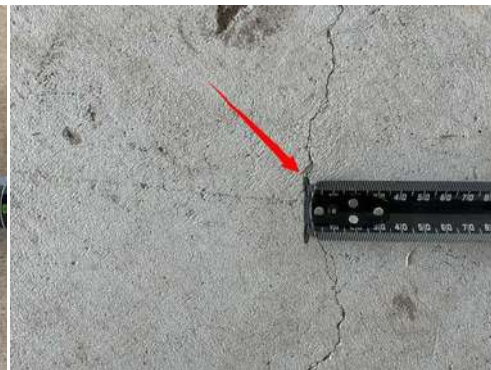
## Floor Findings

Minor hairline slab cracks - Note. Whilst these cracks appeared to be minor at the time of inspection, we strongly recommend you monitor these cracks and if worsening occurs contact a qualified concreter for further advice.

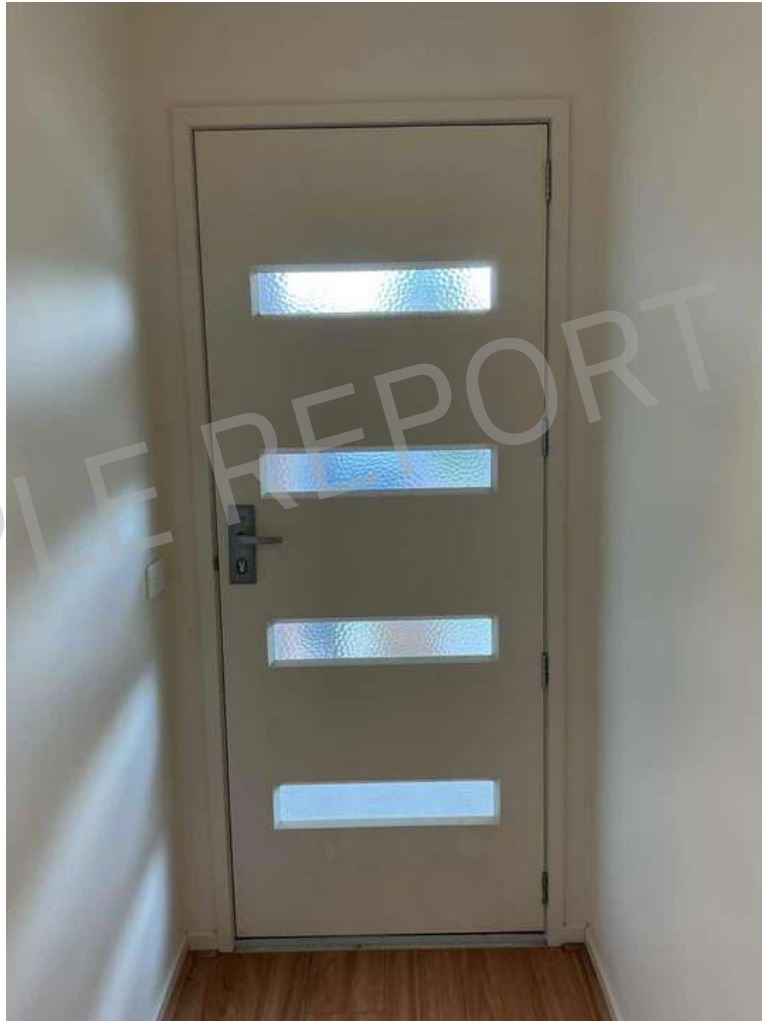
#### **Front Entry Doors**

The doors are in serviceable condition with no notable defects observed.

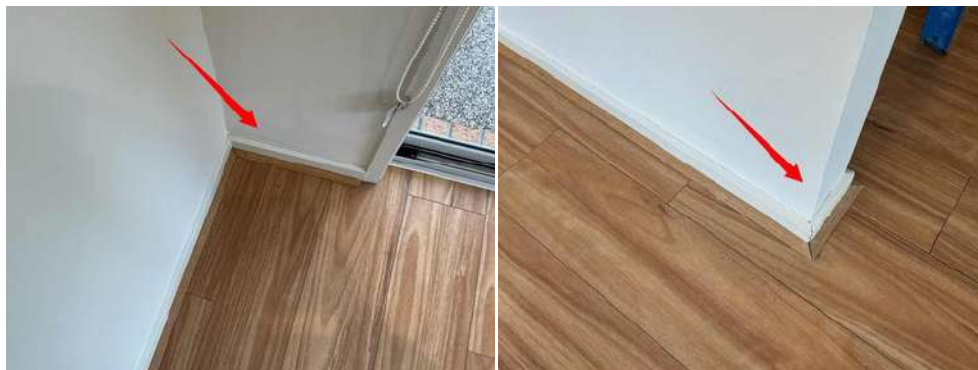
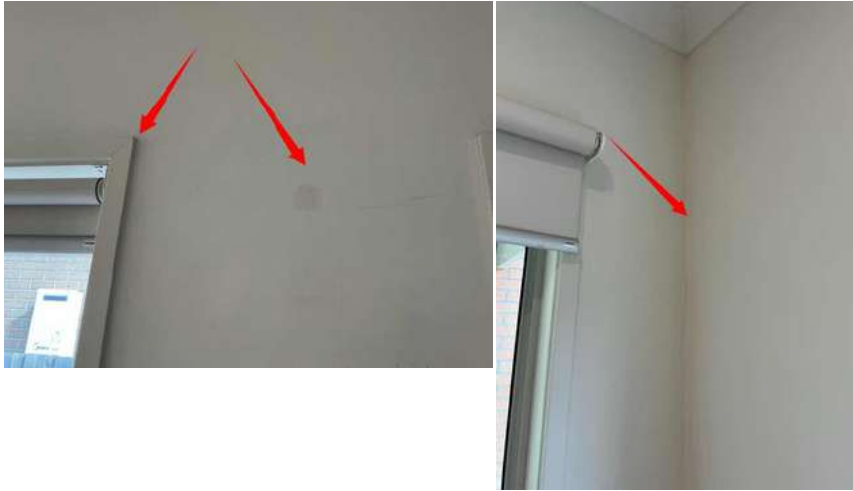
General ageing and/or denting and the like is evident on wall linings - Recommendations: A qualified painter should be engaged to assess and repair as required.

Settlement Cracks Noted. These are typical and generally patch and paint will suffice, however we recommend you monitor these cracks and if they become wider or longer, you will need to contact a structural engineers to assess.

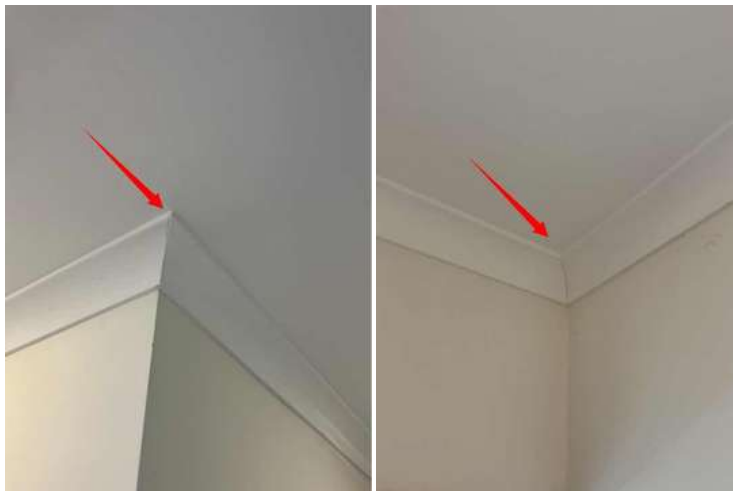
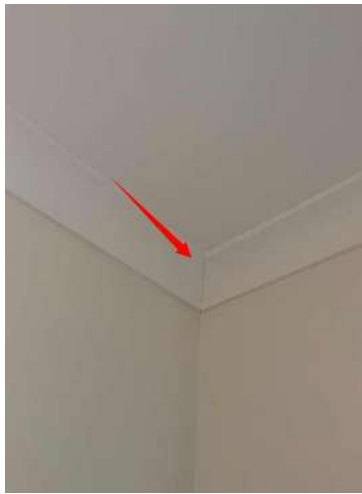
#### **Ceiling**

Settlement Cracks Noted. These are typical and generally patch and paint will suffice, however monitoring these cracks is advised for 12 months and if they become worse, further investigation by a suitably qualified professional is advised.

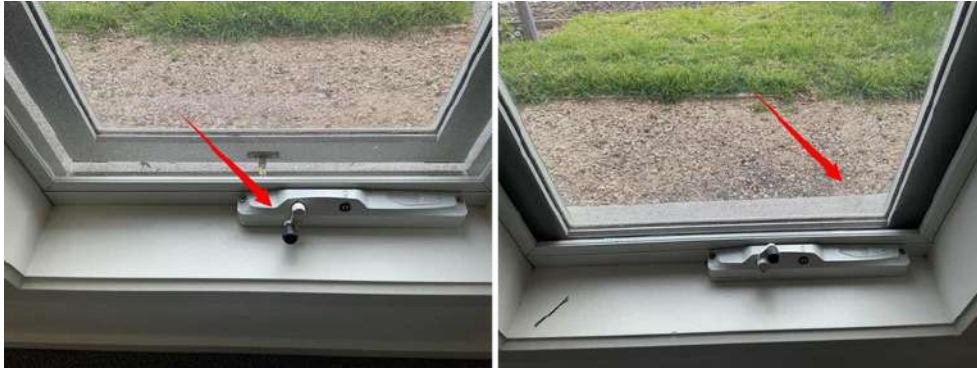
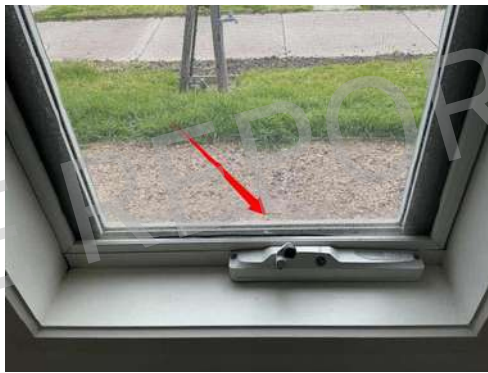
## Windows

General age wear deterioration - The window frame/components showed evidence of ageing and wear. General maintenance works required.

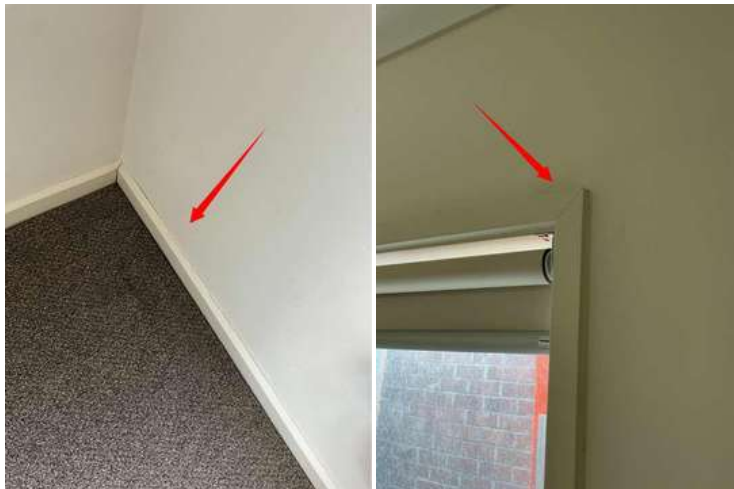
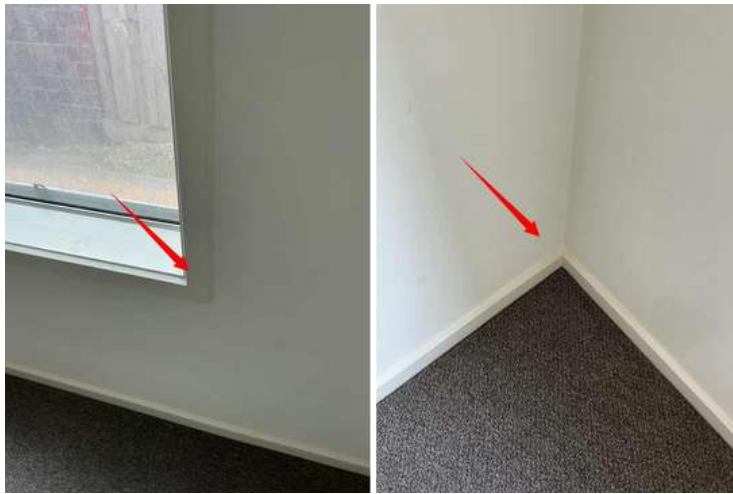
### Walls

Settlement Cracks Noted. These are typical and generally patch and paint will suffice, however we recommend monitor these cracks and if become wider or longer, you will need to contact a structural engineers to assess.

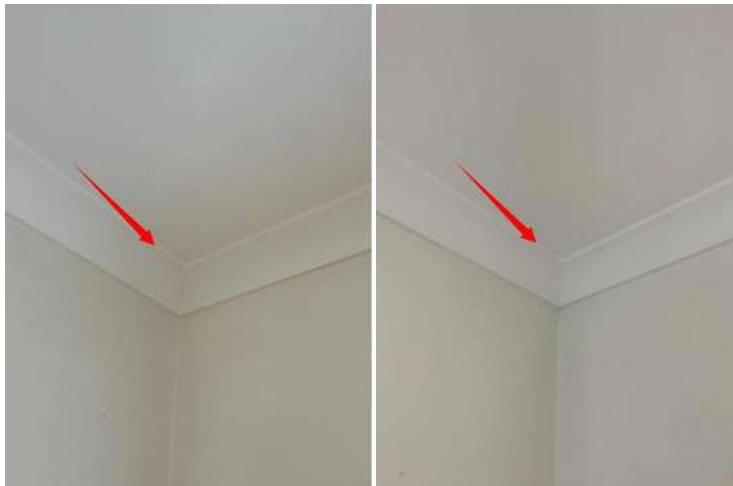
#### **Ceiling**

Settlement Cracks Noted. These are typical and generally patch and paint will suffice, however monitoring these cracks advised for 12 months and if become wider or longer, you will need to contact a structural engineers to assess.

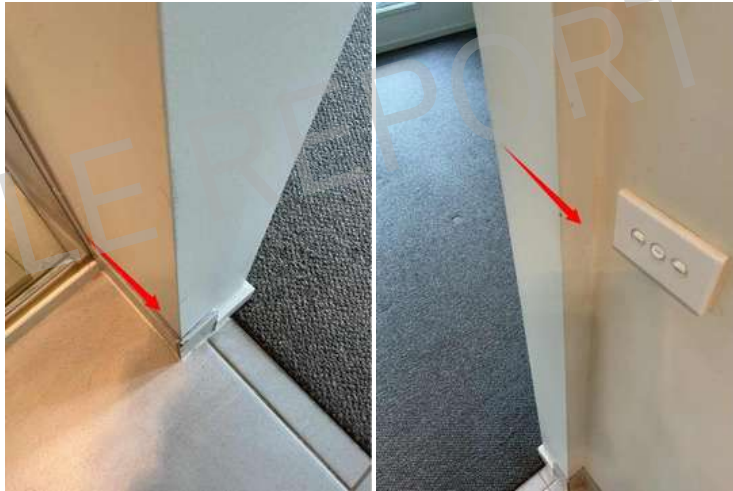
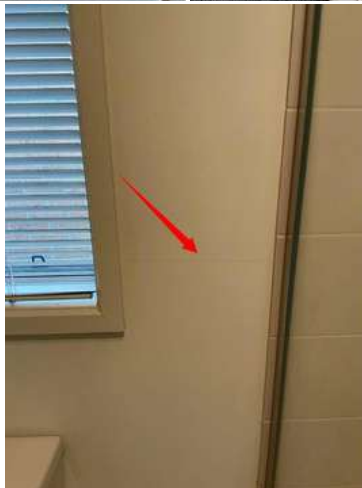
Settlement Cracks Noted . These are typical and generally patch and paint will suffice, however Monitoring these cracks advised for 12 months and if become wider or longer, you will need to contact a structural engineers to assess.

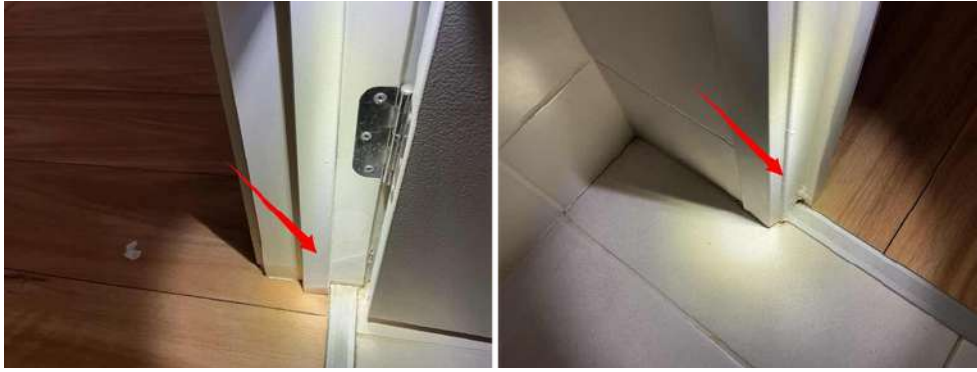
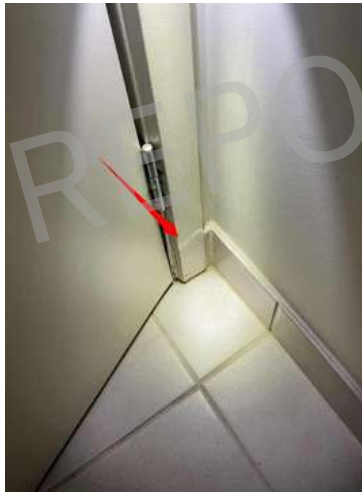
Water damaged door. Possible due to leak in bathroom. Replacement recommended.

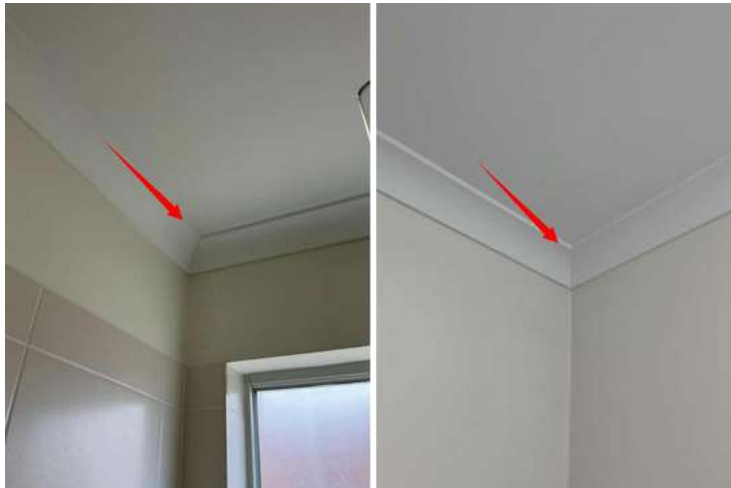
Settlement Cracks Noted. These are typical and generally patch and paint will suffice, however monitoring these cracks advised for 12 months and if become wider or longer, you will need to contact a structural engineers to assess.

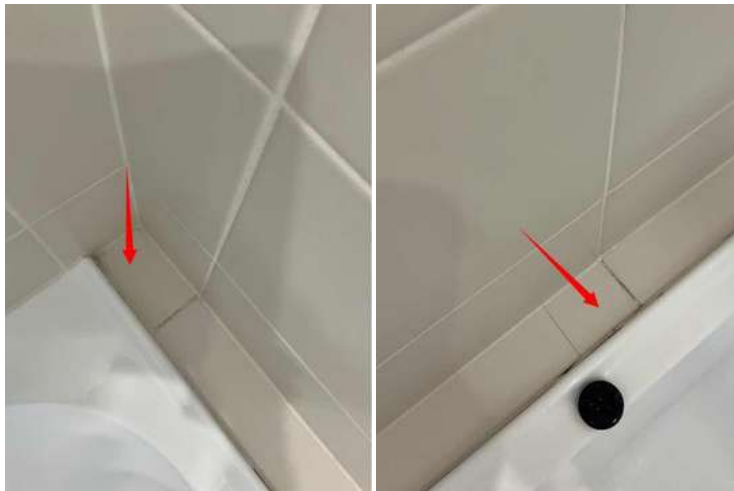
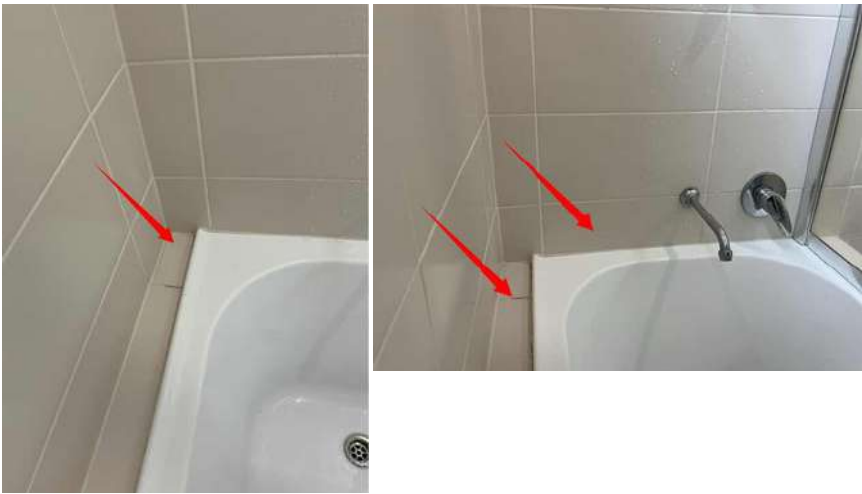
Upon visual inspection, the silicone in the bath areas shows signs of deterioration, such as cracking and peeling. This can lead to water ingress and potential damage. It is recommended to remove the old silicone and apply a new, high-quality, mold-resistant silicone sealant. Ensure all surfaces are clean and dry before application to ensure proper adhesion and longevity.

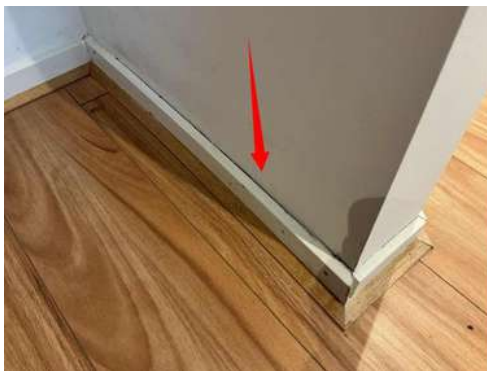
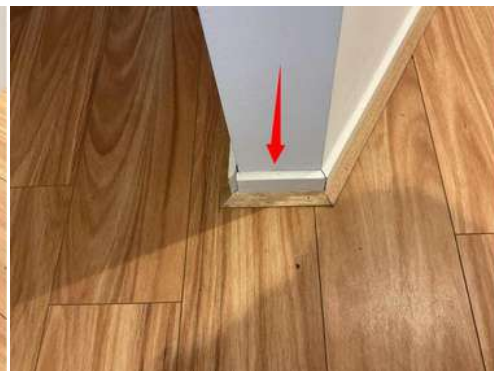
General ageing and/or denting and/or wear and/or previous wall patching and the like is evident on wall linings -  
 Recommendations: A qualified painter should be engaged to assess and repair as required.

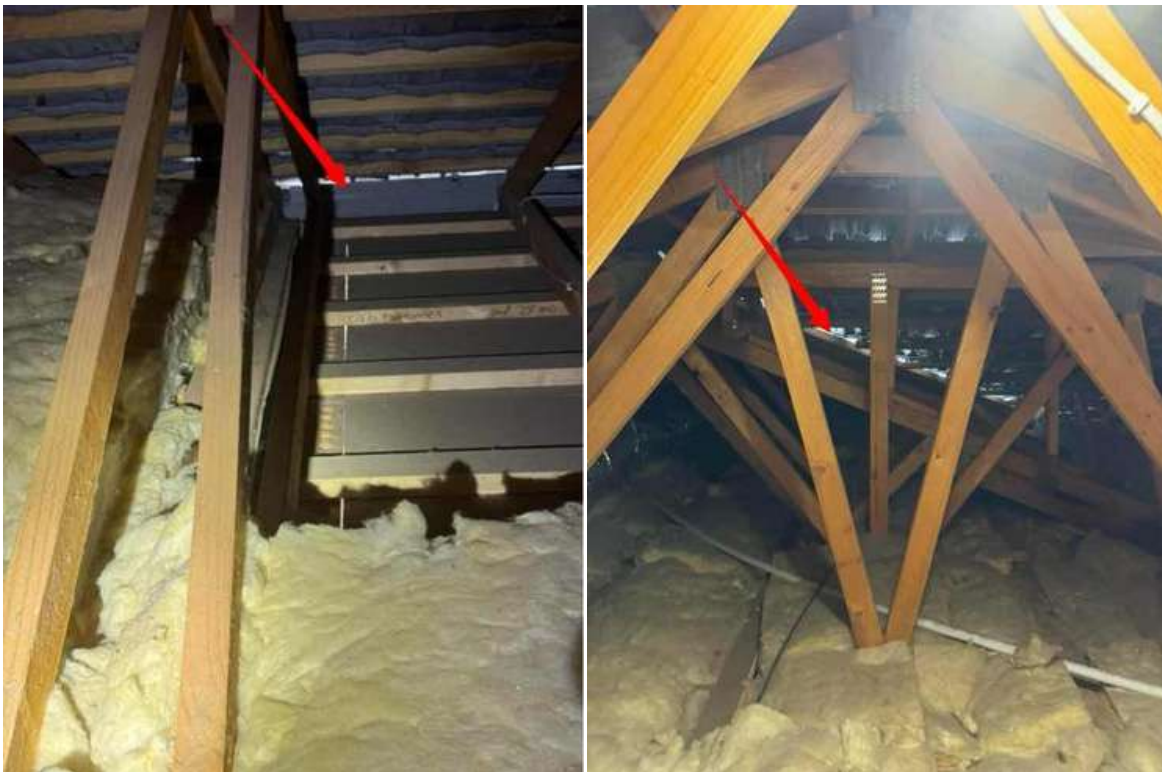
flashing gaps visible. Water entry likely. A qualified roofer should be engaged for advice and recommendations.

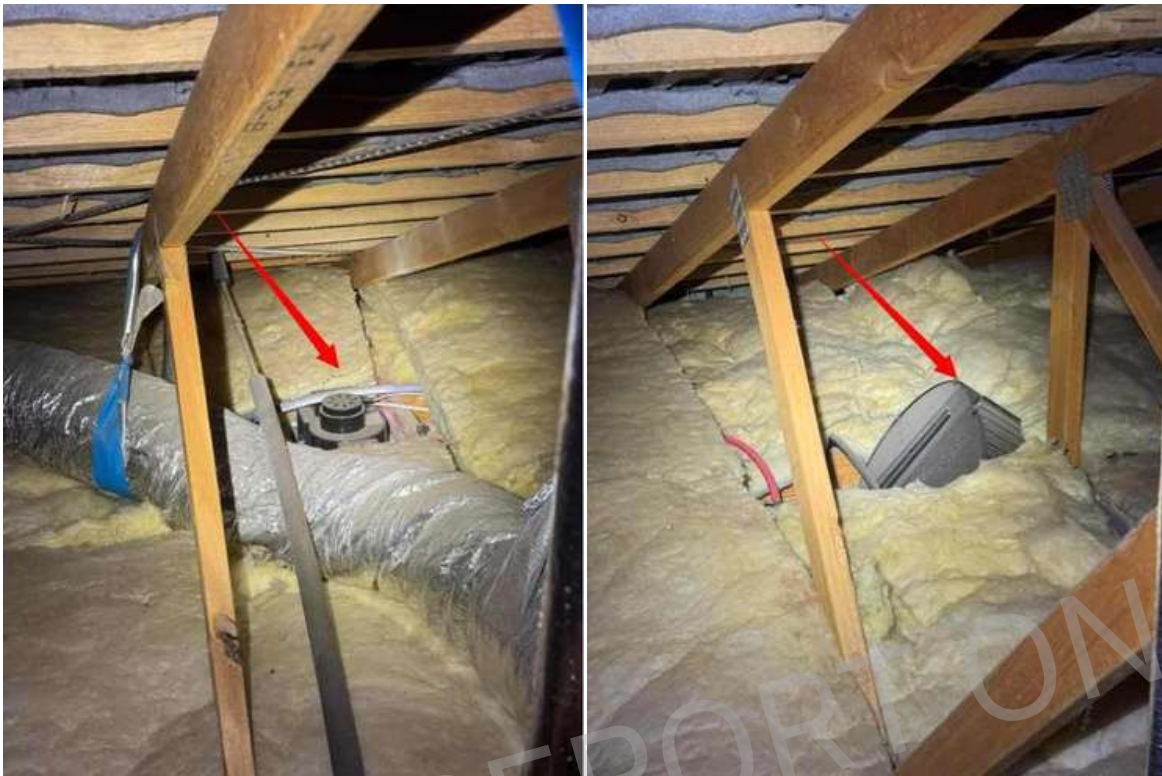
Upon visual inspection, the internal fan ducting was found to be improperly connected, lacking a direct link to the external atmosphere. This can lead to inadequate ventilation and potential moisture buildup. It is recommended that a suitably licensed or qualified tradesperson be engaged to properly connect the ducting to an external vent, ensuring effective airflow and compliance with building standards.

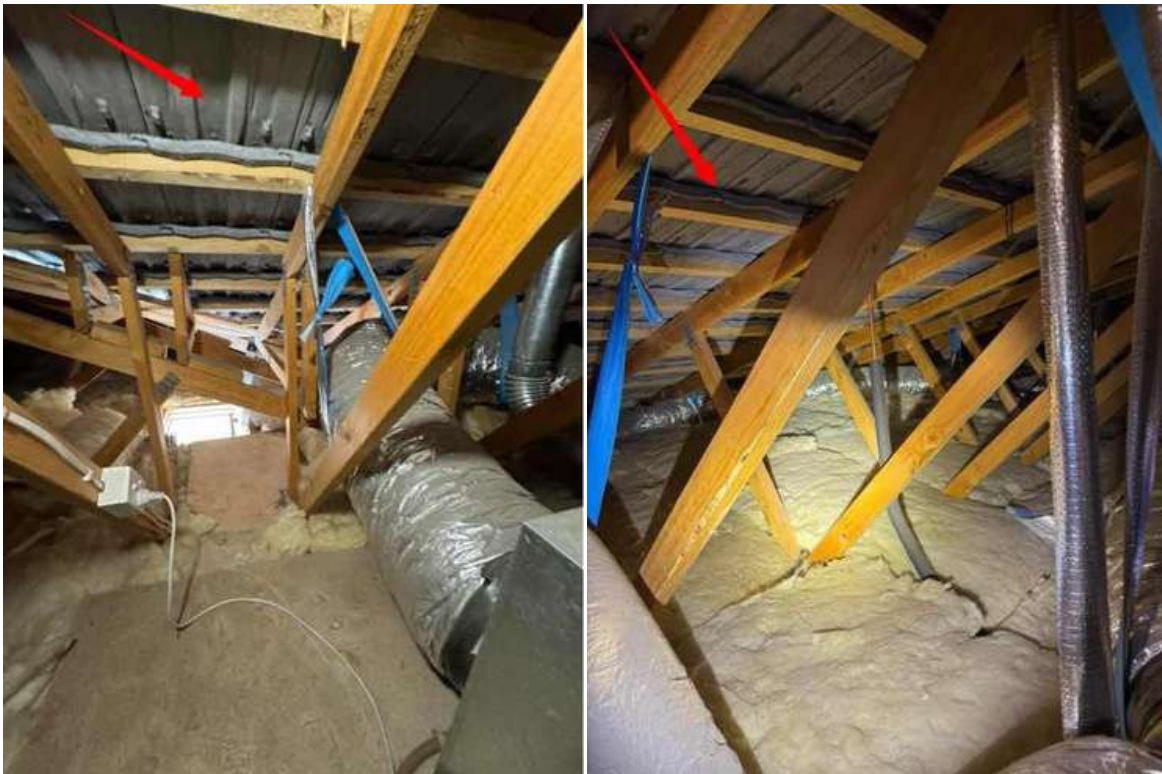
Sarking is not Installed.
