# Pre Purchase Inspection Report

## Inspectmate Pty Ltd

Report/Agreement # 25082509092479

Inspection Date: 25 Aug 2025

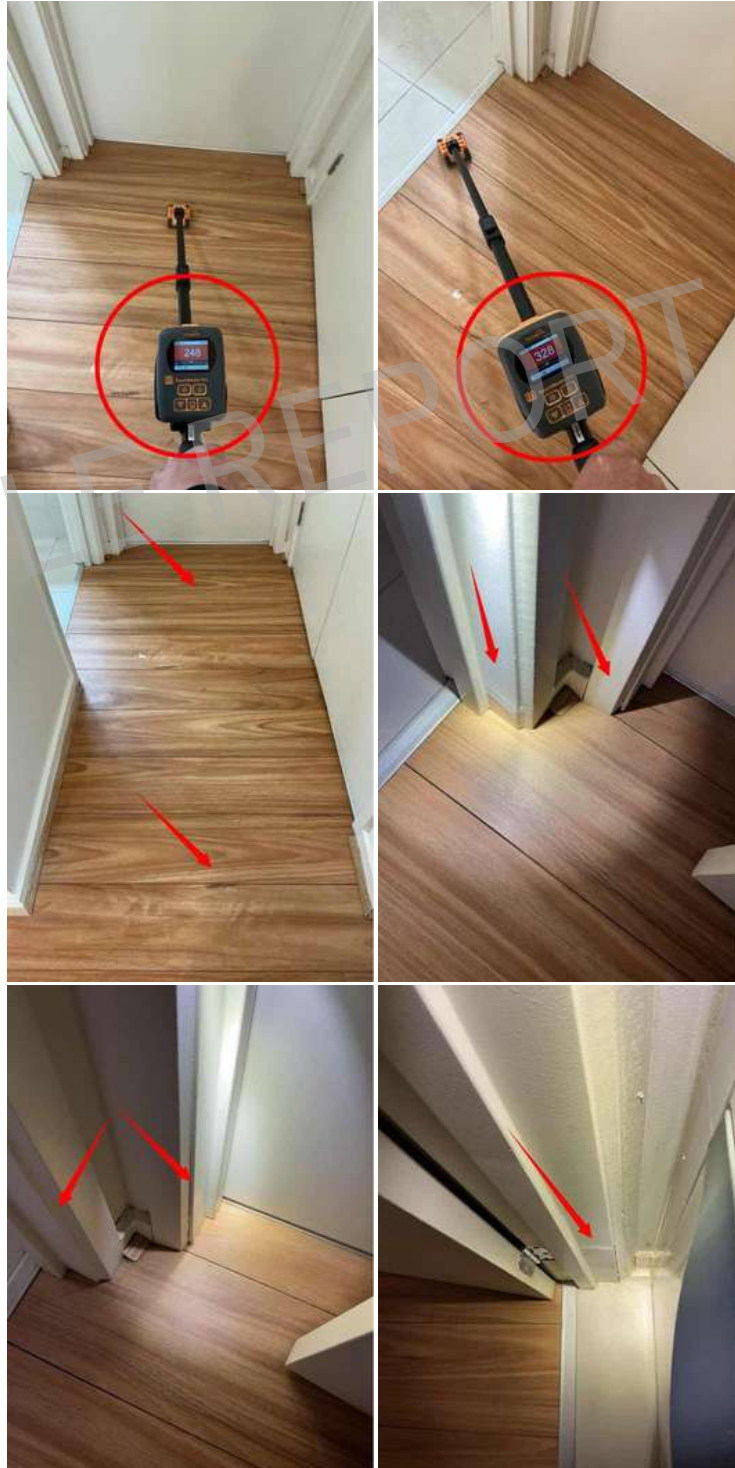
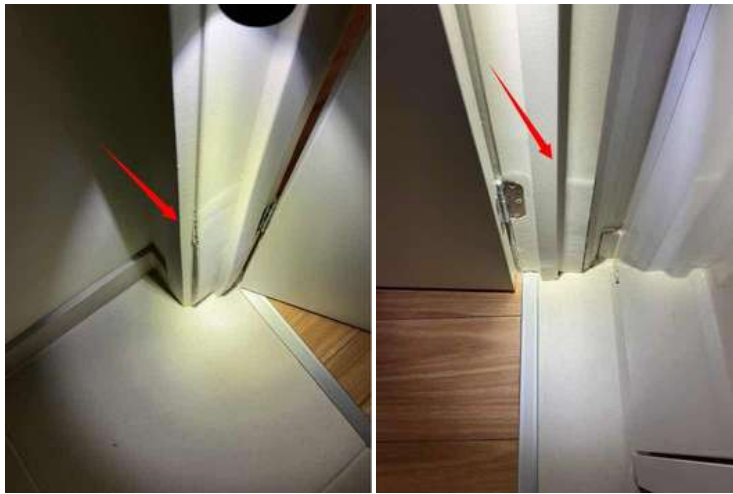
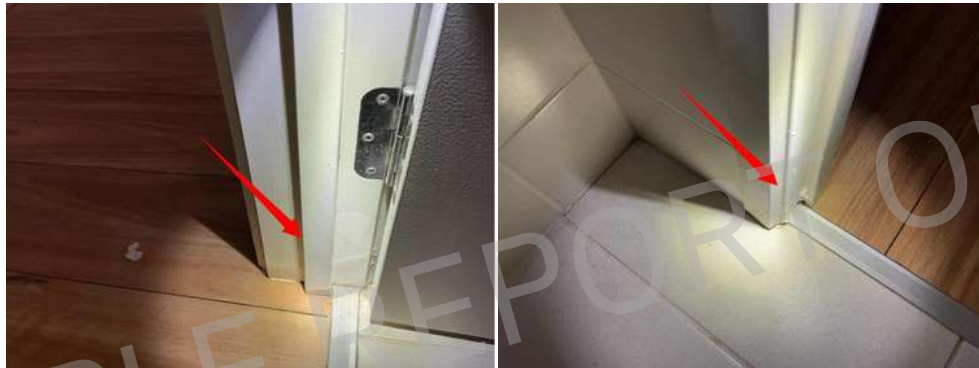
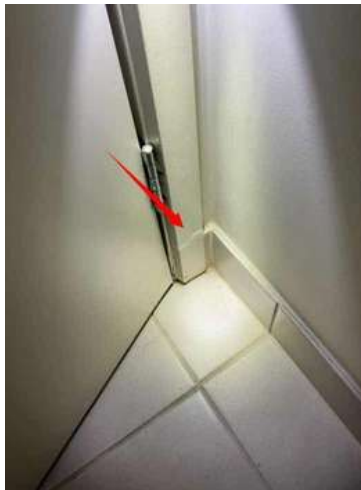
Upon visual inspection, Swelling and high levels of moisture found between the laundry and bathroom along hallway areas. We recommend a further leak and pressure test the water lines and bath leak test. Consult an appropriate licensed professional trade for a scope of works and cost of repairs for the issue prior to contracts becoming binding.
